RECREATION GROUND COMMITTEE MEETING AGENDA

Tollesbury Parish Council

7. Annual Play Equipment Inspection

Inspected: 17-June-2020 - 14:10 by Alan Lingley RPII Annual Inspector

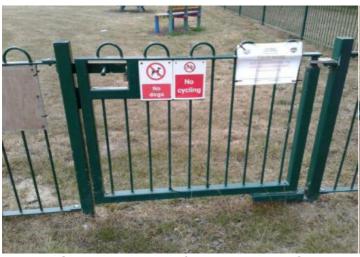
Item: Ancillary Items - Gate - Self Closing Risk Level: N - Risk Assessment not Undertaken

Finding: Gate locked at time of inspection due to Covid 19 Action: -

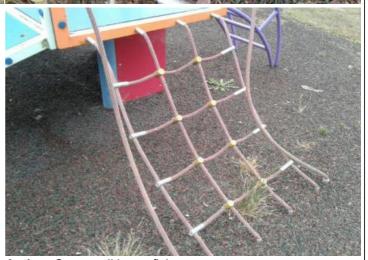
Finding: There is an opening in the barriers exceeding the width allowed (500mm) in BS EN 1176, this is a low risk failure and no remedial action is required

Finding: There is an opening in the barriers exceeding the Action: Monitor - No remedial work recommended

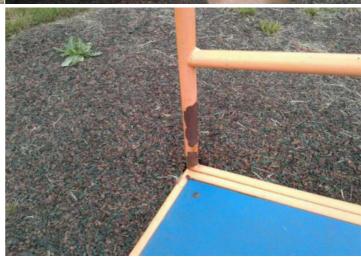
Finding: A number of fixing(s) have worked loose

Action: Secure all loose fixings

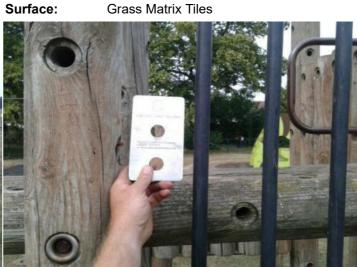
Finding: The item fails to meet the requirements of BS EN Action: Monitor - No remedial work recommended 1176 Part 1 4.2.7.2 head and neck entrapment in the barriers and/or steps

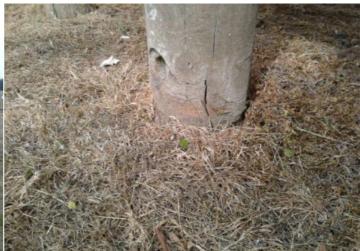
Finding: There is some strimmer / machinery damage apparent on the posts, this can penetrate the preservative applied to the timber and accelerate the rotting process

Action: Monitor for any deterioration (rot) and replace as required

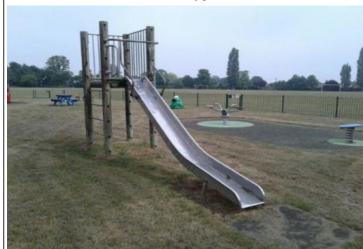
Item:Other - Free Standing SlideRisk Level:V - Very Low RiskManufacturer:Wicksteed PlaygroundsSurface:Grass Matrix Tiles

Finding: There are a number of dents in the slide surface

Action: Monitor for any further deterioration and repair as required

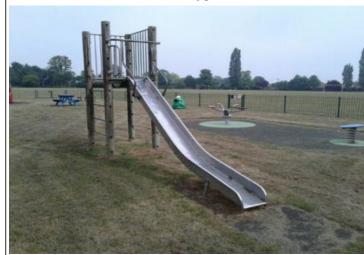
Finding: The item fails to meet the requirements of BS EN **Action:** Monitor - No remedial work recommended 1176 Part 1 4.2.7.2 head and neck entrapment in the barriers and/or steps

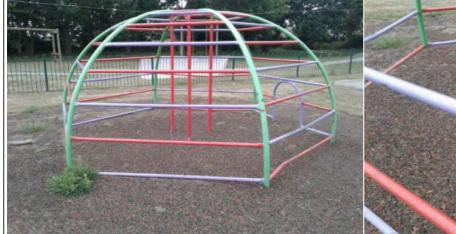
Finding: The paintwork on this item has been damaged or worn exposing the metal underneath which is rusting

Action: Treat any rusting components and repaint

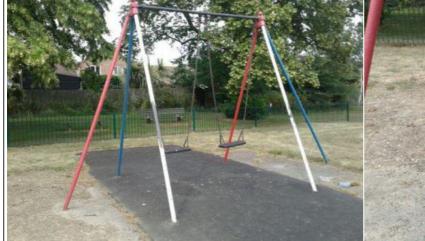
Finding: The seats are too close to the frame as defined in Action: Monitor - No remedial work recommended BS EN 1176 Part 2; this is a low risk failure and no remedial action is required

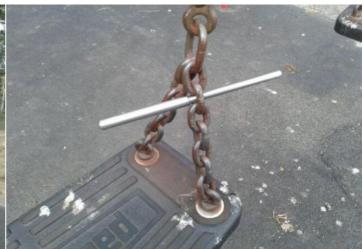
Finding: The chain openings are in excess of the 8.6mm as **Action:** Monitor - No remedial work recommended recommended by BS EN 1176

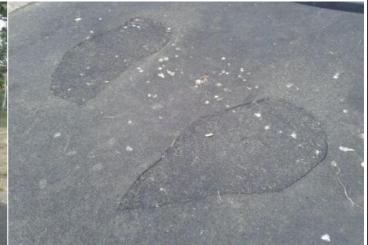
Item:Swings - 1 Bay 2 Seat (Flat)Risk Level:L - Low RiskManufacturer:Wicksteed PlaygroundsSurface:Wet Pour

Finding: There are gaps opening between the surfacing and **Action:** Monitor for any further deterioration and repair as the edging surround or between the joints in the surfacing required

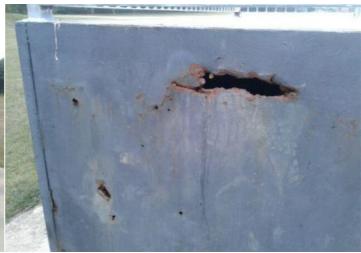
Finding: Parts of the steel on this item have corroded excessively and the metal has perforated in places

Risk Level: M - Moderate Risk
Surface: Concrete

Action: Ensure all affected areas are treated and repaired

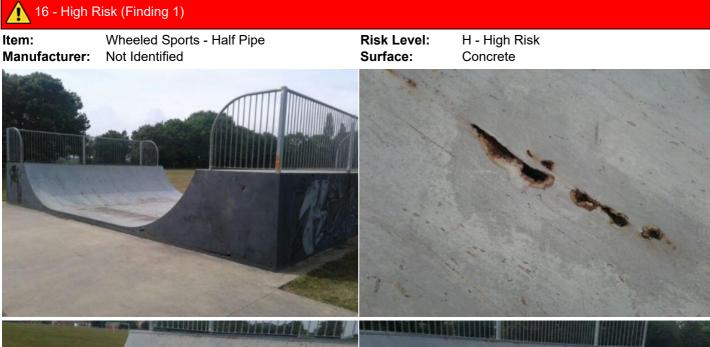
Finding: The riding surface of the ramp is severely damaged- The damage on the surface of the ramps suggests that the metal riding surface is deteriorating we recommend an internal inspection of the item is carried to ascertain the structural stability of the item

We would recommend, as we have done on the previous ramp, to re-plate all over, clean the welds flush and re-paint, also patch up the side where they have rusted through

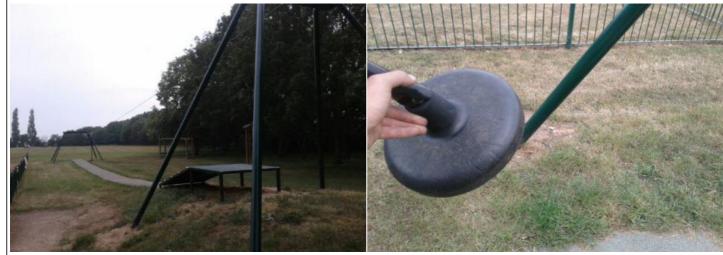
Item:Other - Cable RunwayRisk Level:L - Low RiskManufacturer:Not IdentifiedSurface:Wet Pour

Finding: The seat is less than 2.0 metres from the post when extended at 45 degrees at the end of the area of travel minimum distance is maintained and does not meet the requirements of BS EN 1176 Part 4

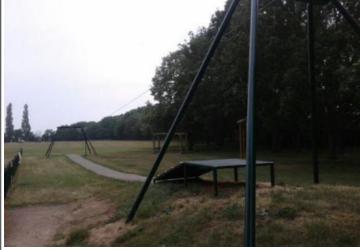
Finding: The seat suspension cover has been damaged

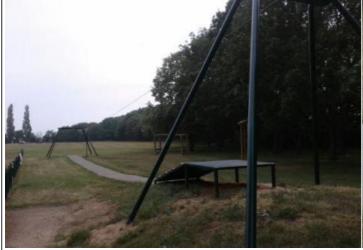
Item: Other - Cable Runway Risk Level: L - Low Risk Manufacturer: Not Identified Surface: Wet Pour

Finding: The height of the seat is less than 350mm when loaded and does not meet the requirements of BS EN 1176 ground level when loaded with 69.5kg Part 4

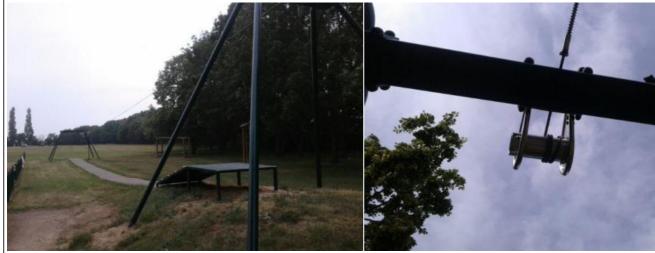
Finding: There are three turns of the cable on the drum

Action: Refer to the contractor for confirmation of correct installation

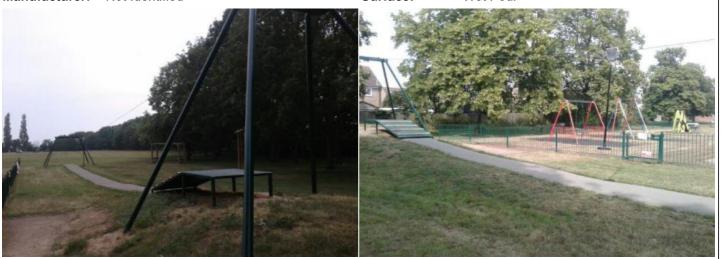
Item:Other - Cable RunwayRisk Level:L - Low RiskManufacturer:Not IdentifiedSurface:Wet Pour

Finding: There is the potential for users to pass through the **Action:** Monitor use freespace of the cableway when entering or exiting the play

area
