# RECREATION GROUND COMMITTEE MEETING AGENDA

### **Tollesbury Parish Council**

#### 7. Safety Inspection Report

To receive <u>Annual Play Area Inspection Report</u> and consider recommendations.

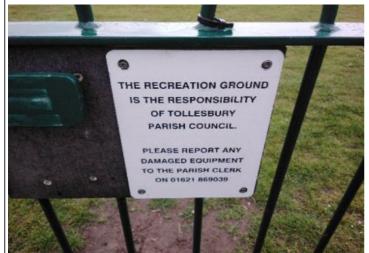
**Finding:** BS EN 1176 Part 7 recommends that signage shall **Action:** Provide additional information include the site name / address

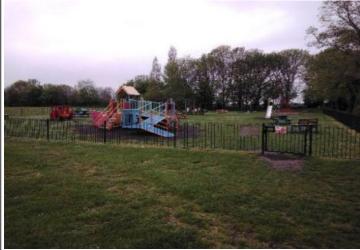
**Finding:** It is recommended that signage, with information including the site address, contact information for maintenance issues and emergency contact details are provided for the facility

Action: Provide in accordance with the recommendations

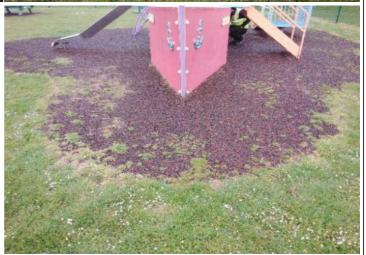
**Finding:** There is weed / vegetation growth on, between, or **Action:** Remove weed / vegetation growth around the edges of the surfacing

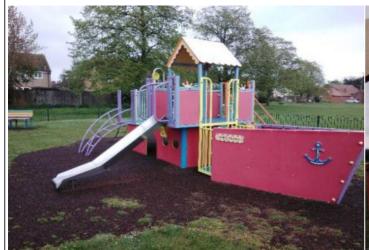
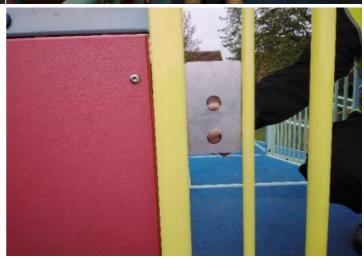
### 5 - Very Low Risk (Finding 3)

**Finding:** The item fails to meet the requirements of BS EN **Action:** Monitor - No remedial work recommended 1176 Part 1 4.2.7.2 head and neck entrapment in the barriers and/or steps

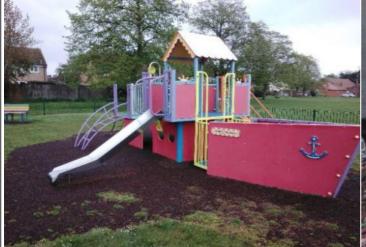
Finding: The weld(s) on the slide run out have failed

Action: Repair item

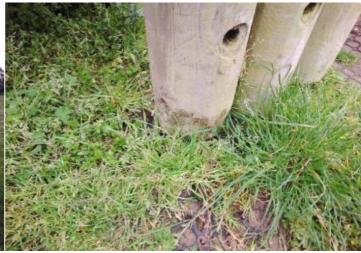
**Finding:** There is some strimmer / machinery damage apparent on the posts, this can penetrate the preservative applied to the timber and accelerate the rotting process

**Action:** Monitor for any deterioration (rot) and replace as required

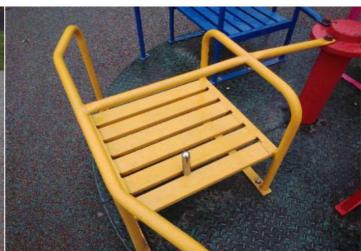
**Finding:** There is/are finger entrapment/s in the seats and the item fails to meet the requirements of BS EN 1176 Part 1 4.2.7.6 Entrapment of fingers

Action: Monitor - No remedial work recommended

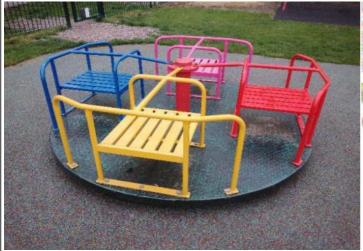
# 6 - Low Risk (Finding 2)

**Finding:** The underside of the rotating platform shall be smooth for the first 500mm towards the axis to comply with the requirements of BS EN 1176 Part 5

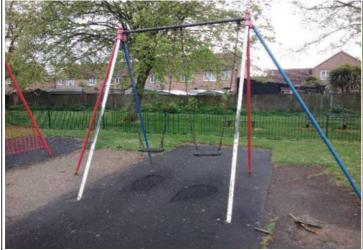
# 4 - Very Low Risk (Finding 1)

Finding: The seats are too close to the frame as defined in Action: Monitor - No remedial work recommended BS EN 1176 Part 2; this is a low risk failure and no remedial action is required

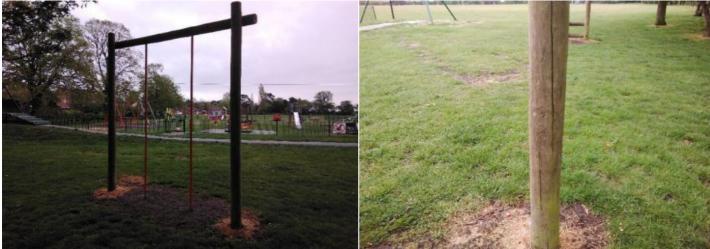
**Finding:** The timber has a number of splits/shakes or air Action: Monitor to ensure the splits do not cross through cracks and this may affect the stability or allow water ingress fixing points of the structure and/or cause any instability which will accelerate the rotting process

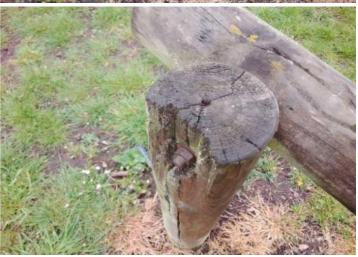
Finding: There is some damage to the item

**Action:** Monitor for any further deterioration and repair as required

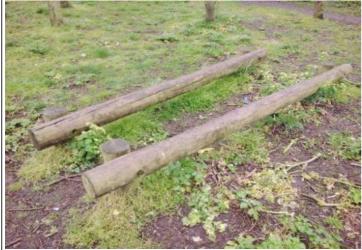
**Finding:** The timber has a number of splits/shakes or air cracks and this may affect the stability or allow water ingress fixing points of the structure and/or cause any instability which will accelerate the rotting process

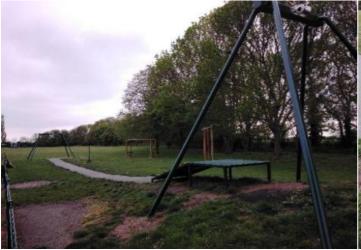
**Finding:** The height of the seat is less than 350mm when loaded and does not meet the requirements of BS EN 1176 ground level when loaded with 69.5kg Part 4

Action: Ensure the seat is a minimum of 350mm above
