TOLLESBURY
PARISH
COUNCIL

AGENDA – RECREATION GROUND COMMITTEE
11TH OCTOBER 2022

7. Play Inspection Report

To receive the report from the Annual Independent Play Area inspection.

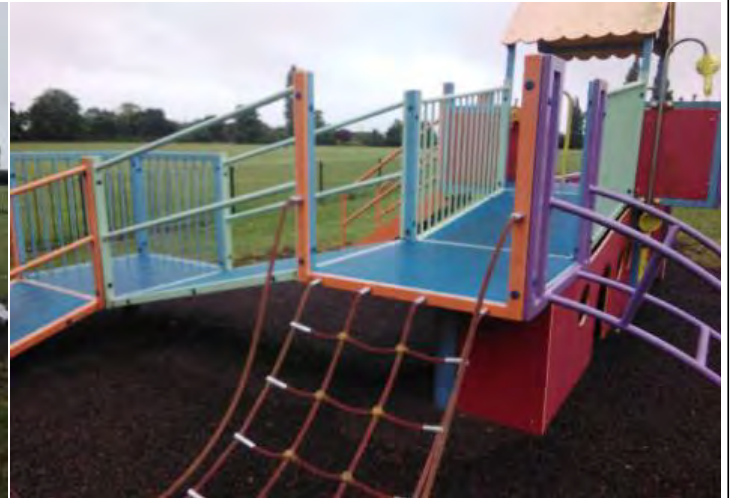
Item: Activity Equipment - Multi Play (Junior)
Manufacturer: Not Identified

Risk Level: V - Very Low Risk
Surface: Bonded Rubber Mulch

Finding: There is an opening in the barriers exceeding the width allowed (500mm) in BS EN 1176, this is a low risk failure and no remedial action is required

Action: Monitor - No remedial work recommended

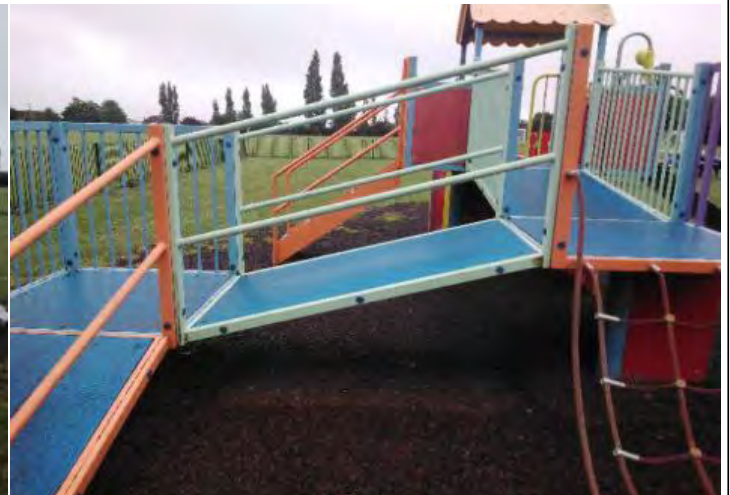
Item: Activity Equipment - Multi Play (Junior)
Manufacturer: Not Identified

Risk Level: L - Low Risk
Surface: Bonded Rubber Mulch

Finding: The unit is easily accessible and should have the appropriate barriers installed to meet the requirements of BS EN 1176 Part 1 as the height of the unit exceeds 600mm

Action: Monitor - No remedial work recommended

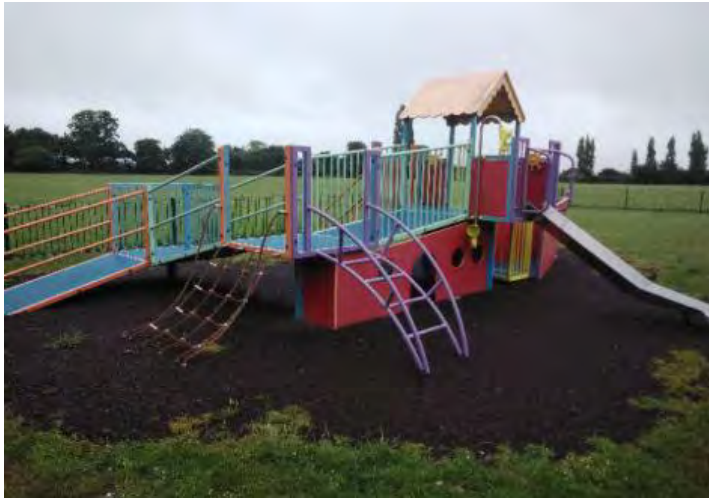
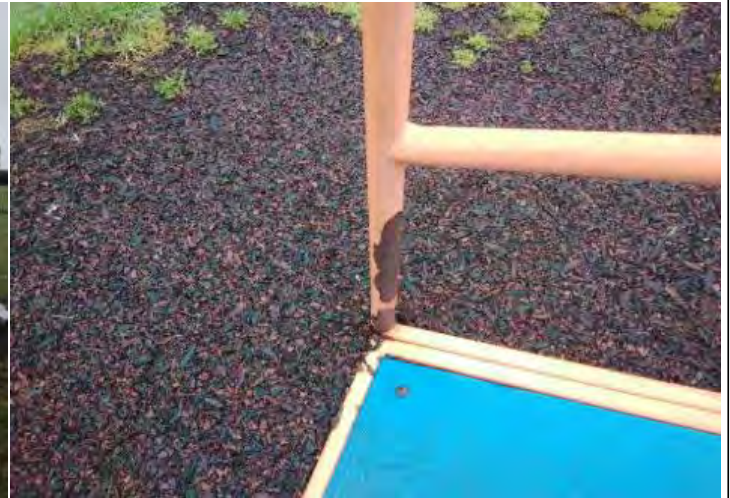
Item: Activity Equipment - Multi Play (Junior)
Manufacturer: Not Identified

Risk Level: L - Low Risk
Surface: Bonded Rubber Mulch

Finding: The paintwork on this item has been damaged or worn exposing the metal underneath which is rusting

Action: Treat any rusting components and repaint

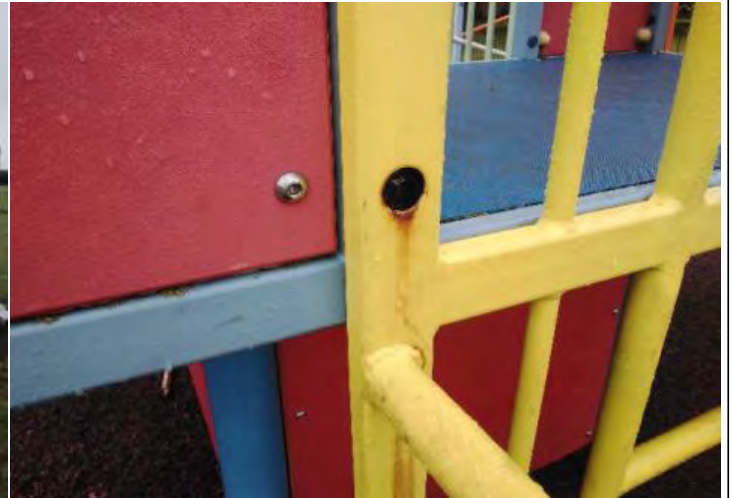
Item: Activity Equipment - Multi Play (Junior)
Manufacturer: Not Identified

Risk Level: V - Very Low Risk
Surface: Bonded Rubber Mulch

Finding: There is/are several inserts missing

Action: Replace missing inserts

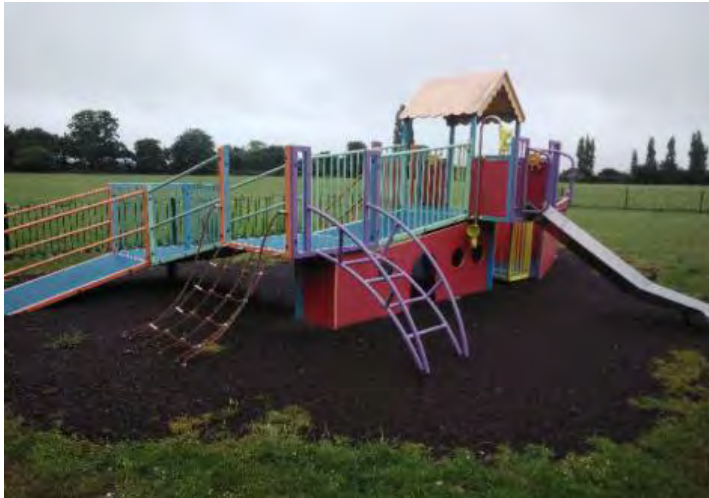
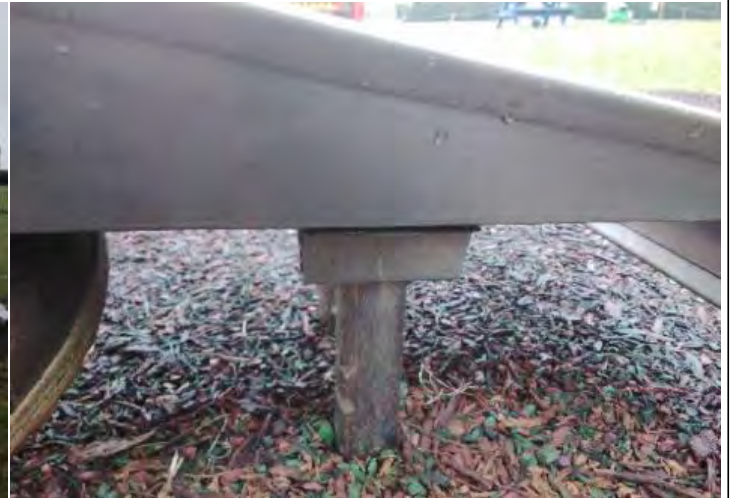
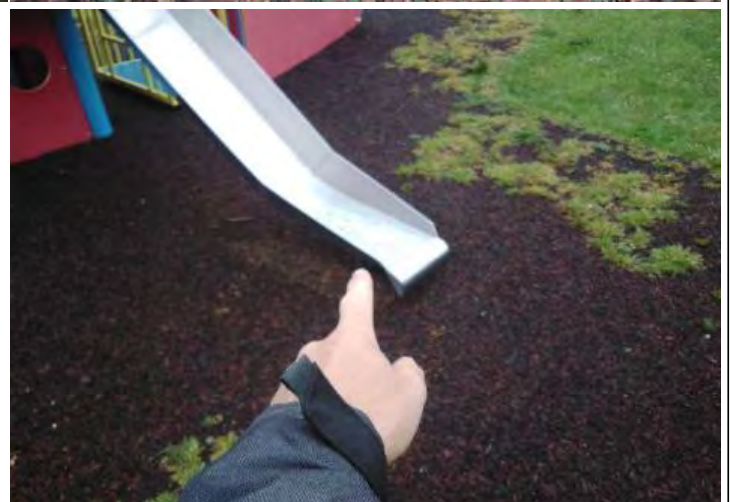
Risk Level: L - Low Risk
Surface: Bonded Rubber Mulch

Finding: The weld(s) on this item have failed

Action: Repair item

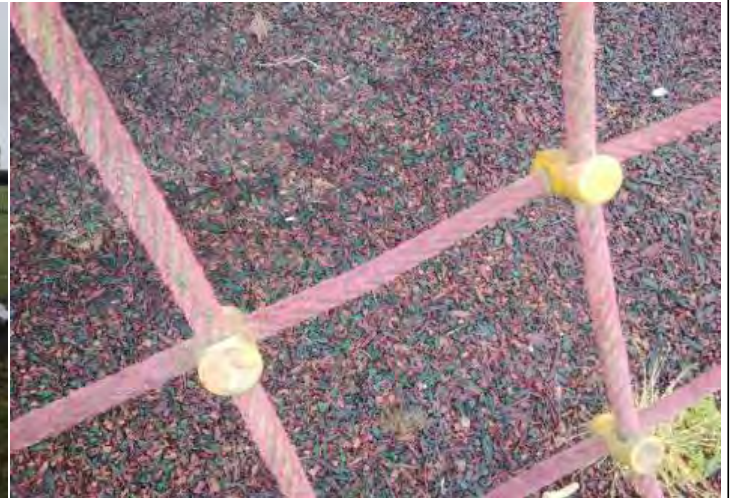
Risk Level: L - Low Risk
Surface: Bonded Rubber Mulch

Finding: The ropes/nets are worn/damaged in places

Action: Monitor for any further deterioration and repair or replace as required

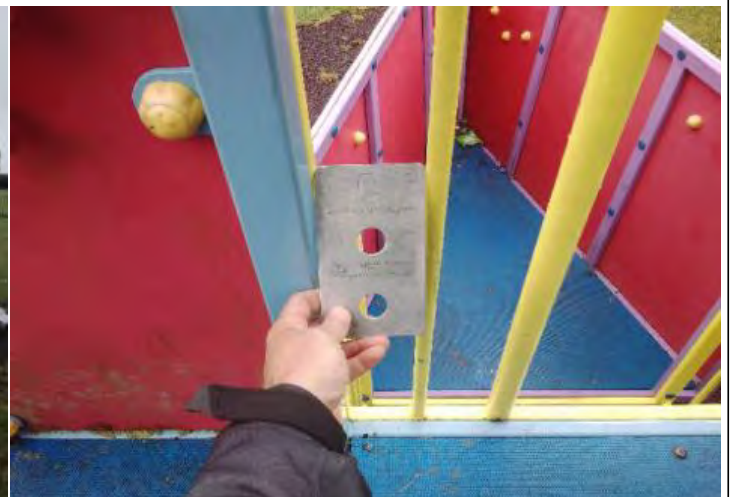
Risk Level: V - Very Low Risk
Surface: Bonded Rubber Mulch

Finding: The item fails to meet the requirements of BS EN 1176 Part 1 4.2.7.2 head and neck entrapment in the barriers and/or steps

Action: Monitor - No remedial work recommended

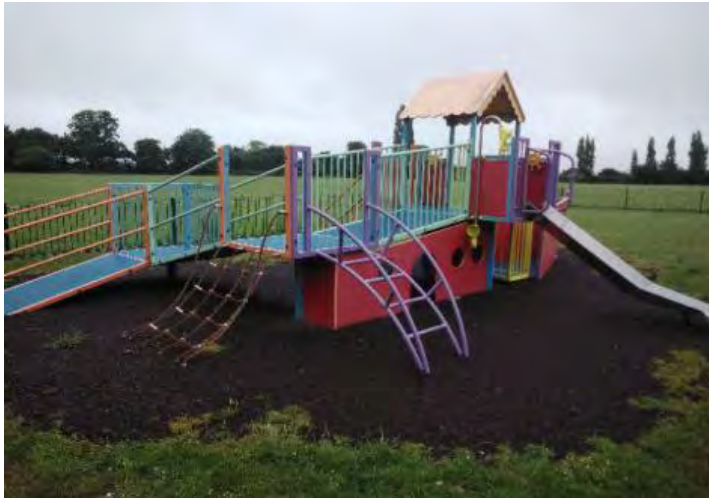
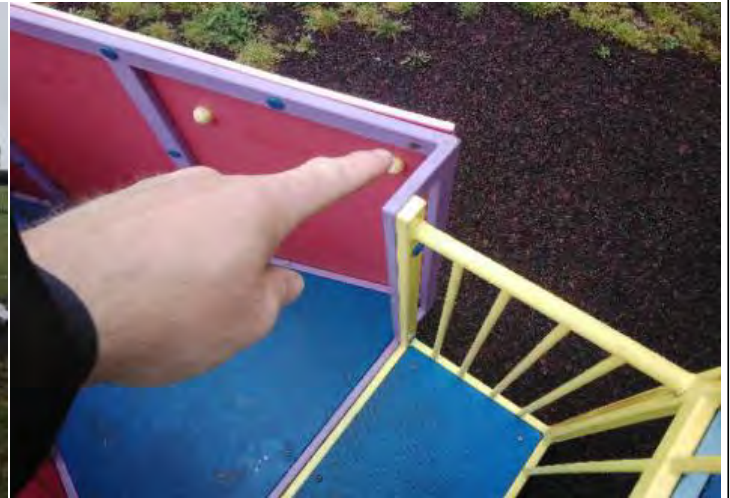
Risk Level: L - Low Risk
Surface: Bonded Rubber Mulch

Finding: There is or are fixings missing on the item

Action: Replace all missing fixings

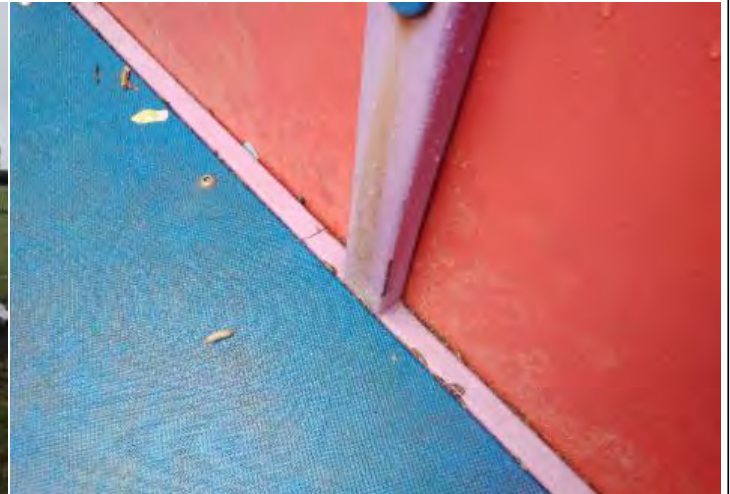
Risk Level: L - Low Risk
Surface: Bonded Rubber Mulch

Finding: The tube(s) on this item have corroded from the inside and split the steel

Action: Replace all affected parts

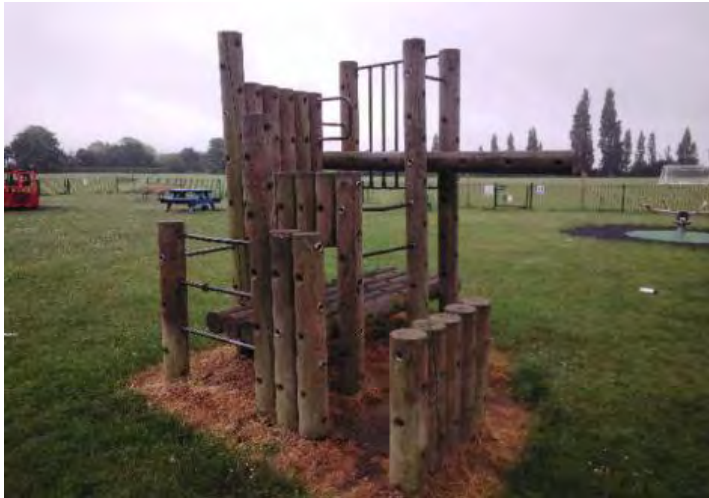
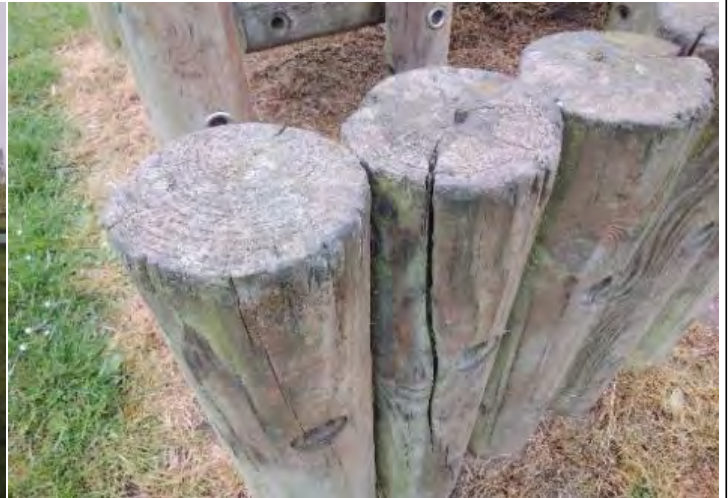
Risk Level: L - Low Risk
Surface: Grass Matrix Tiles

Finding: The timber has a number of splits/shakes or air cracks and this may affect the stability or allow water ingress which will accelerate the rotting process

Action: Monitor to ensure the splits do not cross through fixing points of the structure and/or cause any instability

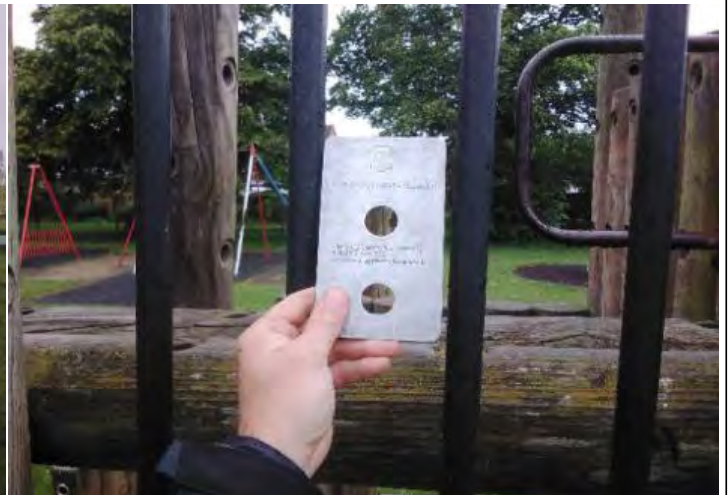
Risk Level: V - Very Low Risk
Surface: Grass Matrix Tiles

Finding: The item fails to meet the requirements of BS EN 1176 Part 1 4.2.7.2 head and neck entrapment in the barriers and/or steps

Action: Monitor - No remedial work recommended

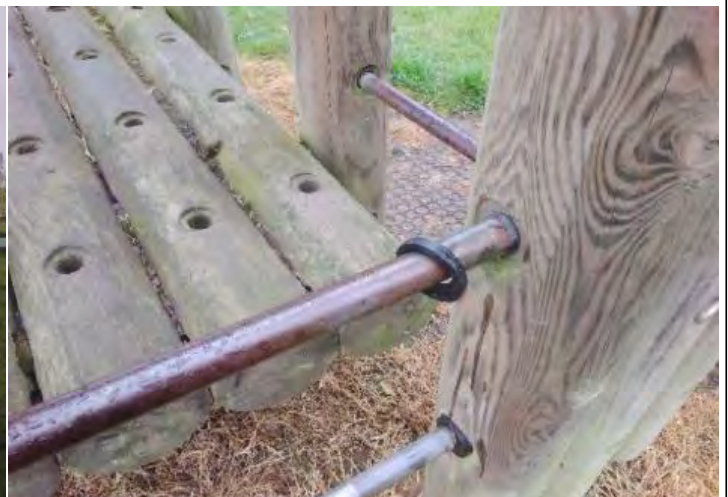
Risk Level: L - Low Risk
Surface: Grass Matrix Tiles

Finding: There is some damage to the item

Action: Monitor for any further deterioration and repair as required

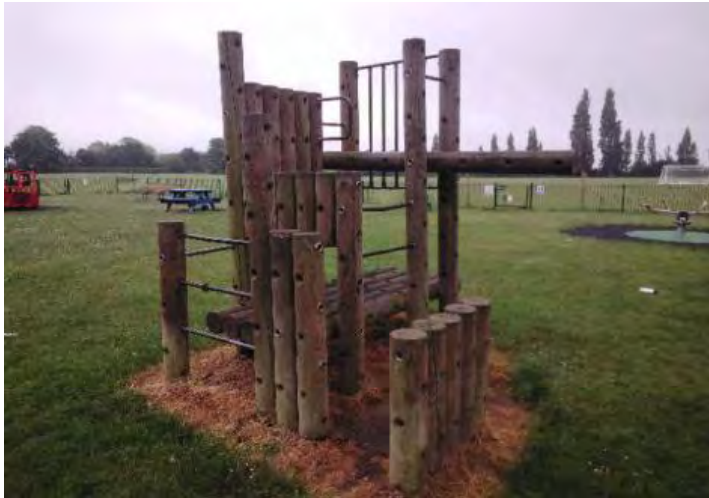
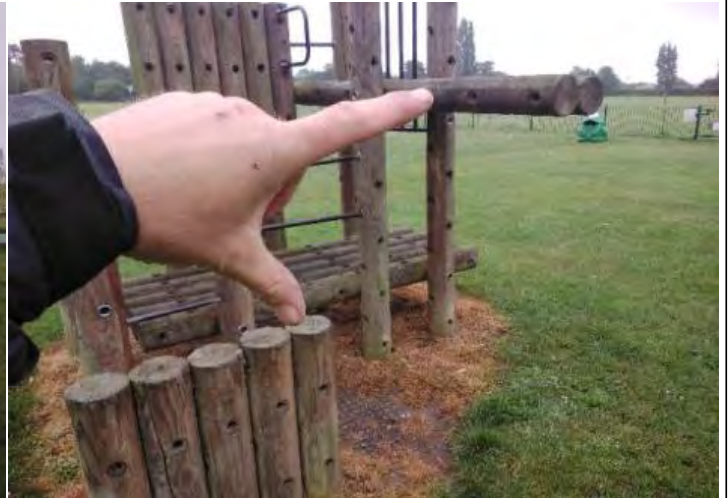
Risk Level: L - Low Risk
Surface: Grass Matrix Tiles

Finding: There are falls in excess of 600mm between adjacent components on the structure, in contravention of the recommendations set out in BS EN 1176 Part 1; 4.2.8.4

Action: Monitor - No remedial work recommended

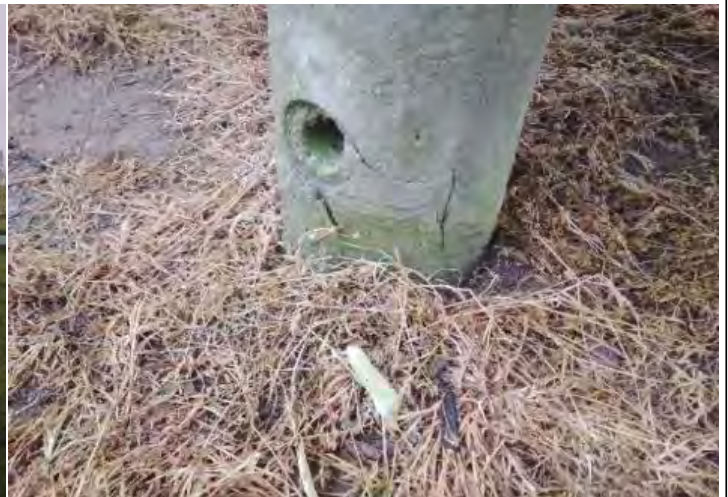
Risk Level: L - Low Risk
Surface: Grass Matrix Tiles

Finding: There is some strimmer / machinery damage apparent on the posts, this can penetrate the preservative applied to the timber and accelerate the rotting process

Action: Monitor for any deterioration (rot) and replace as required

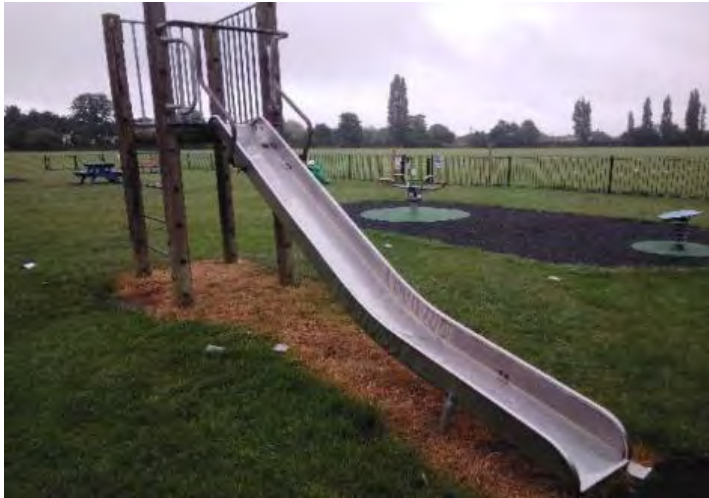
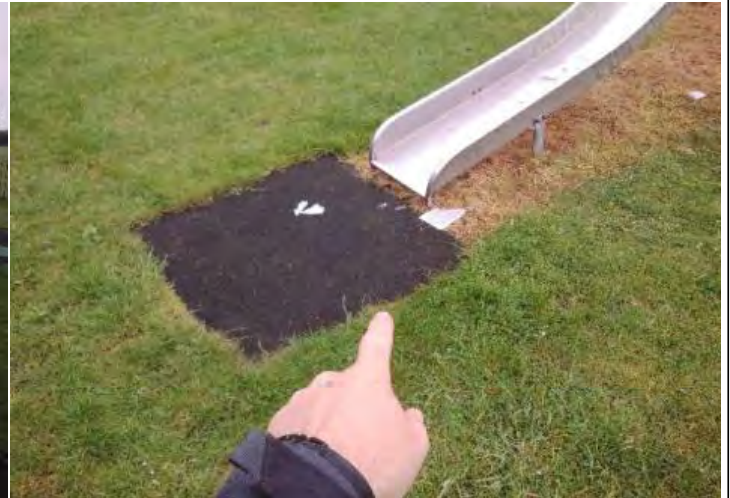
Item: Other - Free Standing Slide
Manufacturer: Wicksteed Playgrounds

Risk Level: V - Very Low Risk
Surface: Grass Matrix Tiles

Finding: The timber edging forms a hard object within the impact area of the equipment in contravention of the requirements of BS EN 1176 Part 1

Action: Monitor - No remedial work recommended

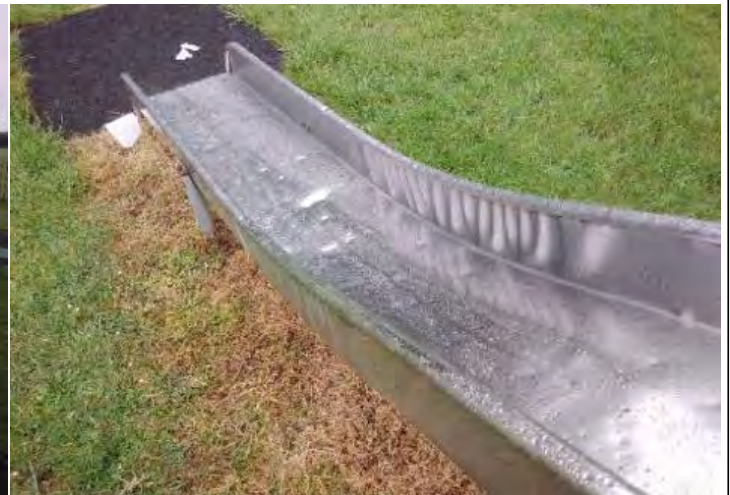
Risk Level: V - Very Low Risk
Surface: Grass Matrix Tiles

Finding: There are a number of dents in the slide surface

Action: Monitor for any further deterioration and repair as required

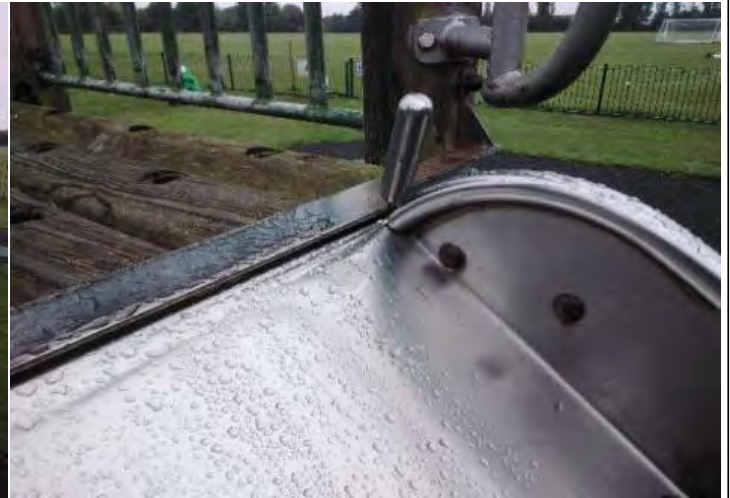
Risk Level: V - Very Low Risk
Surface: Grass Matrix Tiles

Finding: There is/are finger entrapment/s in the slide starting section and the item fails to meet the requirements of BS EN 1176 Part 1 4.2.7.6 Entrapment of fingers

Action: Monitor - No remedial work recommended

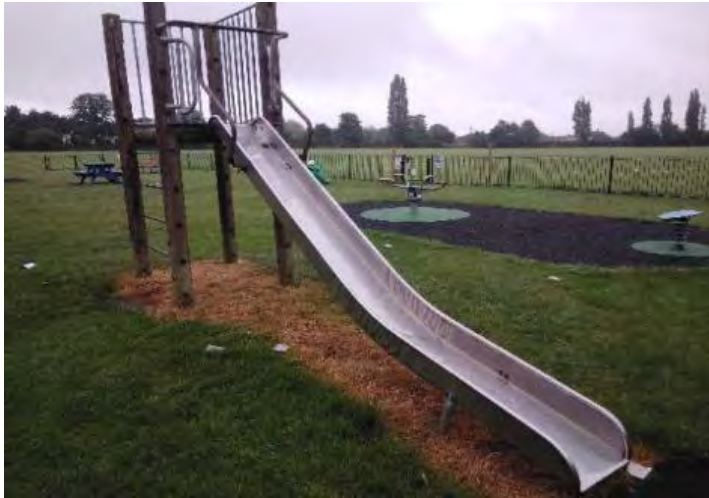
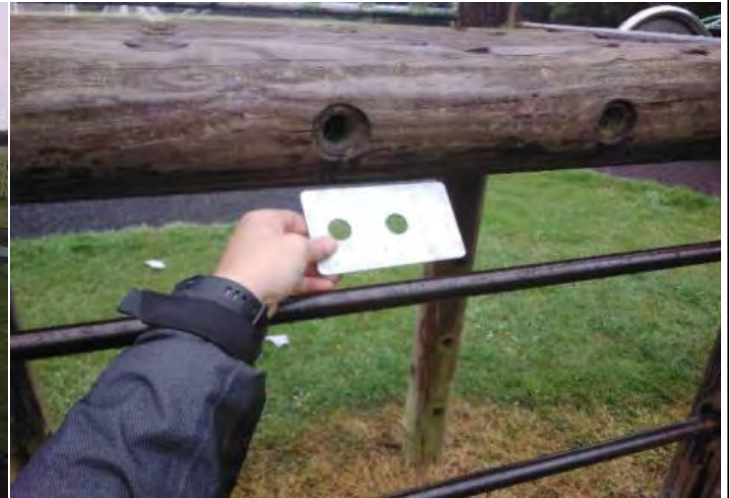
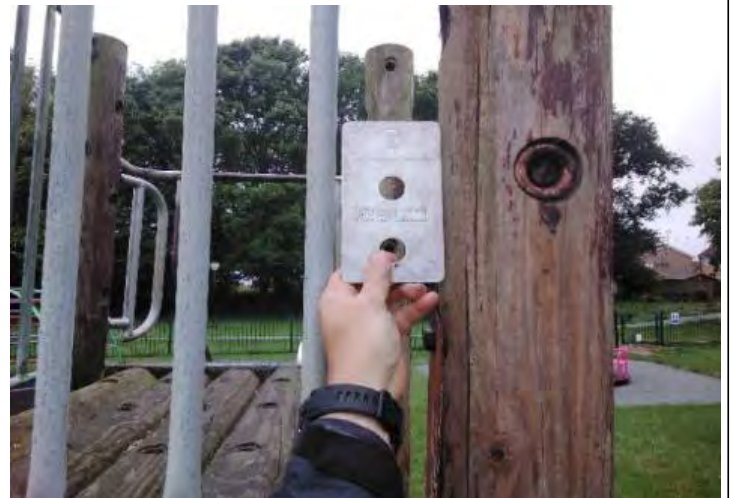
Risk Level: V - Very Low Risk
Surface: Grass Matrix Tiles

Finding: The item fails to meet the requirements of BS EN 1176 Part 1 4.2.7.2 head and neck entrapment in the barriers and/or steps

Action: Monitor - No remedial work recommended

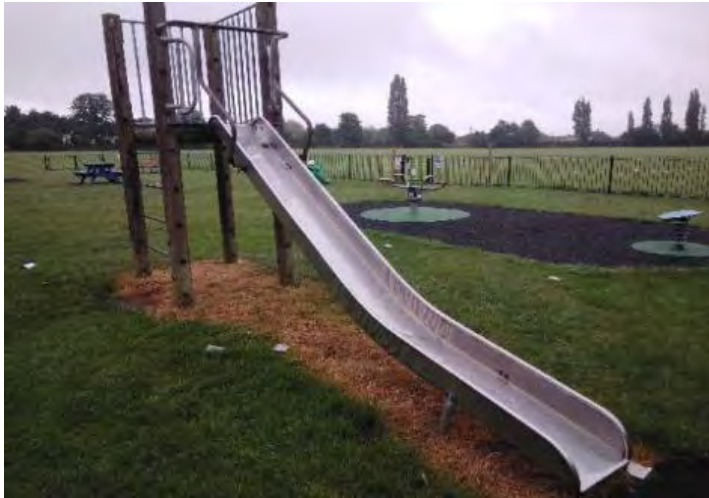
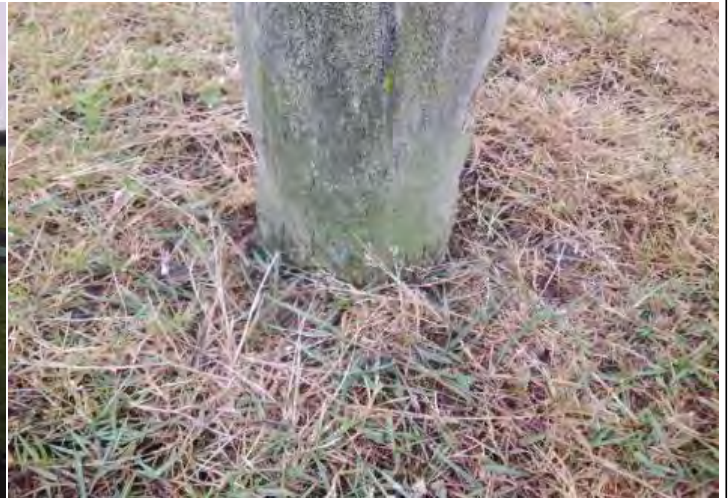
Risk Level: L - Low Risk
Surface: Grass Matrix Tiles

Finding: There is some strimmer / machinery damage apparent on the posts, this can penetrate the preservative applied to the timber and accelerate the rotting process

Action: Monitor for any deterioration (rot) and replace as required

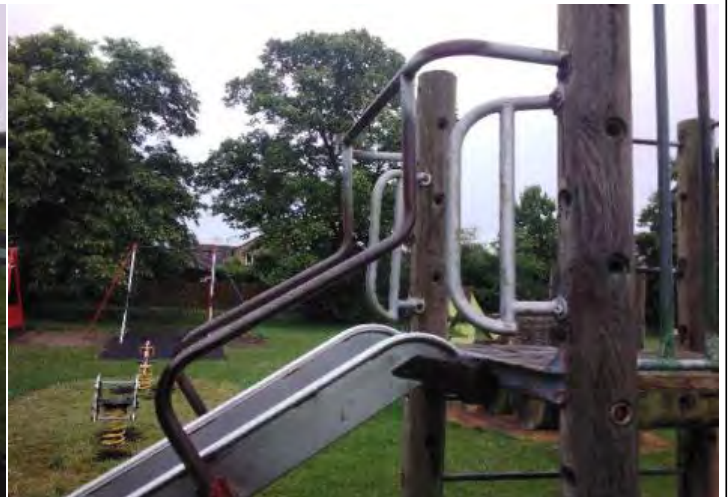
Risk Level: L - Low Risk
Surface: Grass Matrix Tiles

Finding: The paintwork on this item has been damaged or worn exposing the metal underneath which is rusting

Action: Treat any rusting components and repaint

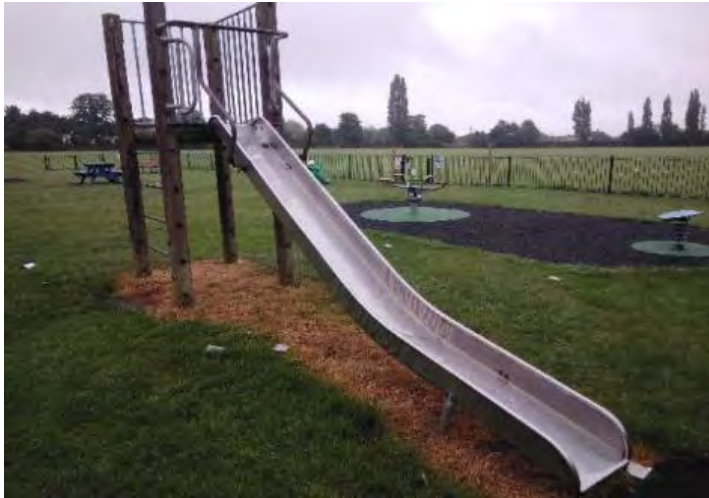
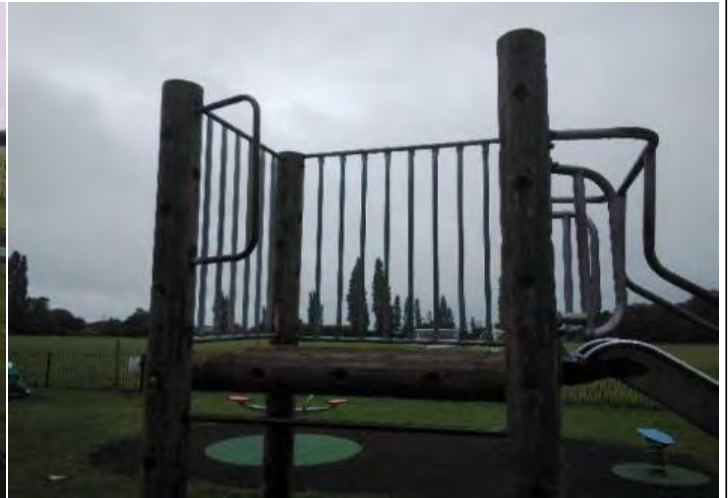
Risk Level: V - Very Low Risk
Surface: Grass Matrix Tiles

Finding: There is an opening in the barriers exceeding the width allowed (500mm) in BS EN 1176, and no guardrail has been provided; this is a low risk failure and no remedial action is required

Action: Monitor - No remedial work recommended

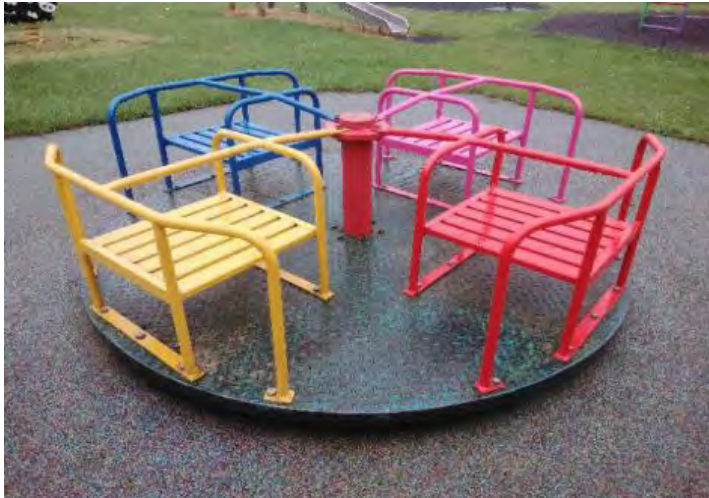
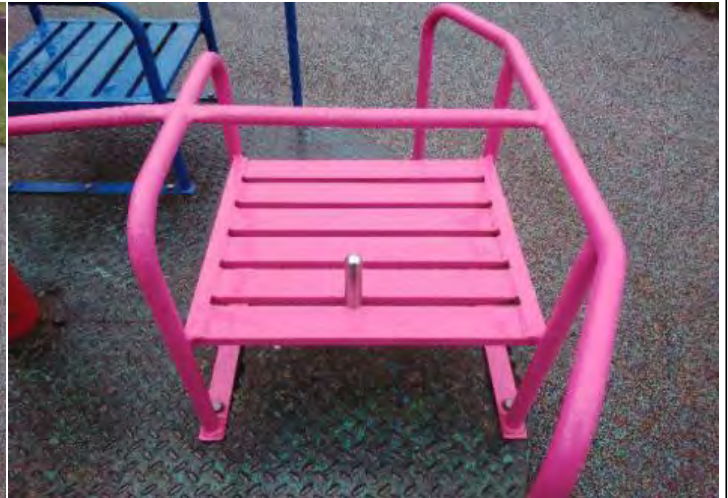
Risk Level: V - Very Low Risk
Surface: Wet Pour

Finding: There is/are finger entrapment/s in the seats and the item fails to meet the requirements of BS EN 1176 Part 1 4.2.7.6 Entrapment of fingers

Action: Monitor - No remedial work recommended

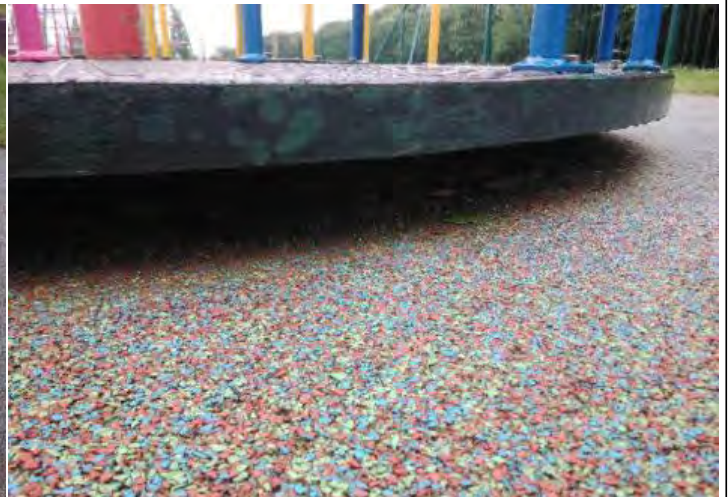
Risk Level: L - Low Risk
Surface: Wet Pour

Finding: The underside of the rotating platform shall be smooth for the first 500mm towards the axis to comply with the requirements of BS EN 1176 Part 5

Action: Monitor - No remedial work recommended

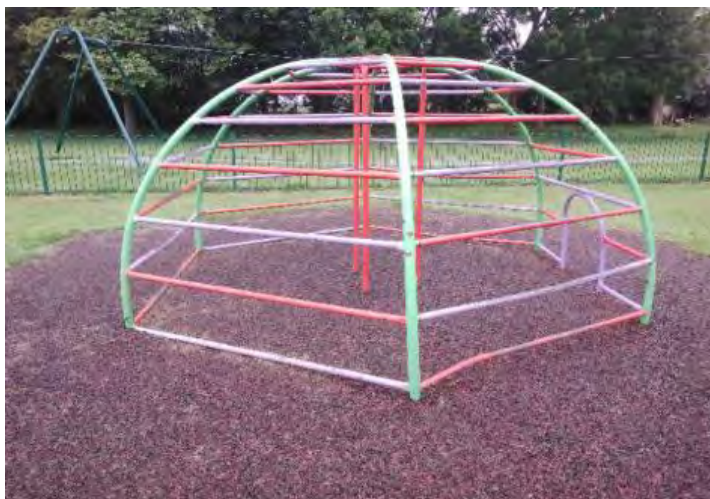
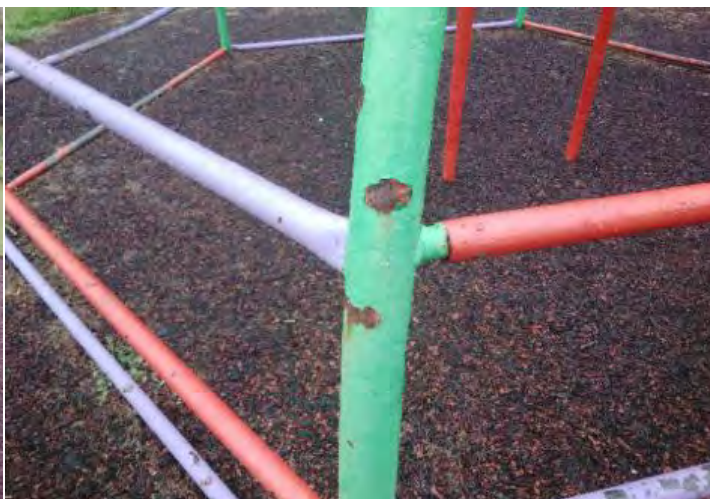
Risk Level: L - Low Risk
Surface: Bonded Rubber Mulch

Finding: The paintwork on this item has been damaged or worn exposing the metal underneath which is rusting

Action: Treat any rusting components and repaint

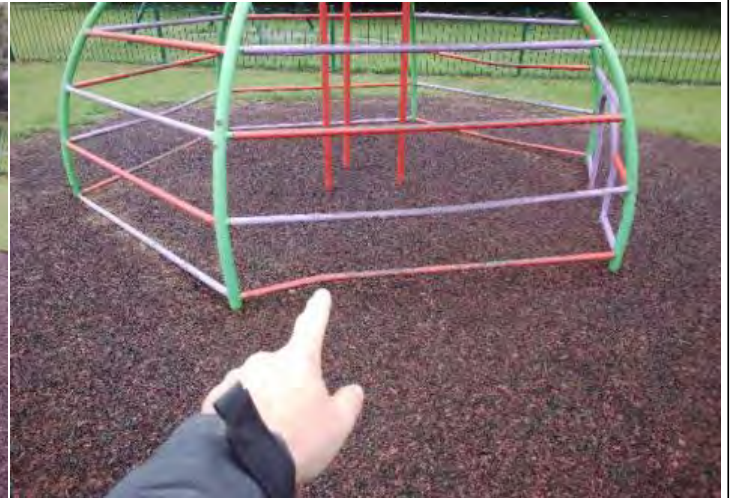
Risk Level: L - Low Risk
Surface: Bonded Rubber Mulch

Finding: There is some damage to the item

Action: Monitor for any further deterioration and repair as required

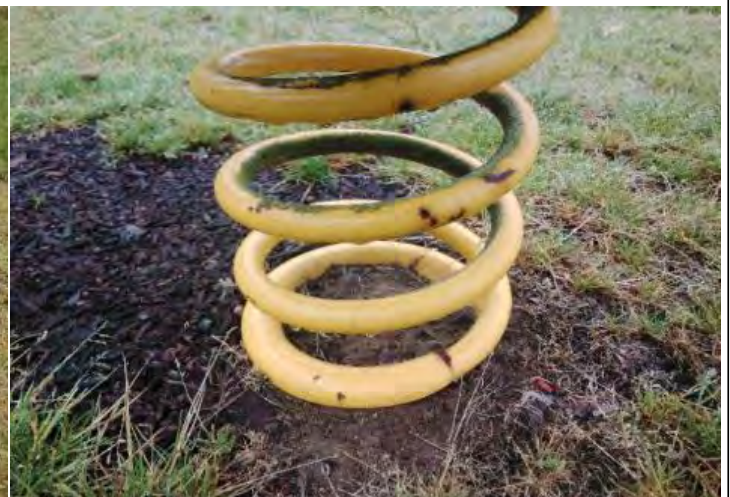
Risk Level: L - Low Risk
Surface: Bonded Rubber Mulch

Finding: The paintwork on this item has been damaged or worn exposing the metal underneath which is rusting

Action: Treat any rusting components and repaint

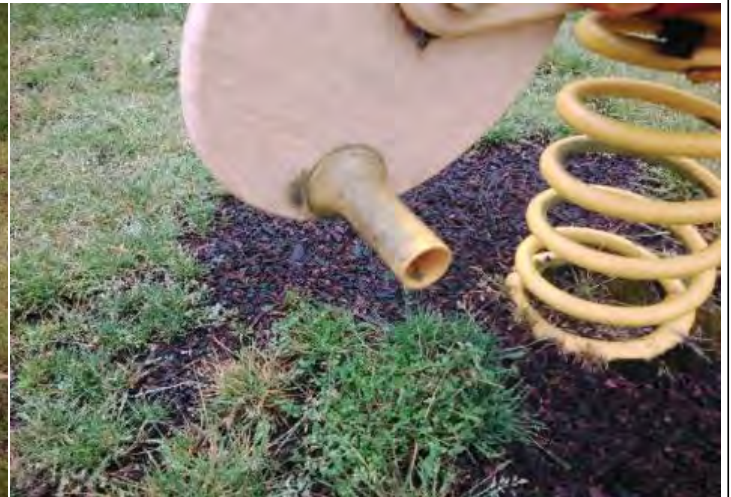
Risk Level: L - Low Risk
Surface: Bonded Rubber Mulch

Finding: The end caps are missing on the Handgrips/Footrests

Action: Replace missing end caps

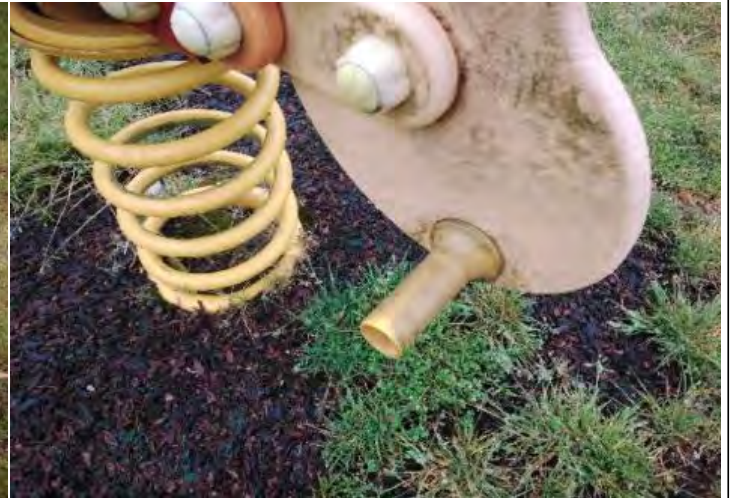
Risk Level: L - Low Risk
Surface: Bonded Rubber Mulch

Finding: The end of handgrips and/or footrests have a cross section of less than 15cm² and fail to meet the requirements of BS EN 1176 Part 6
Action: Monitor - No remedial work recommended

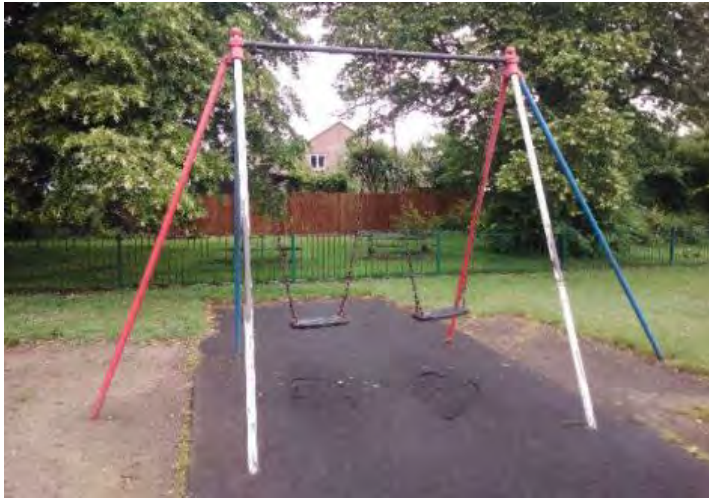
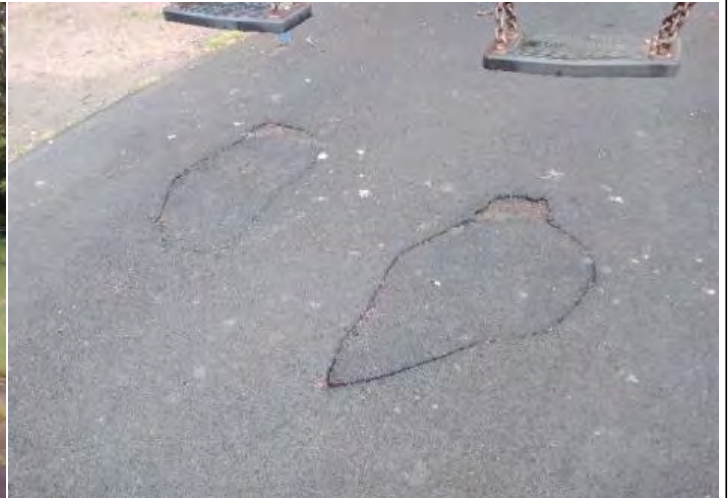
Risk Level: L - Low Risk
Surface: Wet Pour

Finding: There is moderate damage to the surface

Action: Repair the damaged areas of surfacing

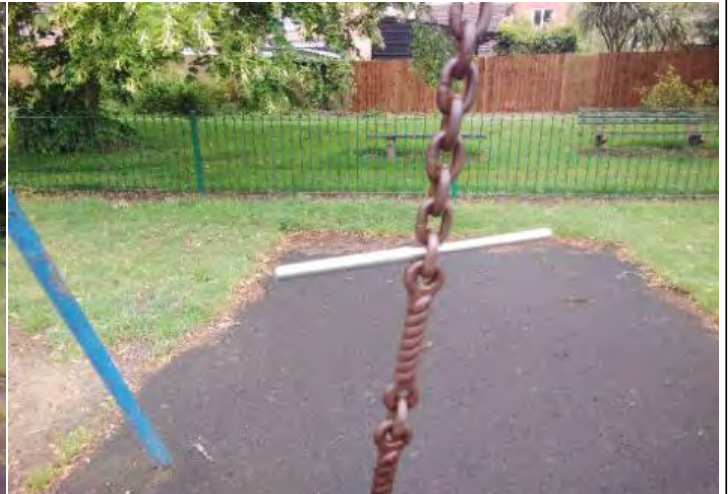
Risk Level: V - Very Low Risk
Surface: Wet Pour

Finding: The chain openings are in excess of the 8.6mm as recommended by BS EN 1176

Action: Monitor - No remedial work recommended

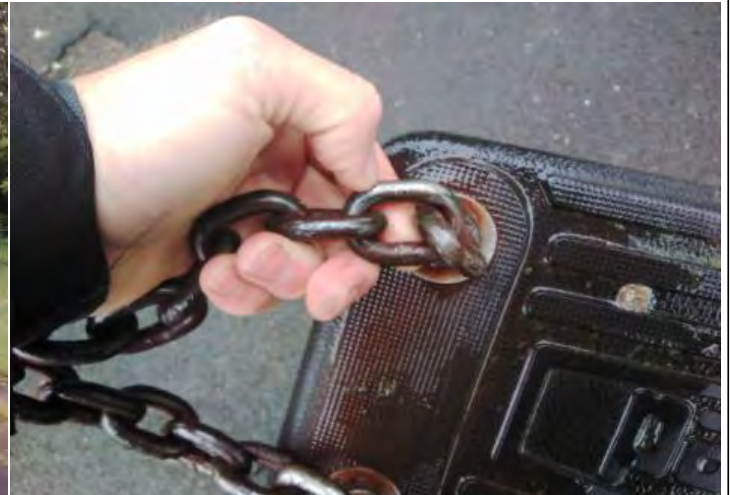
Risk Level: L - Low Risk
Surface: Wet Pour

Finding: There is some notable evidence of chain wear

Action: Monitor for any further deterioration and replace when 40% worn

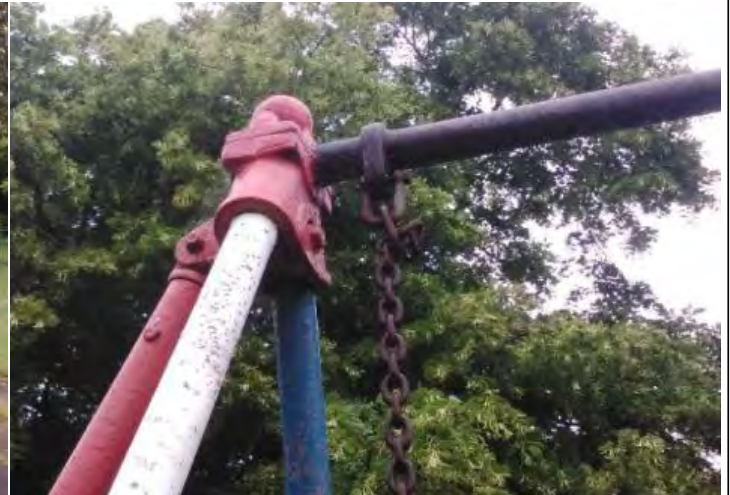
Risk Level: L - Low Risk
Surface: Wet Pour

Finding: The bushes are worn or missing

Action: Replace worn or missing bushes

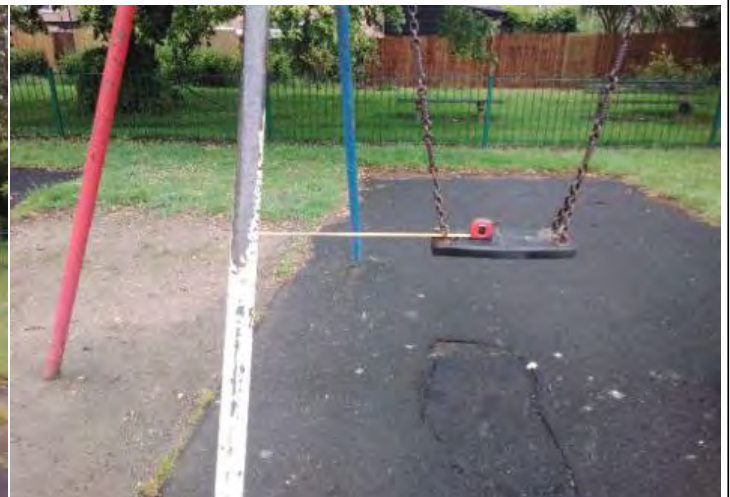
Risk Level: V - Very Low Risk
Surface: Wet Pour

Finding: The seats are too close to the frame as defined in BS EN 1176 Part 2; this is a low risk failure and no remedial action is required

Action: Monitor - No remedial work recommended

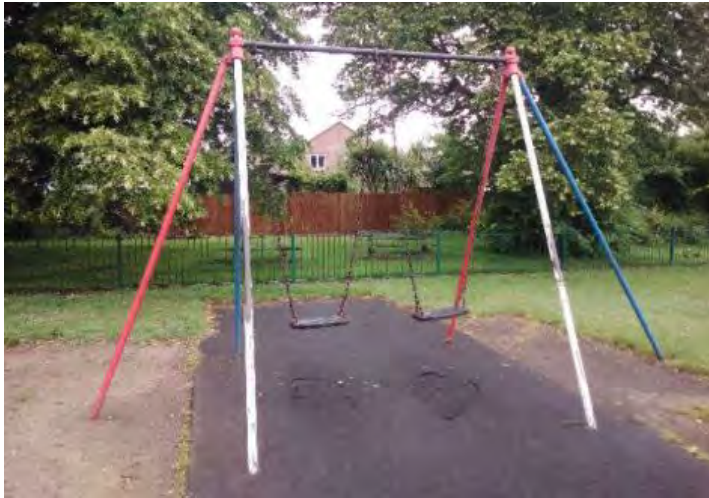
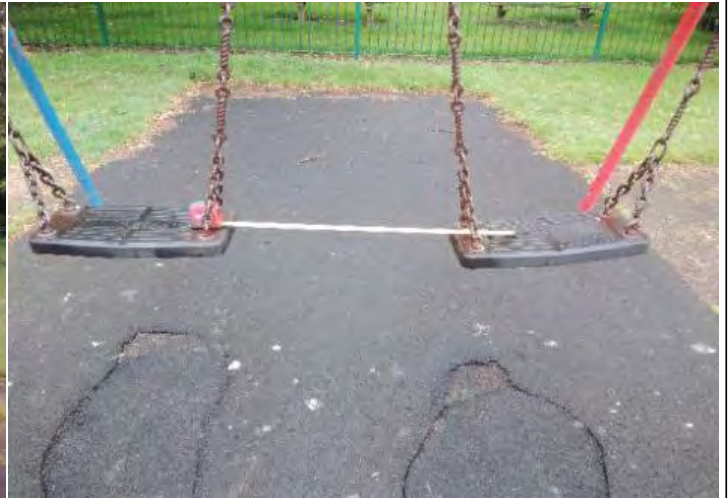
Risk Level: V - Very Low Risk
Surface: Wet Pour

Finding: The seats are too close to each other as defined in BS EN 1176 Part 2; this is a low risk failure and no remedial action is required
Action: Monitor - No remedial work recommended

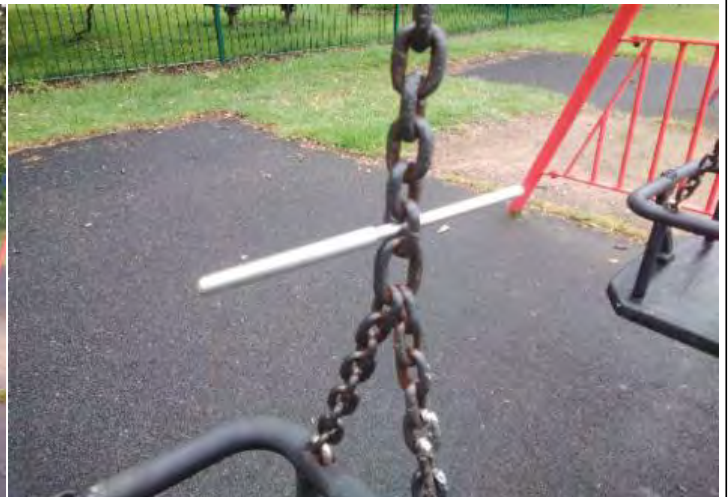
Risk Level: V - Very Low Risk
Surface: Wet Pour

Finding: The chain openings are in excess of the 8.6mm as recommended by BS EN 1176
Action: Monitor - No remedial work recommended

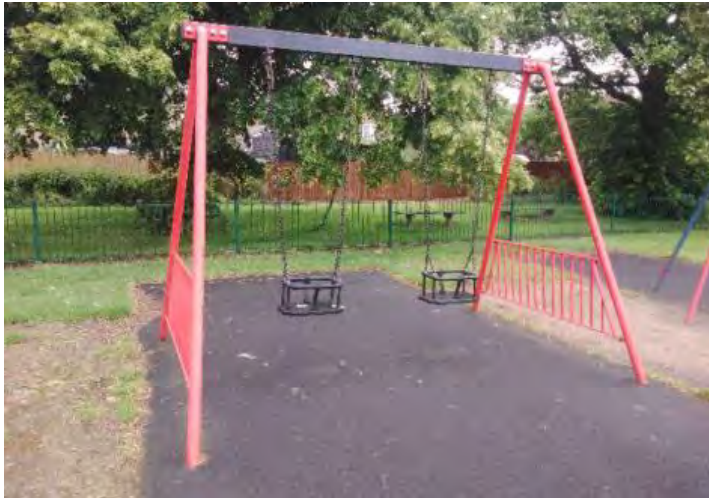
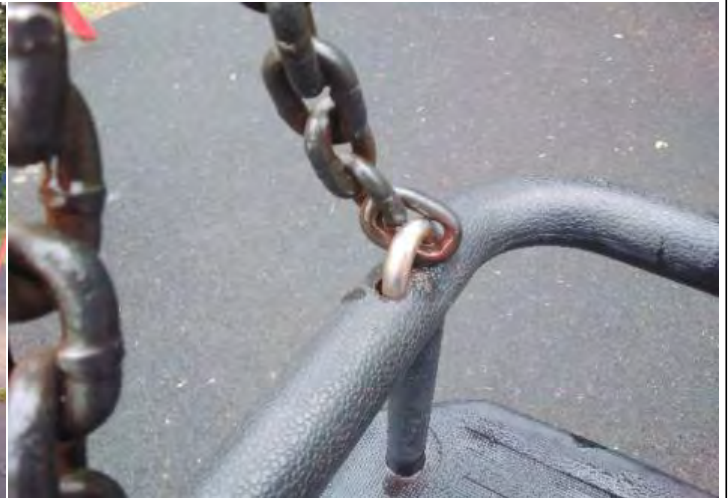
Risk Level: L - Low Risk
Surface: Wet Pour

Finding: There is some notable evidence of chain wear

Action: Monitor for any further deterioration and replace when 40% worn

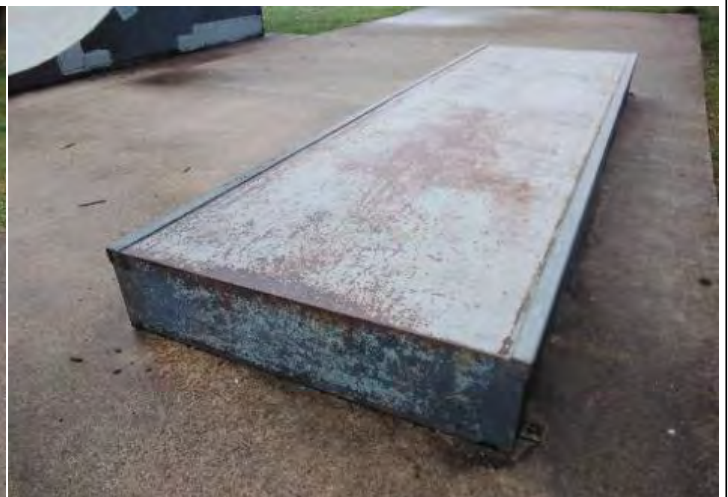
Risk Level: L - Low Risk
Surface: Concrete

Finding: The paintwork on this item has been damaged or worn exposing the metal underneath which is rusting

Action: Treat any rusting components and repaint

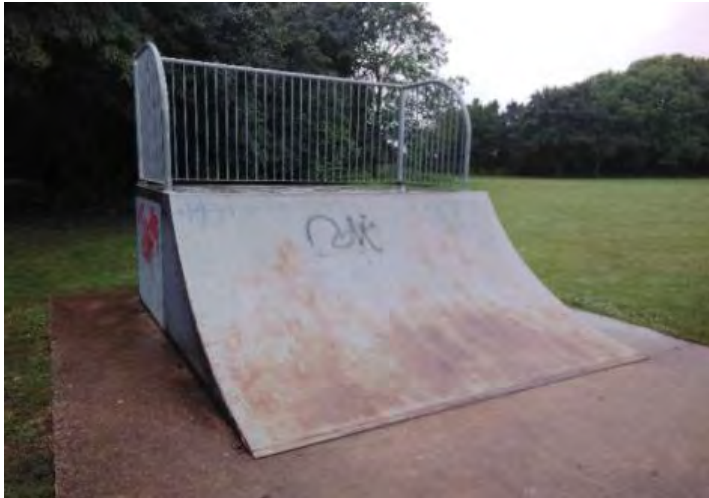
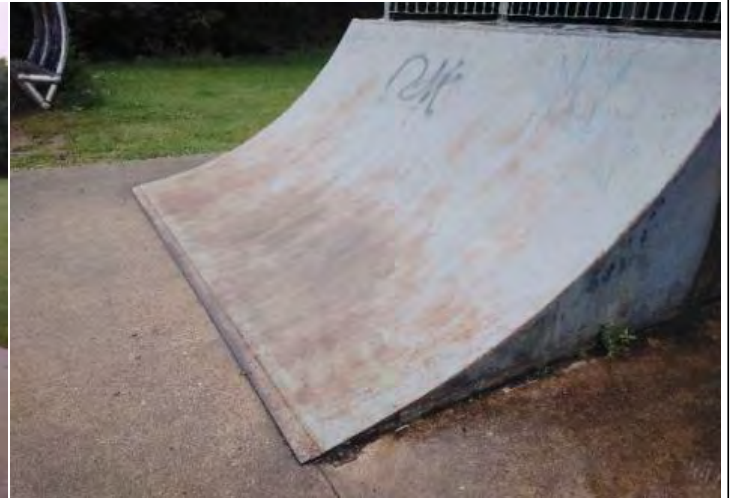
Risk Level: L - Low Risk
Surface: Concrete

Finding: The paintwork on this item has been damaged or worn exposing the metal underneath which is rusting

Action: Treat any rusting components and repaint

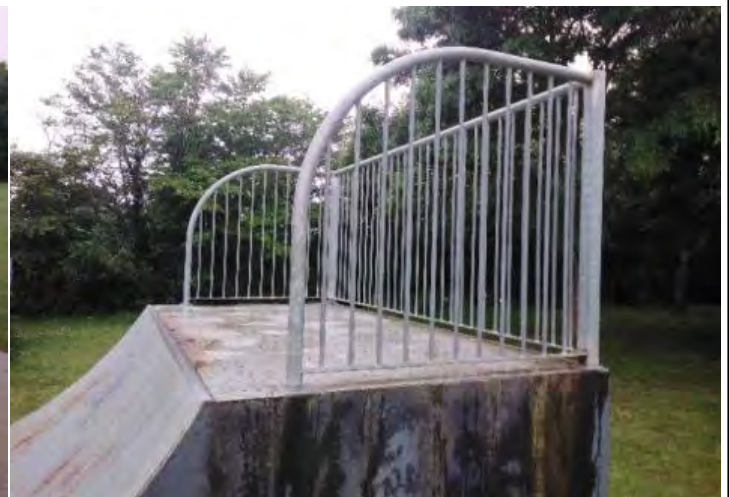
Risk Level: L - Low Risk
Surface: Concrete

Finding: The height of the barrier is less than 1200mm and fails the requirements of BS EN 14974

Action: Monitor - No remedial work recommended
