TOLLESBURY
PARISH
COUNCIL

AGENDA – RECREATION GROUND COMMITTEE
11TH OCTOBER 2022

7. Play Inspection Report

To receive the report from the Annual Independent Play Area inspection.

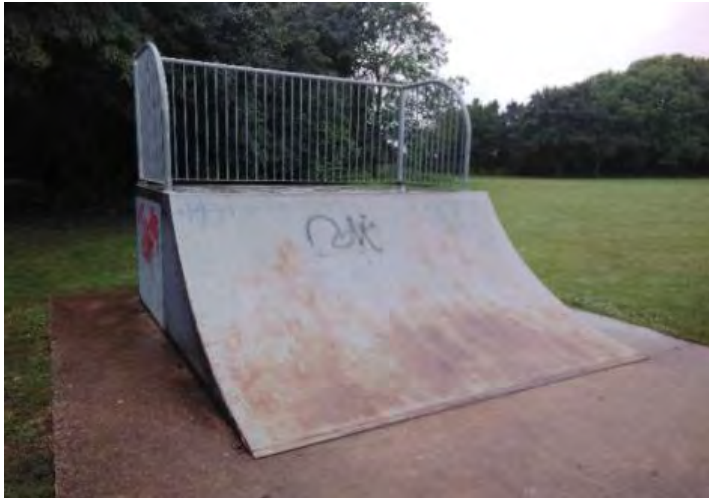
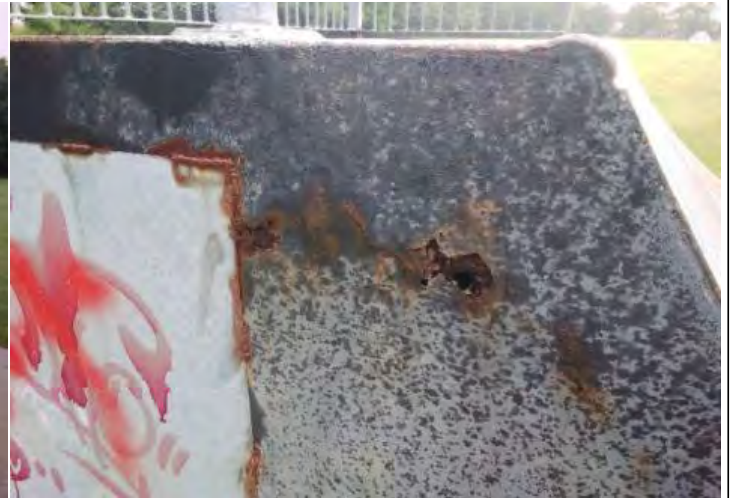
Risk Level: L - Low Risk
Surface: Concrete

Finding: Parts of the steel on this item have corroded excessively and the metal has perforated in places

Action: Ensure all affected areas are treated and repaired

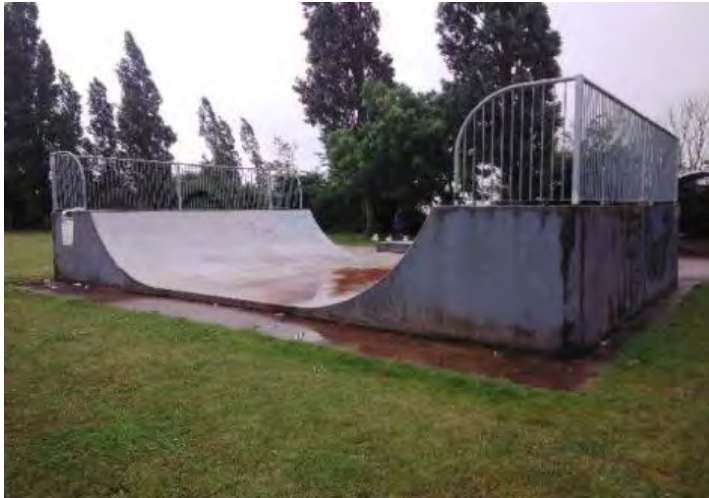
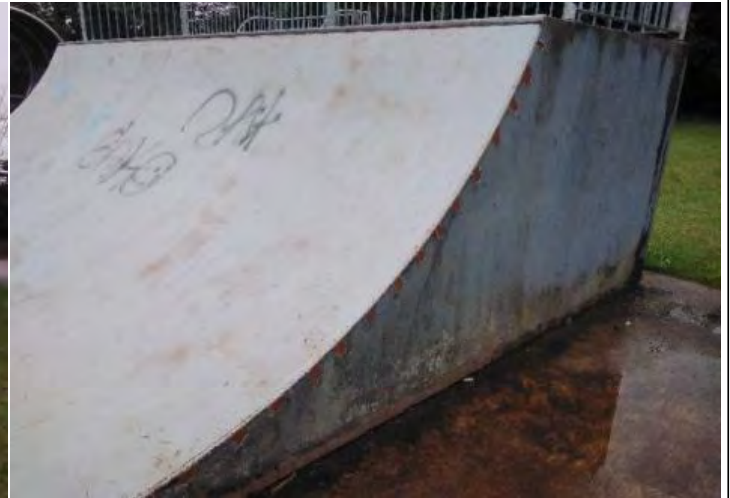
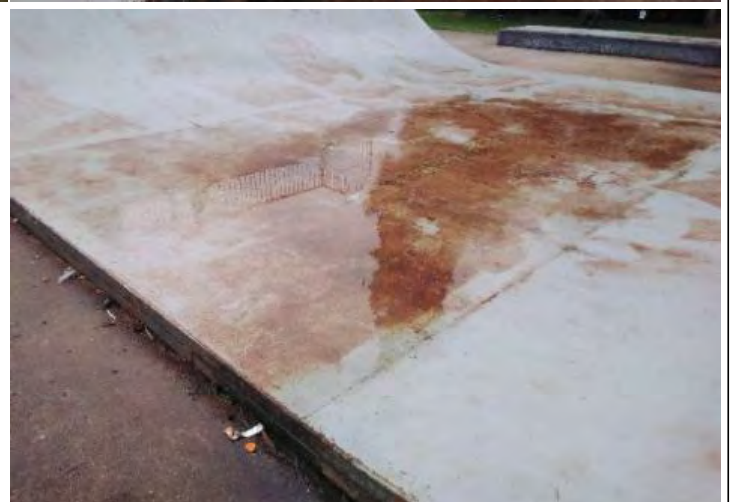
Risk Level: L - Low Risk
Surface: Concrete

Finding: The paintwork on this item has been damaged or worn exposing the metal underneath which is rusting

Action: Treat any rusting components and repaint

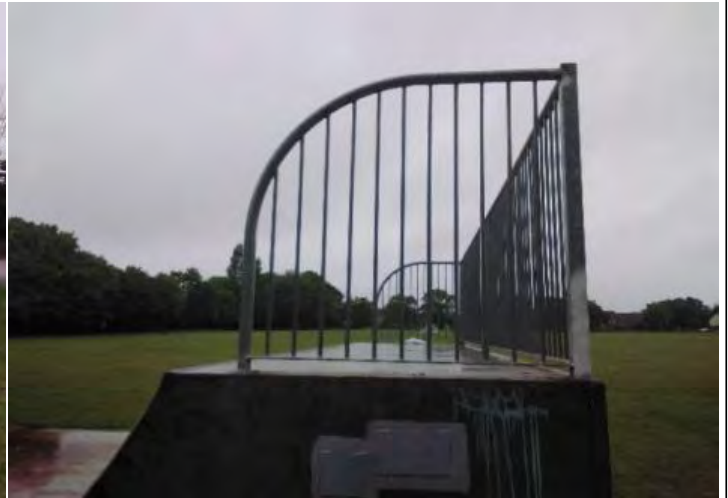
Risk Level: L - Low Risk
Surface: Concrete

Finding: The height of the barrier is less than 1200mm and fails the requirements of BS EN 14974
Action: Monitor - No remedial work recommended

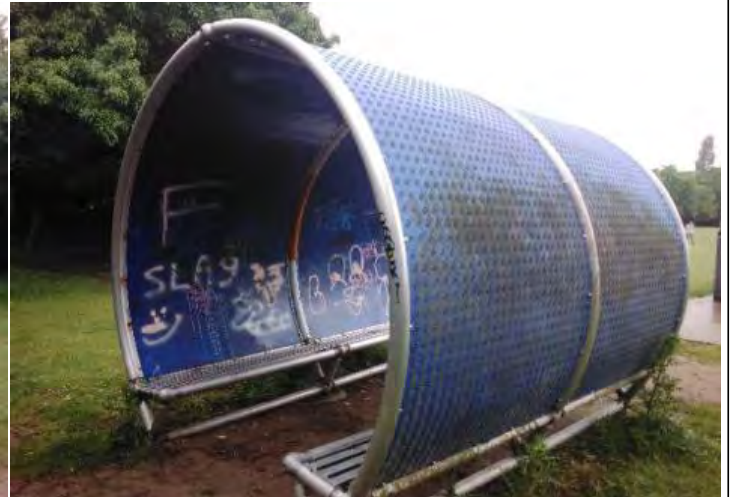
Risk Level: L - Low Risk
Surface: Grass

Finding: There is excessive movement within the structure

Action: Monitor for any further deterioration and repair as required

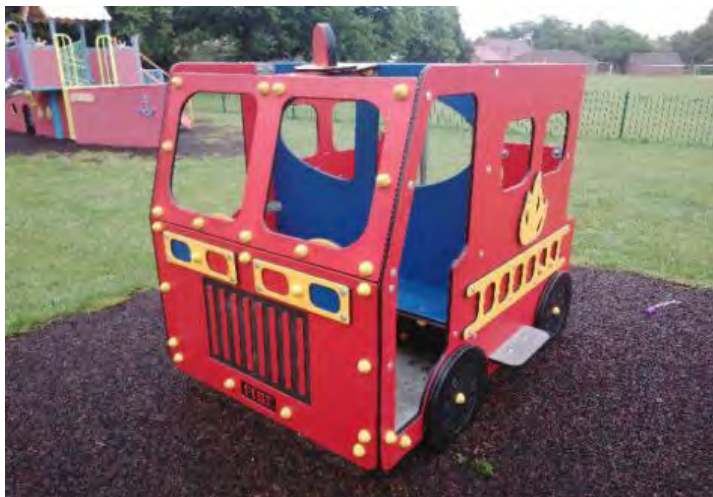
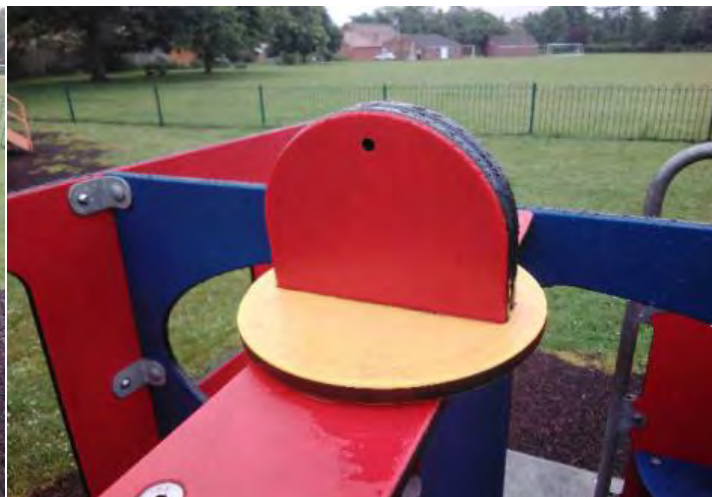
Risk Level: L - Low Risk
Surface: Bonded Rubber Mulch

Finding: There is or are fixings missing on the item

Action: Replace all missing fixings

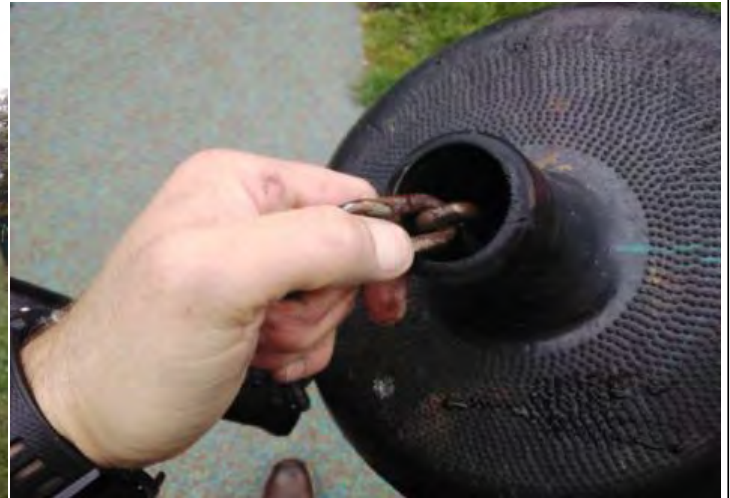
Risk Level: L - Low Risk
Surface: Wet Pour

Finding: There is some notable evidence of chain wear

Action: Monitor for any further deterioration and replace when 40% worn

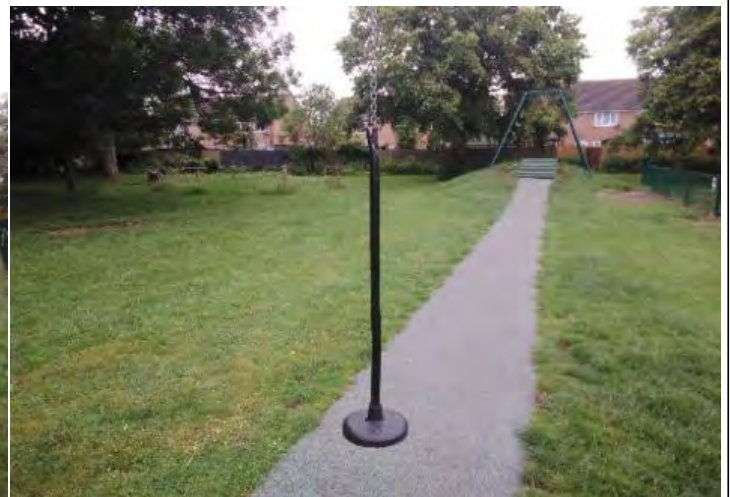
Risk Level: L - Low Risk
Surface: Wet Pour

Finding: The seat suspension cover has been damaged

Action: Monitor for any further deterioration and replace as required

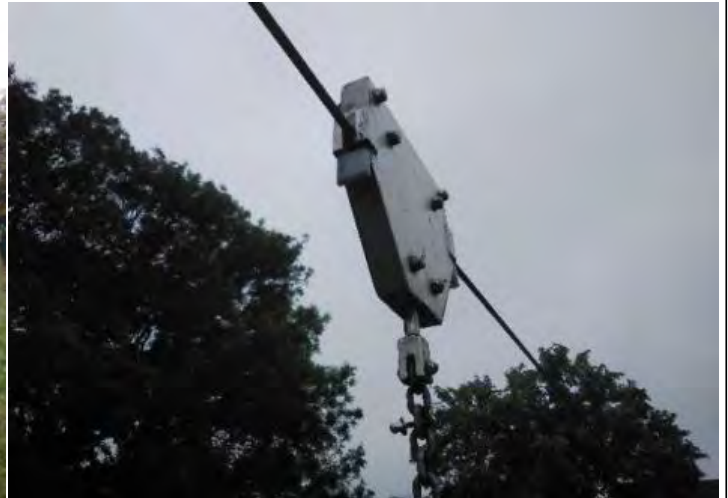
Risk Level: V - Very Low Risk
Surface: Wet Pour

Finding: The nylon inserts are worn or missing at the point the cable enters the traveller

Action: Replace worn or missing inserts as required

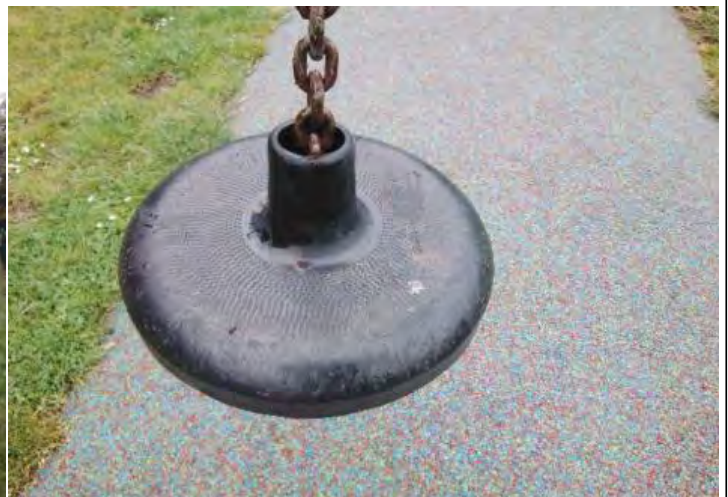
Risk Level: N - Risk Assessment not Undertaken
Surface: Wet Pour

Finding: The seat connection cannot be inspected without dismantling the seat

Action: Dismantle the seat to inspect the seat connection for wear

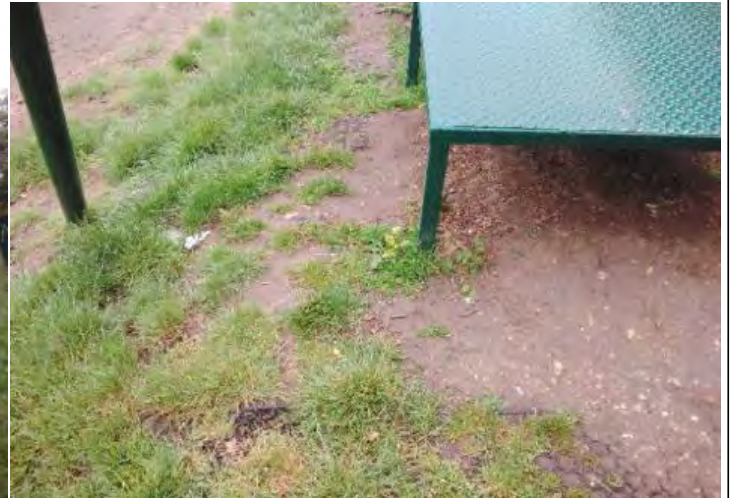
Risk Level: L - Low Risk
Surface: Wet Pour

Finding: There is moderate damage to the surface

Action: Repair the damaged areas of surfacing
