## **Tollesbury Parish Council**

Notice is hereby given that the Meeting of Tollesbury Parish Council will be held on **Tuesday 7<sup>th</sup> March 2023**, in **The Pavilion, Tollesbury Recreation Ground, Elysian Gardens** commencing at **7.30 pm**, to which members of the Council are summoned for the transaction of the under-mentioned business.

Year 1 (2022/23) monitoring report to the Marine Management Organisation

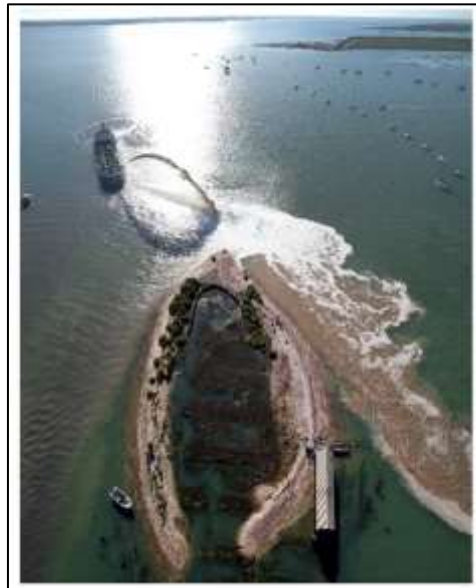
**Figure 4.** Sediment plume in Thorn Fleet drifting north-westward during rainbow delivery as dredger discharges 47 minutes before the ebb.

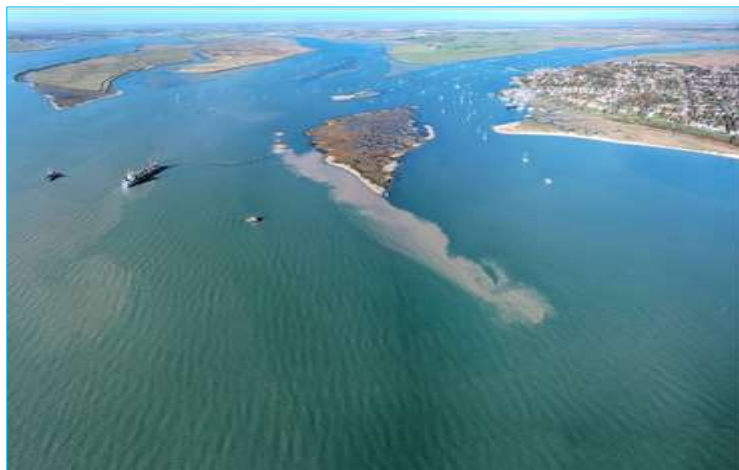
**Figure 5.** Cobmarsh Island: sediment plume deriving from pipeline delivery<sup>1</sup> from the trailing suction hopper dredger, Sospan Dau.

The second cycle of turbidity testing was carried out on 17 November 2021 at the locations indicated above (Figure 2). Figure 5 shows the sediment plume being carried east on the ebb toward the estuary mouth, on day seven of the delivery schedule to Cobmarsh Island. A westerly wind of force 1 to 3 prevailed. The water turbidity reading was the highest in Thorn Fleet/Little Ditch and was obtained while oyster dredging was taking place upriver of this location; this is likely to have influenced the result. Readings at the other three locations were not significantly different from those obtained earlier in the year (see Table 4, below, and refer to Table 2, above).

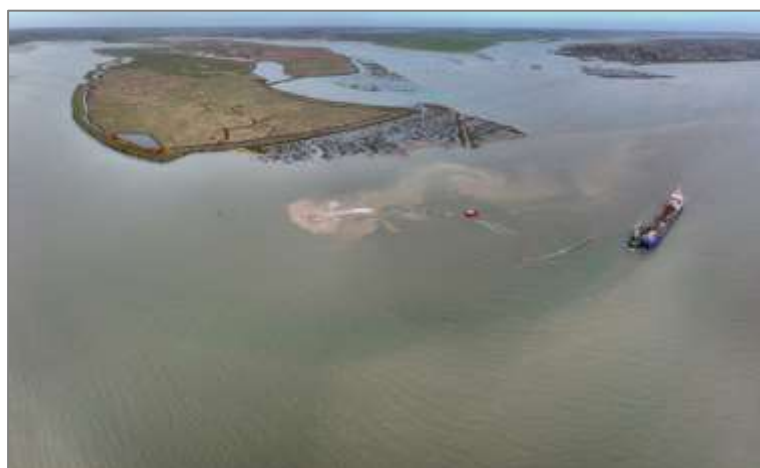
**Figure 6.** Discharging by pipeline at the start of the ebb at Old Hall on 3 January 2022 @ 12:54 pm (the day before readings were collected).

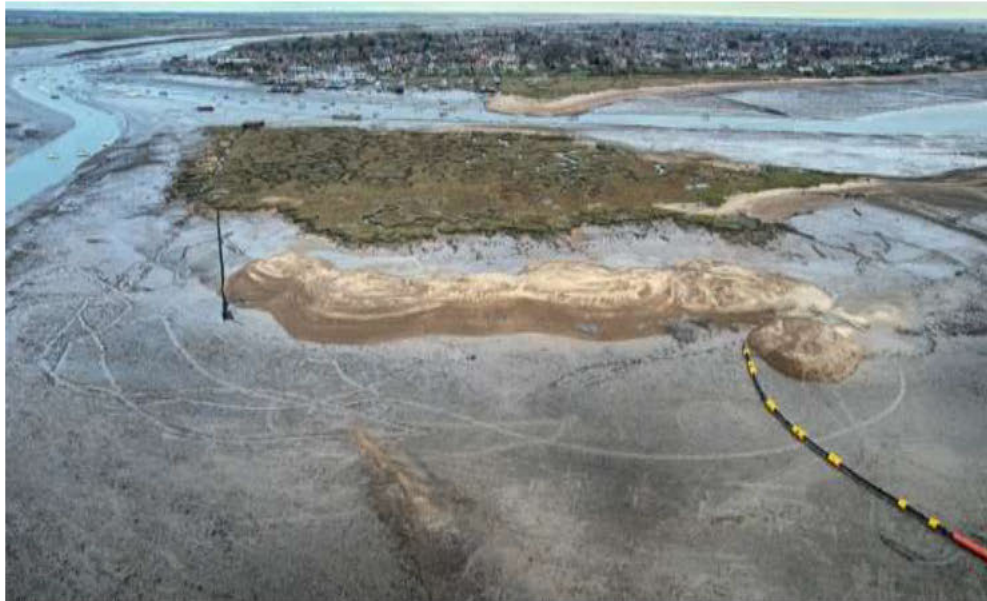
**Figure 8.** Cobmarsh Island after delivery of the 6th hopper load. The pipeline remains in place at low tide to be reconnected to the dredger when it returns on the next tide; a further 31 loads were delivered. Line of retention fencing on the west side of the recharge (see Section 6). View north: Mersea Island in the background and Mersea Fleet to the west.

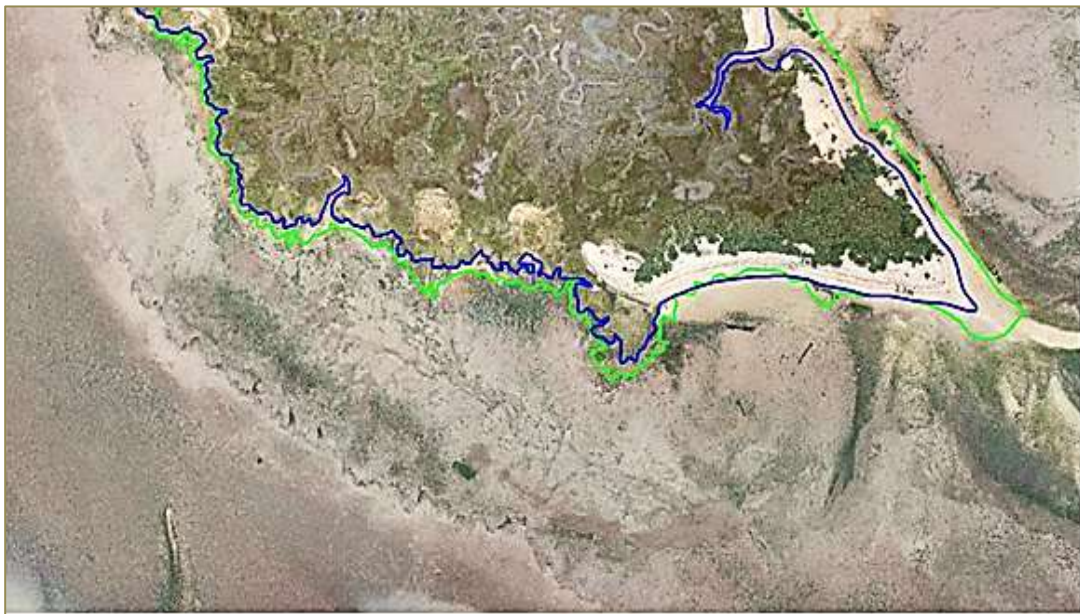
**Figure 10.** Edge erosion of saltmarsh, southern margin of Cobmarsh Island, between 2014 (green line) and 13 September 2021, two months before recharge delivery, (blue line). The width of loss during this seven-year period generally ranged between 3m and 5m (0.43m – 0.71m annual rate of loss), with a maximum edge loss of 11m (1.58 annually).

It has now been possible to accurately determine recent marsh edge erosion along the southern perimeter of Cobmarsh Island (Figure 10). Over the seven years between 2014 and September 2021 (two months before recharge delivery commenced) there was a width loss of between 3m and 5m (0.43m – 0.71m annually), but this extends to 11m in places (1.6m per year). Erosion has not been observed along this margin since the recharge was placed.

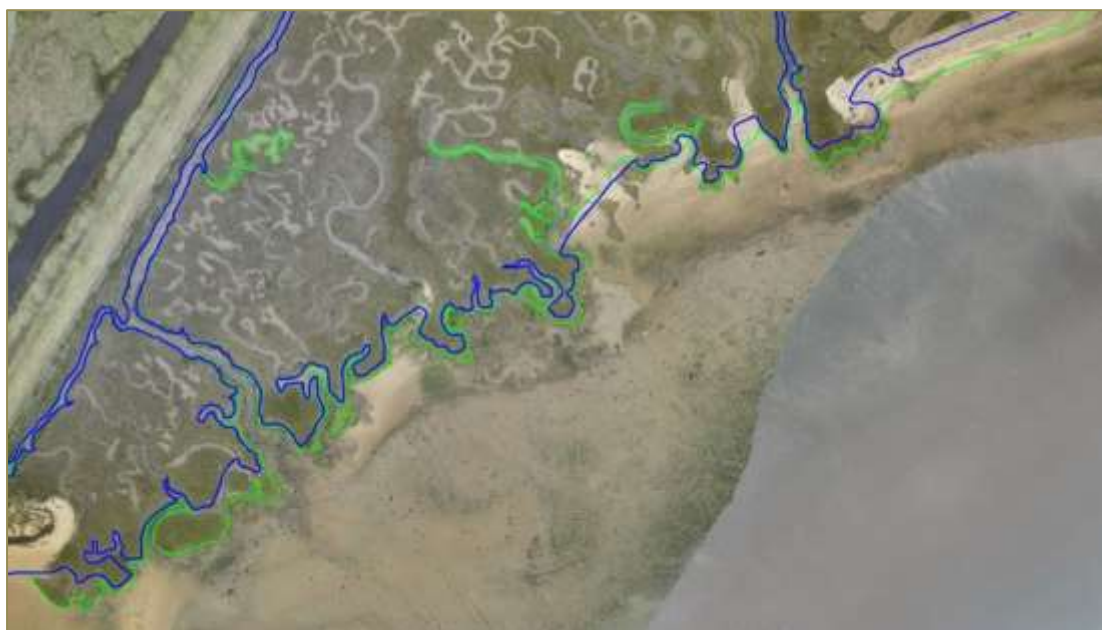
**Figure 12.** Edge erosion of saltmarsh, south-eastern margin of Old Hall between 2014 (green line) and 13 September 2021, two months before recharge delivery began (blue line). The width of loss during this seven year period generally ranged between 2m and 3m (0.28m – 0.43m annually), with a maximum loss of 9m in places (1.28m annually).

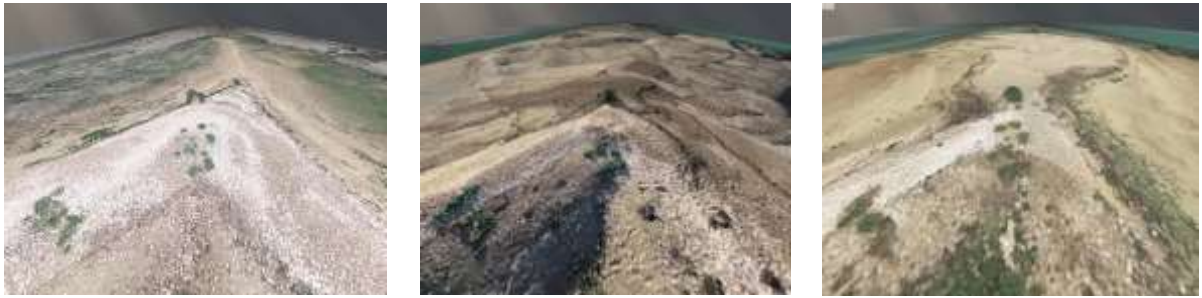
**Figure 14. Packing Marsh Island:** From left to right: pre placement, post placement 1 (1 day after delivery), post placement 2 (1 year after delivery).

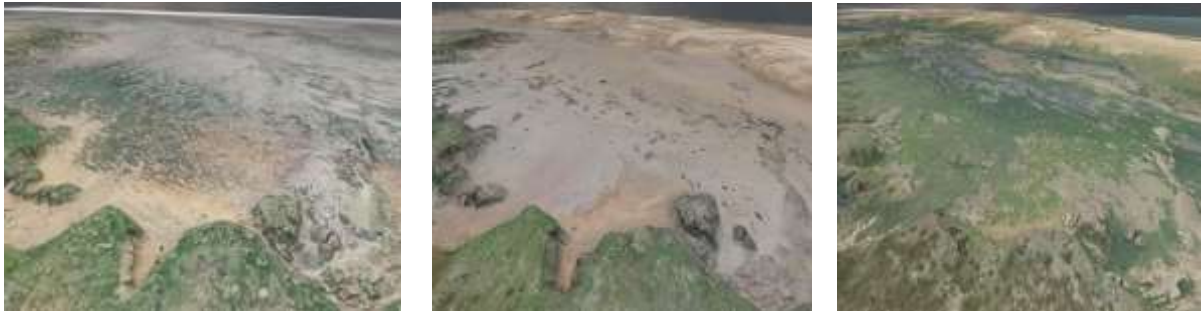
**Figure 15. Cobmarsh Island:** from left to right: pre placement, post placement 1 (2 weeks after delivery), post placement 2 (9 months after delivery).

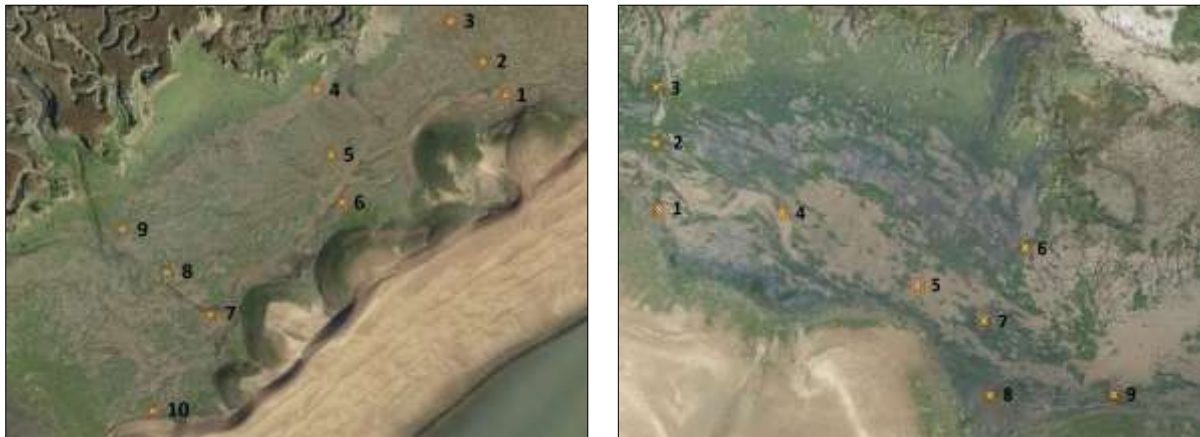
**Figure 22.** Distribution of canes located behind the central area of the recharge at Old Hall (left) and Cobmarsh (right).

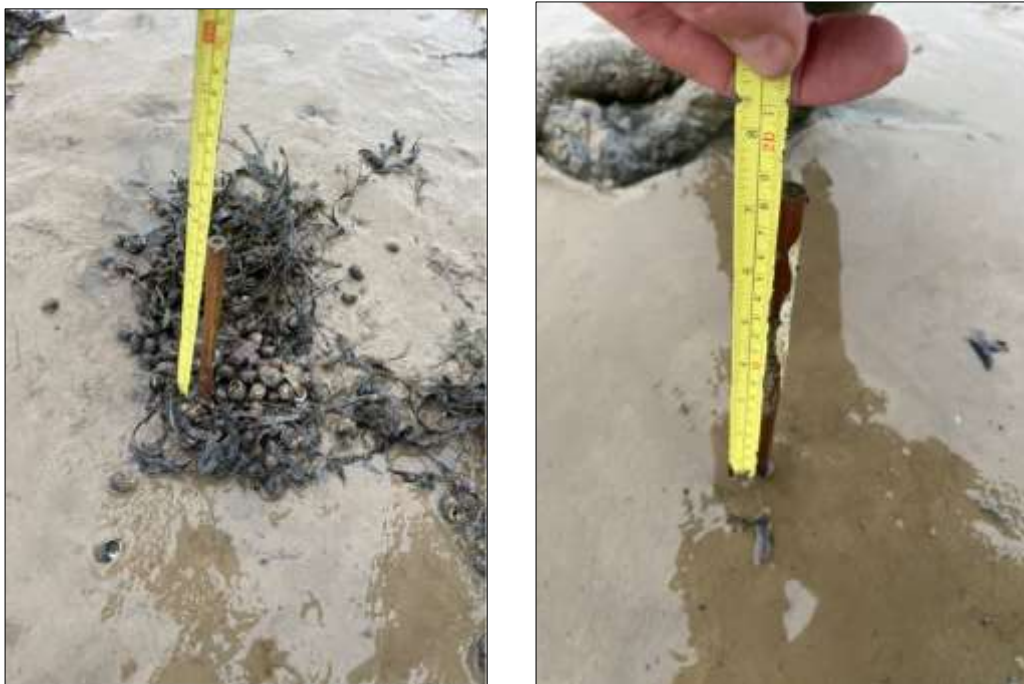
**Figure 23.** Taking siltation readings. At Old Hall (left), brown seaweed had wrapped around the cane and had to be moved to obtain the reading. Live common periwinkle (edible periwinkle: *Littorina littorea*) were clustered beneath the seaweed. A reading of 184mm was taken at the location on the right (Cobmarsh Island) giving an accretion measure of 16mm.

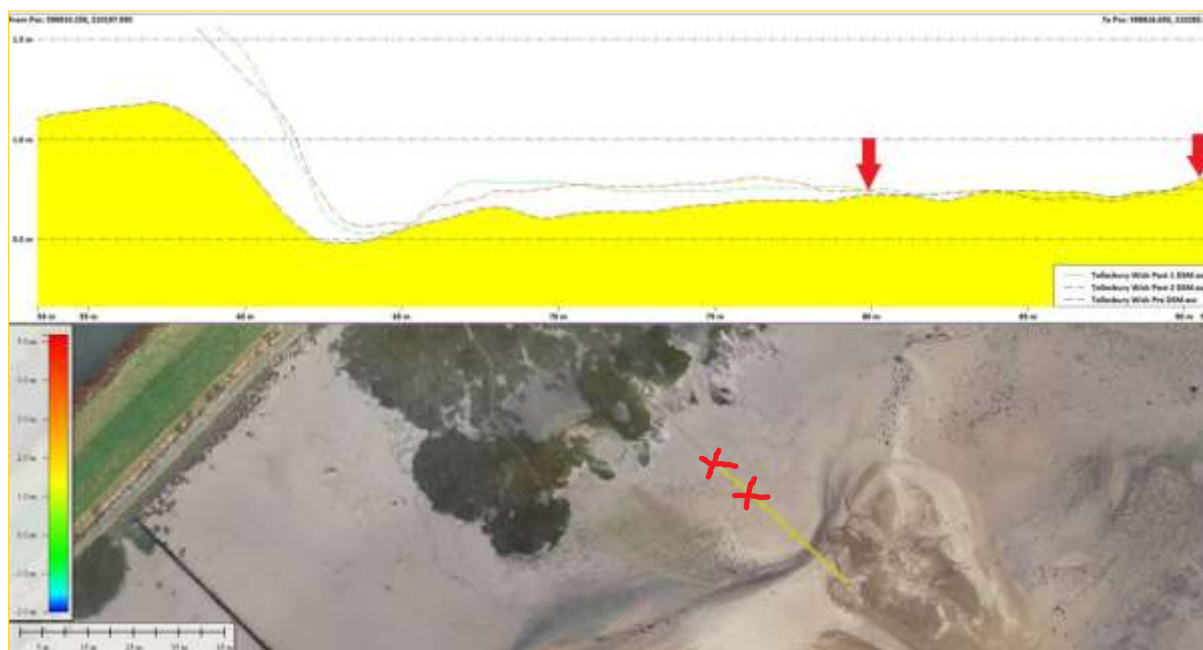
**Figure 24.** Tollesbury Wick: foreshore height change since placement (black dotted line pre-placement level; green dotted line post 1 data (obtained 23 Nov 2021); red dotted line post 2 data (obtained 3 Oct 2022). Placement was completed on 12 Nov 2021.

In the absence of field measurements, a profile of the foreshore behind the recharge was obtained from the surface model (Figure 24). This indicates that the foreshore has increased by 119mm in places. However, field observation suggests that this is fine sand washed from the crest of the new recharge.

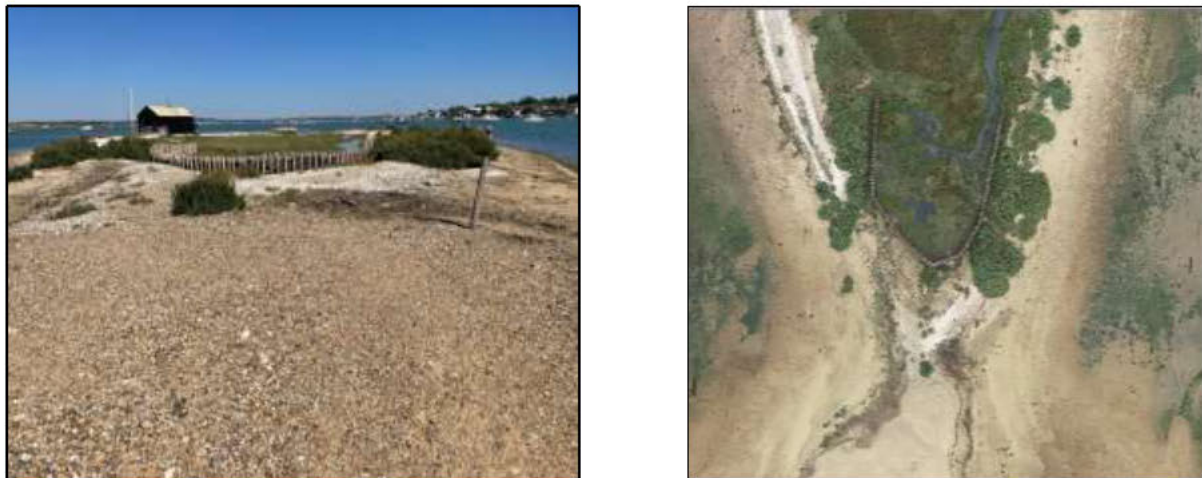
**Figure 28.** Packing Marsh fencing is effectively restricting rollover since dredgings were fully discharged (on 8 November 2021). Image on the left (11 August 2022) and right (13 September 2022), looking north.  
**Note:** the round shrubs (shrubby sea-blite, *Suaeda vera*) outside the fencing have established at the upper limit of tidal inundation on the former recharge placed in 1998.

At Packing Marsh Island the fence is stable and has yet to be tested by a surge tide (Figure 28).

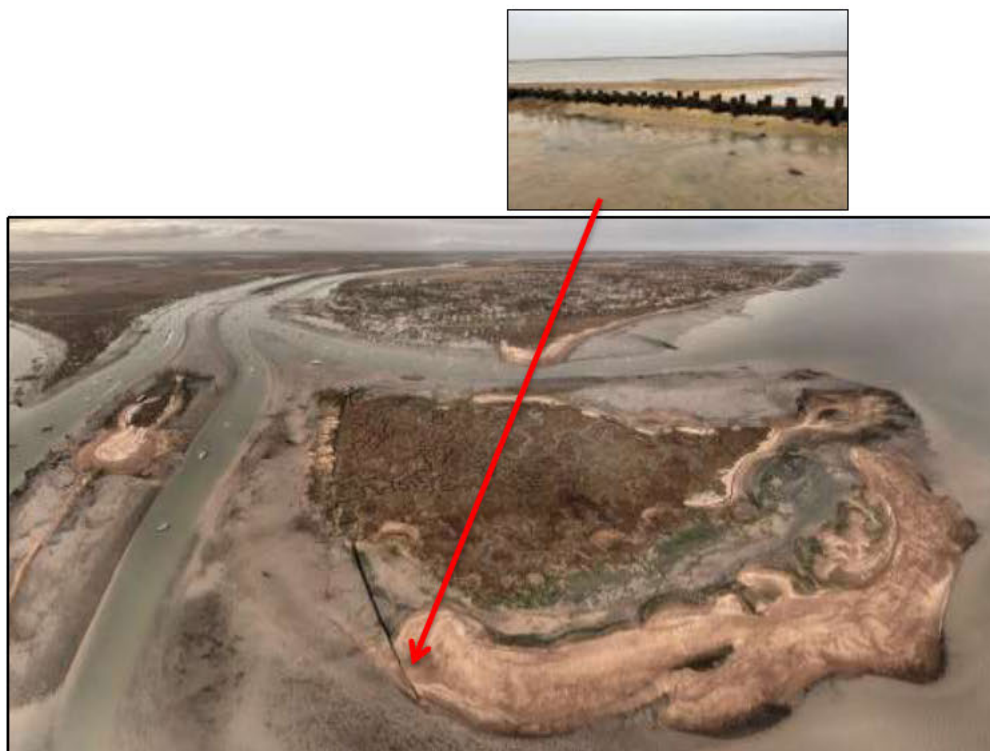
**Figure 29.** View NE with Packing Marsh Island to the west and Mersea Island in the background. The Mersea Fleet cuts between the two islands. The fence runs from north to south across the western foreshore. The photo was taken on 16 January 2023, just over one year after recharge was completed, on 27 December 2021. Inset shows the movement of material around the southern end of the fence on 12 January 2023 (looking west).

At Cobmarsh Island, some material has been transported around the southern end of the fence (Figure 29).

The fence at Cobmarsh acts as a beach control groyne capturing material migrating west, driven by longshore drift and easterly winds. Wave refraction, influenced by the fence and mud flat topography, has moved some of the sands and gravels around the end of the structure to the west side, while driving it northward (landward); westerly winds push it back against the fence. There is no indication of material drifting towards the Mersea Fleet: hydrodynamic processes will naturally move the material landwards, and this is already being observed (see Section 3). It has been demonstrated during winter 2022/23 that the fencing is able to withstand extreme winds.
