# RECREATION GROUND COMMITTEE MEETING AGENDA

### **Tollesbury Parish Council**

#### 7. Safety Inspection Report

To receive <u>Annual Play Area Inspection Report</u> and consider recommendations.

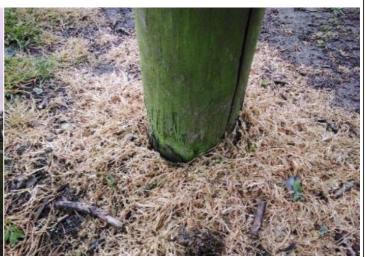
There is some strimmer / machinery damage apparent on the posts, this can penetrate the preservative applied to the timber and accelerate the rotting process - Monitor for any deterioration (rot) and replace as required

Action: Monitor for any deterioration (rot) and replace as required
