TOLLESBURY
PARISH
COUNCIL

AGENDA – RECREATION GROUND COMMITTEE
11TH OCTOBER 2022

7. Play Inspection Report

To receive the report from the Annual Independent Play Area inspection.

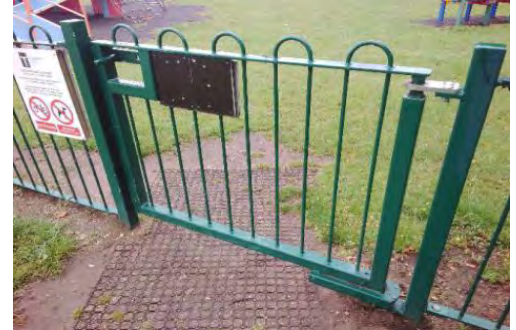
Item: Gate - Self Closing
Manufacturer: Unknown
Surface Type: N/A
Item Quantity: 3
Equipment Compliance: N/A
Surface Area Compliance: N/A

The surface has eroded in some areas - Reinstate the surface

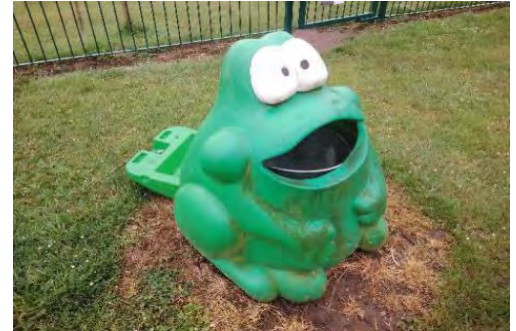
Item: Litter Bin
Manufacturer: Owner/Operator
Surface Type: N/A
Item Quantity: 1
Equipment Compliance: N/A
Surface Area Compliance: N/A

The lid or door of the litter bin is not secured - Ensure the lid or door is kept locked

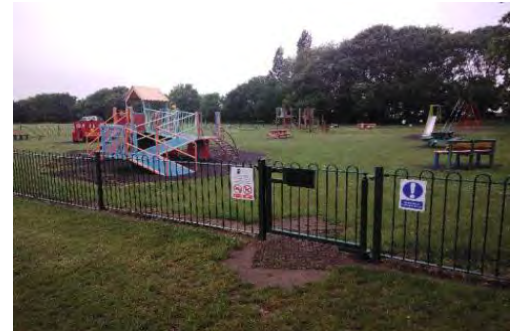
Item: Site General
Manufacturer: Unknown
Surface Type: N/A
Item Quantity: 1
Equipment Compliance: N/A
Surface Area Compliance: N/A

There is weed / vegetation growth on, between, or around the edges of the surfacing - Remove weed / vegetation growth

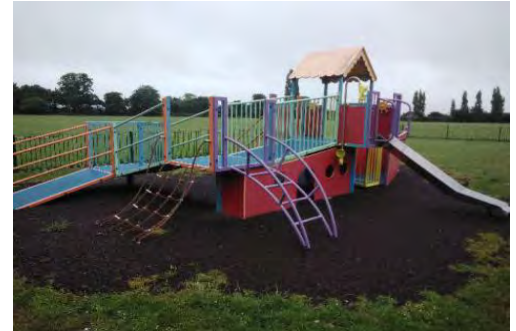
Item: Multi Play (Junior)
Manufacturer: Not Identified
Surface Type: Bonded Rubber Mulch
Item Quantity: 1
Equipment Compliance: No
Surface Area Compliance: Yes

There is an opening in the barriers exceeding the width allowed (500mm) in BS EN 1176, this is a low risk failure and no remedial action is required - Monitor - No remedial work recommended

The paintwork on this item has been damaged or worn exposing the metal underneath which is rusting - Treat any rusting components and repaint

There is/are several inserts missing - Replace missing inserts

The ropes/nets are worn/damaged in places - Monitor for any further deterioration and repair or replace as required

There is or are fixings missing on the item - Replace all missing fixings

The unit is easily accessible and should have the appropriate barriers installed to meet the requirements of BS EN 1176 Part 1 as the height of the unit exceeds 600mm - Monitor - No remedial work recommended

The weld(s) on this item have failed - Repair item

The item fails to meet the requirements of BS EN 1176 Part 1 4.2.7.2 head and neck entrapment in the barriers and/or steps - Monitor - No remedial work recommended

The tube(s) on this item have corroded from the inside and split the steel - Replace all affected parts

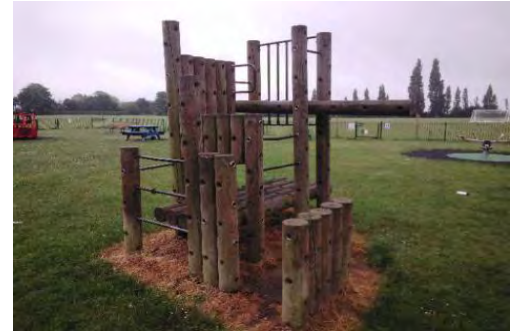
Item: Climbing Frame
Manufacturer: Wicksteed Playgrounds
Surface Type: Grass Matrix Tiles
Item Quantity: 1
Equipment Compliance: No
Surface Area Compliance: Yes

The timber has a number of splits/shakes or air cracks and this may affect the stability or allow water ingress which will accelerate the rotting process - Monitor to ensure the splits do not cross through fixing points of the structure and/or cause any instability

There are falls in excess of 600mm between adjacent components on the structure, in contravention of the recommendations set out in BS EN 1176 Part 1; 4.2.8.4 - Monitor - No remedial work recommended

The item fails to meet the requirements of BS EN 1176 Part 1 4.2.7.2 head and neck entrapment in the barriers and/or steps - Monitor - No remedial work recommended

There is some damage to the item - Monitor for any further deterioration and repair as required

There is some strimmer / machinery damage apparent on the posts, this can penetrate the preservative applied to the timber and accelerate the rotting process - Monitor for any deterioration (rot) and replace as required

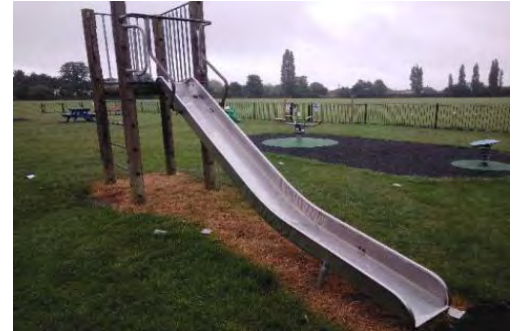
Item: Free Standing Slide
Manufacturer: Wicksteed Playgrounds
Surface Type: Grass Matrix Tiles
Item Quantity: 1
Equipment Compliance: No
Surface Area Compliance: No

The timber edging forms a hard object within the impact area of the equipment in contravention of the requirements of BS EN 1176 Part 1 - Monitor - No remedial work recommended

There are a number of dents in the slide surface - Monitor for any further deterioration and repair as required

There is/are finger entrapment/s in the slide starting section and the item fails to meet the requirements of BS EN 1176 Part 1 4.2.7.6 Entrapment of fingers - Monitor - No remedial work recommended

The item fails to meet the requirements of BS EN 1176 Part 1 4.2.7.2 head and neck entrapment in the barriers and/or steps - Monitor - No remedial work recommended

There is some strimmer / machinery damage apparent on the posts, this can penetrate the preservative applied to the timber and accelerate the rotting process - Monitor for any deterioration (rot) and replace as required

The paintwork on this item has been damaged or worn exposing the metal underneath which is rusting - Treat any rusting components and repaint

There is an opening in the barriers exceeding the width allowed (500mm) in BS EN 1176, and no guardrail has been provided; this is a low risk failure and no remedial action is required - Monitor - No remedial work recommended

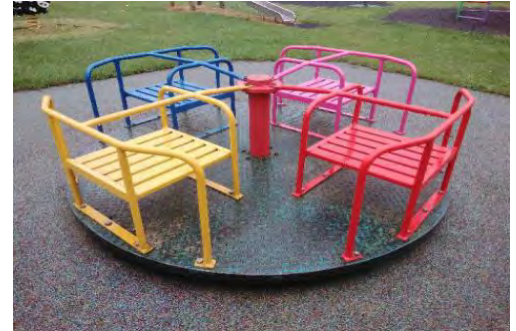
Item: Roundabout
Manufacturer: Hunts
Surface Type: Wet Pour
Item Quantity: 1
Equipment Compliance: No
Surface Area Compliance: Yes

There is/are finger entrapment/s in the seats and the item fails to meet the requirements of BS EN 1176 Part 1 4.2.7.6
Entrapment of fingers - Monitor - No remedial work recommended

The underside of the rotating platform shall be smooth for the first 500mm towards the axis to comply with the requirements of BS EN 1176 Part 5 - Monitor - No remedial work recommended

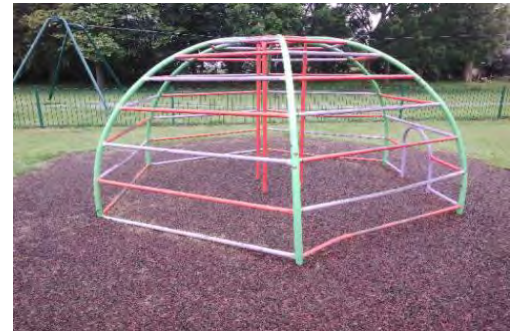
Item: Climbing Frame
Manufacturer: Wicksteed Playgrounds
Surface Type: Bonded Rubber Mulch
Item Quantity: 1
Equipment Compliance: Yes
Surface Area Compliance: Yes

The paint is flaking off the metalwork - Rub down and re-paint

The paintwork on this item has been damaged or worn exposing the metal underneath which is rusting - Treat any rusting components and repaint

There is some damage to the item - Monitor for any further deterioration and repair as required

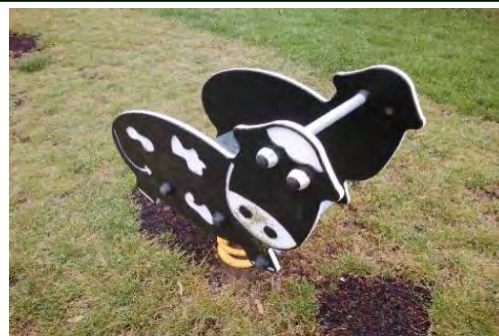
Item: Spring Cow
Manufacturer: Not Identified
Surface Type: Bonded Rubber Mulch
Item Quantity: 1
Equipment Compliance: Yes
Surface Area Compliance: Yes

The paintwork on this item has been damaged or worn exposing the metal underneath which is rusting - Treat any rusting components and repaint

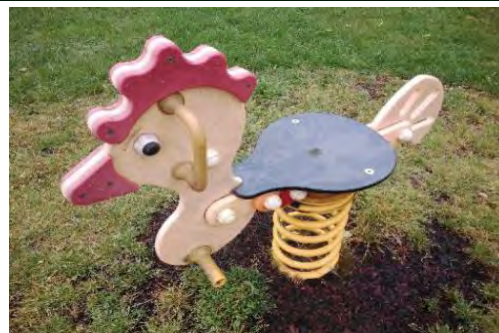
Item: Spring Bird
Manufacturer: Not Identified
Surface Type: Bonded Rubber Mulch
Item Quantity: 1
Equipment Compliance: No
Surface Area Compliance: Yes

The end caps are missing on the Handgrips/Footrests - Replace missing end caps

The end of handgrips and/or footrests have a cross section of less than 15cm² and fail to meet the requirements of BS EN 1176 Part 6 - Monitor - No remedial work recommended

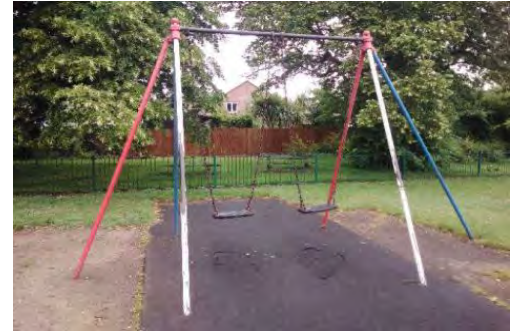
Item: 1 Bay 2 Seat (Flat)
Manufacturer: Wicksteed Playgrounds
Surface Type: Wet Pour
Item Quantity: 1
Equipment Compliance: No
Surface Area Compliance: Yes

There is moderate damage to the surface - Repair the damaged areas of surfacing

There is some notable evidence of chain wear - Monitor for any further deterioration and replace when 40% worn

The bushes are worn or missing - Replace worn or missing bushes

The seats are too close to each other as defined in BS EN 1176 Part 2; this is a low risk failure and no remedial action is required - Monitor - No remedial work recommended

The chain openings are in excess of the 8.6mm as recommended by BS EN 1176 - Monitor - No remedial work recommended

The seats are too close to the frame as defined in BS EN 1176 Part 2; this is a low risk failure and no remedial action is required - Monitor - No remedial work recommended

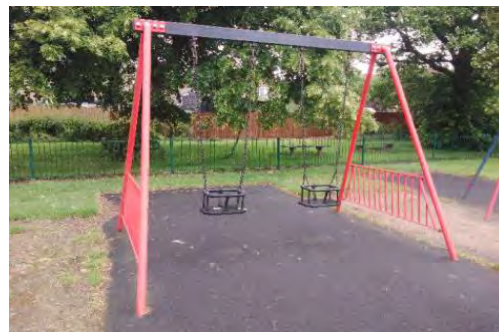
Item: 1 Bay 2 Seat (Cradle)
Manufacturer: Not Identified
Surface Type: Wet Pour
Item Quantity: 1
Equipment Compliance: No
Surface Area Compliance: Yes

The chain openings are in excess of the 8.6mm as recommended by BS EN 1176 - Monitor - No remedial work recommended

There is some notable evidence of chain wear - Monitor for any further deterioration and replace when 40% worn

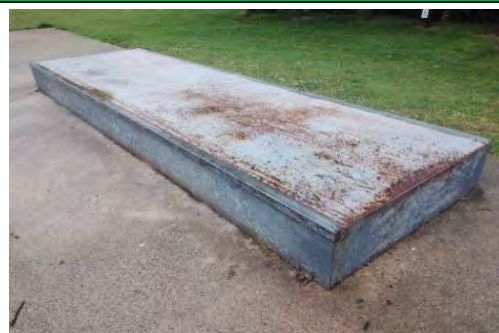
Item: Grind Box
Manufacturer: Not Identified
Surface Type: Concrete
Item Quantity: 1
Equipment Compliance: Yes
Surface Area Compliance: Yes

The paintwork on this item has been damaged or worn exposing the metal underneath which is rusting - Treat any rusting components and repaint

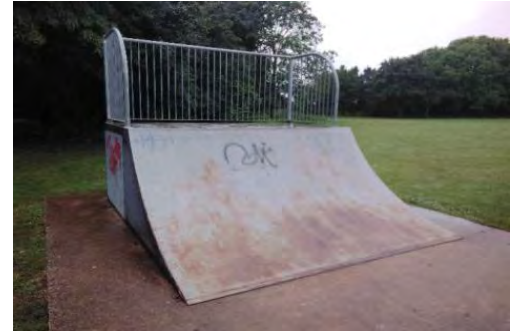
Item: Quarter Pipe
Manufacturer: Not Identified
Surface Type: Concrete
Item Quantity: 1
Equipment Compliance: No
Surface Area Compliance: Yes

The paintwork on this item has been damaged or worn exposing the metal underneath which is rusting - Treat any rusting components and repaint

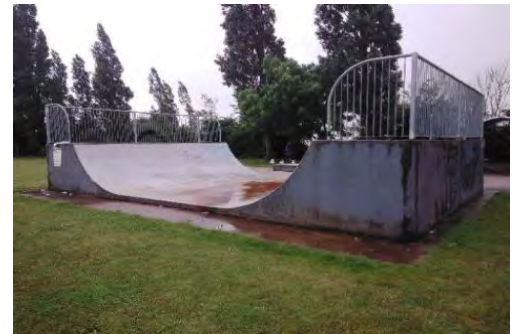
Item: Half Pipe
Manufacturer: Not Identified
Surface Type: Concrete
Item Quantity: 1
Equipment Compliance: No
Surface Area Compliance: Yes

The paintwork on this item has been damaged or worn exposing the metal underneath which is rusting - Treat any rusting components and repaint

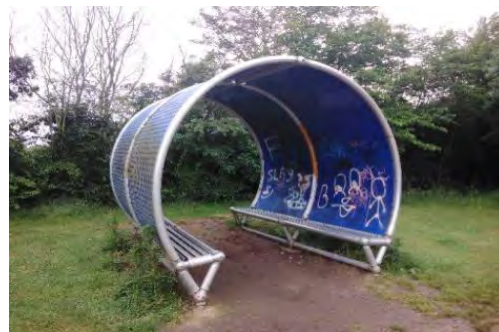
Item: Shelter
Manufacturer: Not Identified
Surface Type: Grass
Item Quantity: 1
Equipment Compliance: N/A
Surface Area Compliance: N/A

The surface has eroded in some areas - Reinstate the surface

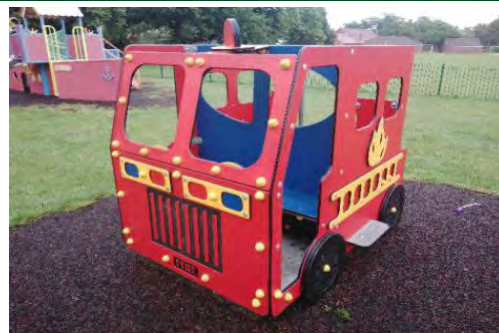
Item: Multi Play (Toddler)
Manufacturer: Not Identified
Surface Type: Bonded Rubber Mulch
Item Quantity: 1
Equipment Compliance: Yes
Surface Area Compliance: Yes

There is or are fixings missing on the item - Replace all missing fixings

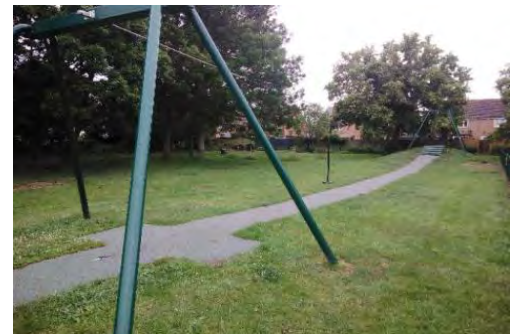
Item: Cable Runway
Manufacturer: Not Identified
Surface Type: Wet Pour
Item Quantity: 1
Equipment Compliance: No
Surface Area Compliance: Yes

There is some notable evidence of chain wear - Monitor for any further deterioration and replace when 40% worn

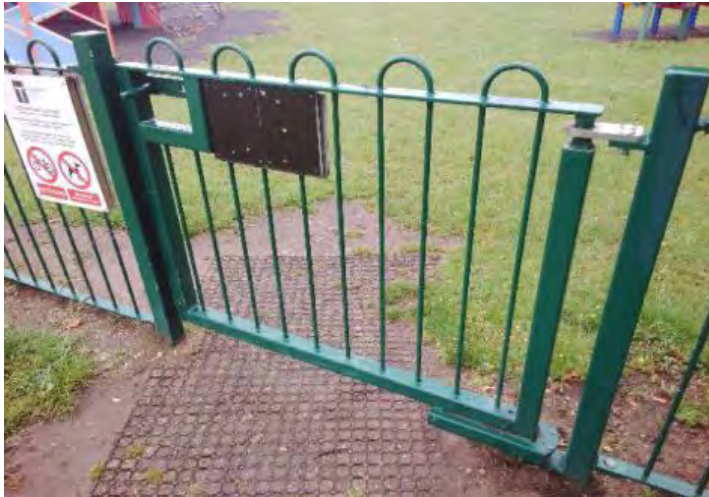
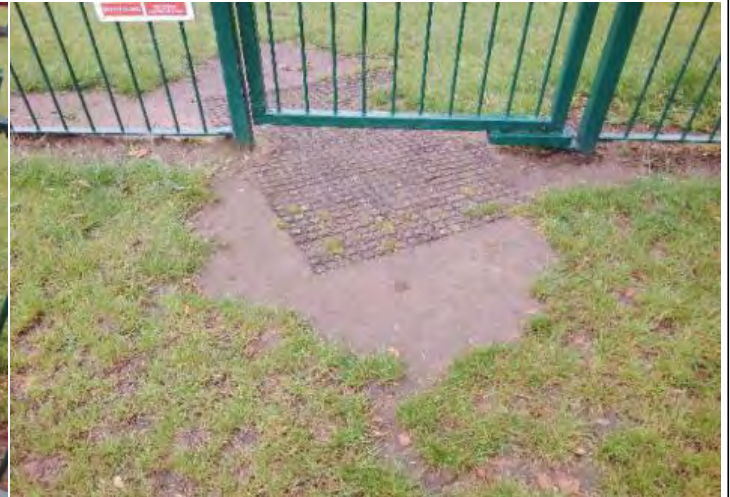
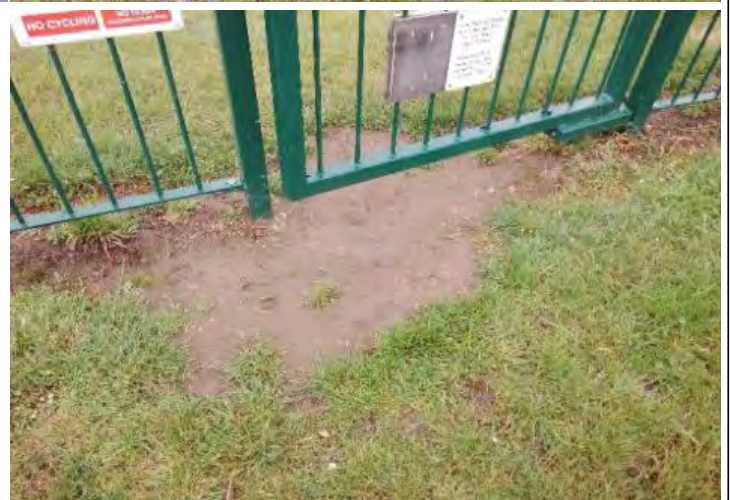
Item: Gates - Gate - Self Closing
Manufacturer: Unknown

Finding: The surface has eroded in some areas

Action: Reinststate the surface

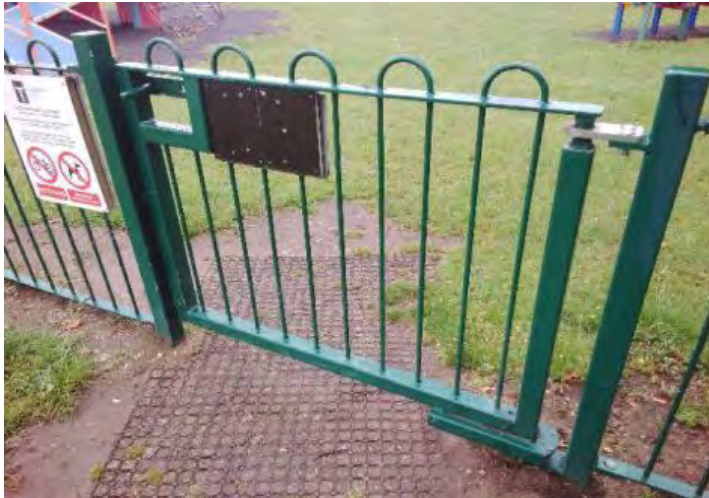
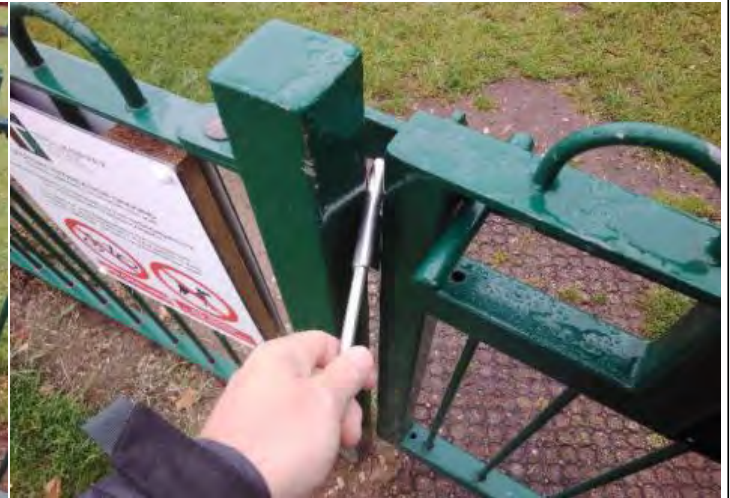
Item: Gates - Gate - Self Closing
Manufacturer: Unknown

Finding: There are openings that are less than 12mm that could trap or crush fingers

Action: Where possible a 12mm gap should be maintained on both sides or between the gate leafs

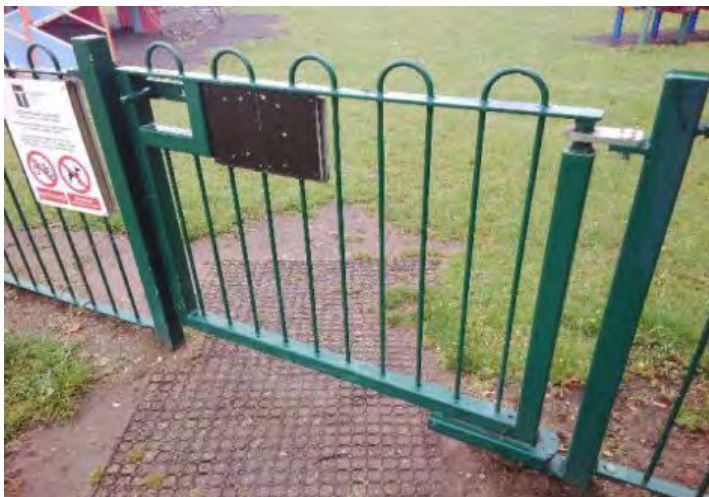
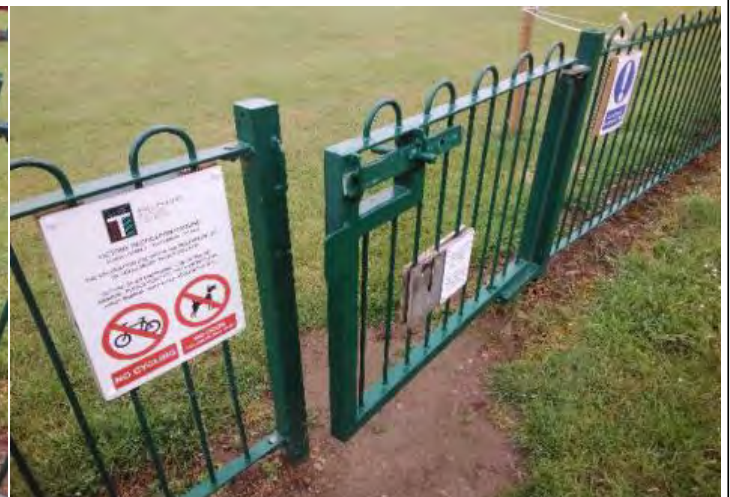
Item: Gates - Gate - Self Closing
Manufacturer: Unknown

Finding: The gate is not operating correctly

Action: Take effective action to ensure the gate closes between 4 and 8 seconds

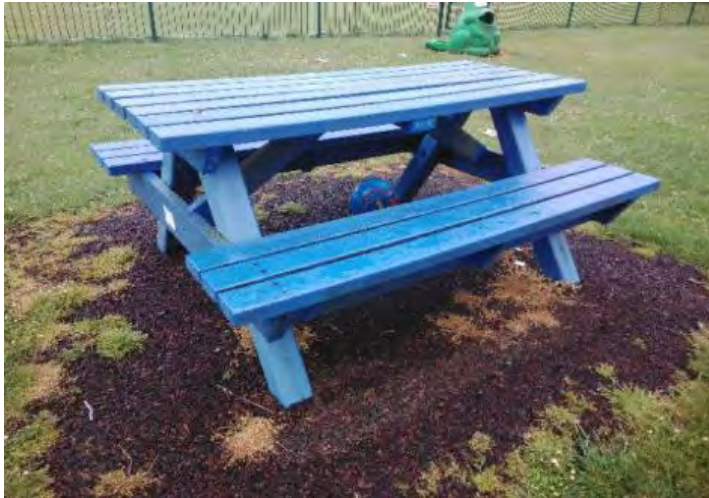
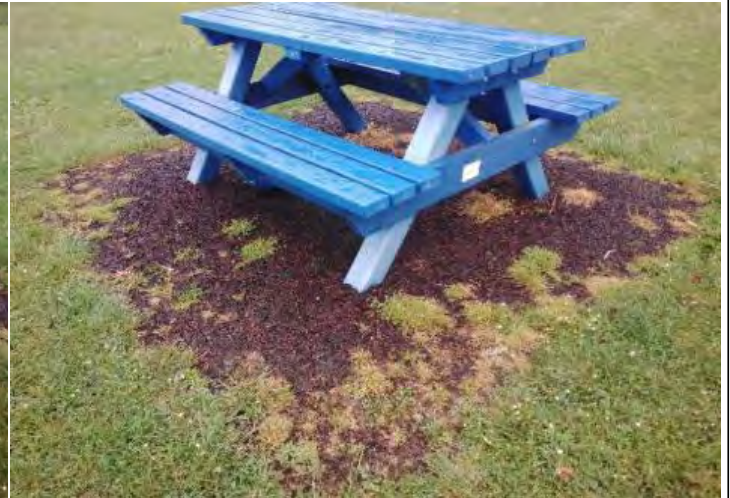
Item: Ancillary Items - Picnic Table
Manufacturer: Owner/Operator

Finding: There is weed / vegetation growth on, between, or around the edges of the surfacing
Action: Remove weed / vegetation growth

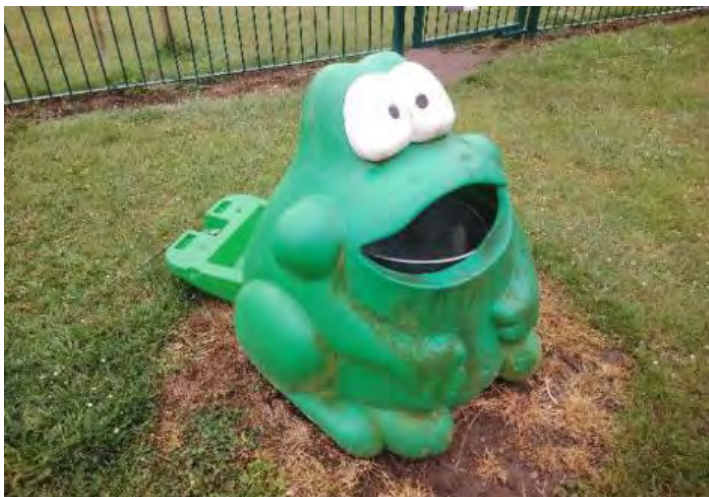
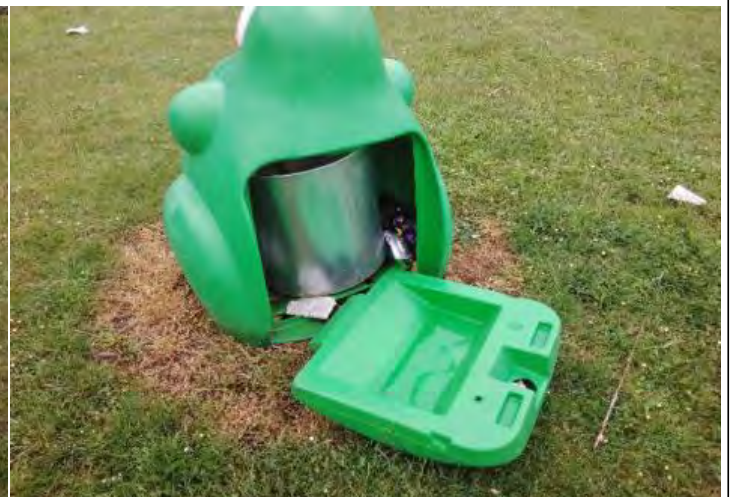
Item: Ancillary Items - Litter Bin
Manufacturer: Owner/Operator

Finding: The lid or door of the litter bin is not secured
Action: Ensure the lid or door is kept locked

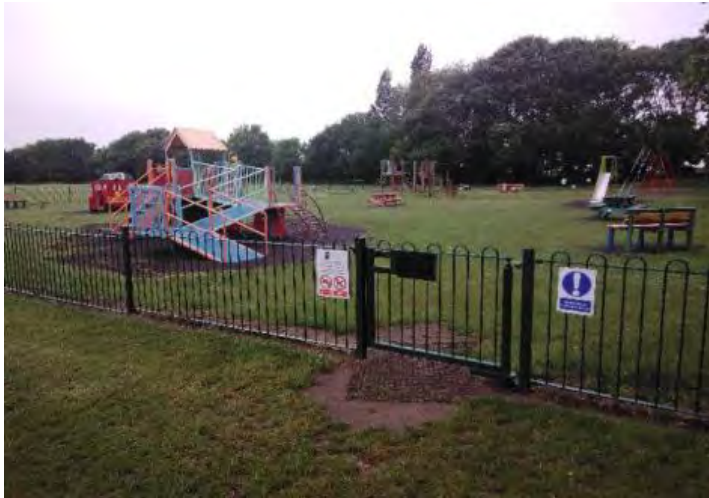
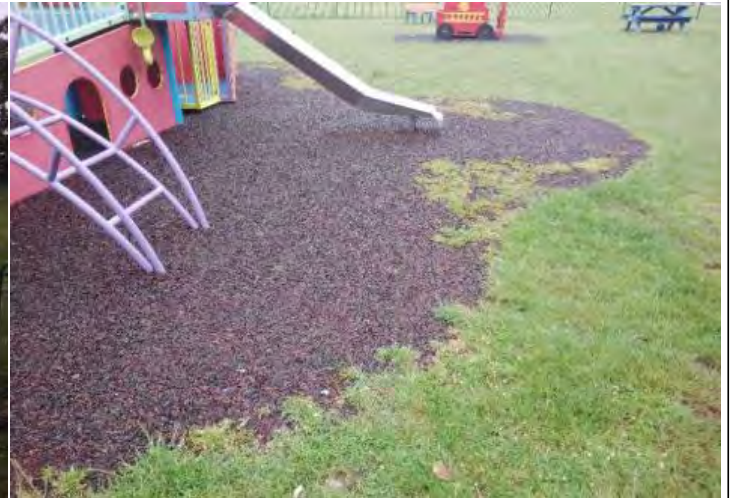
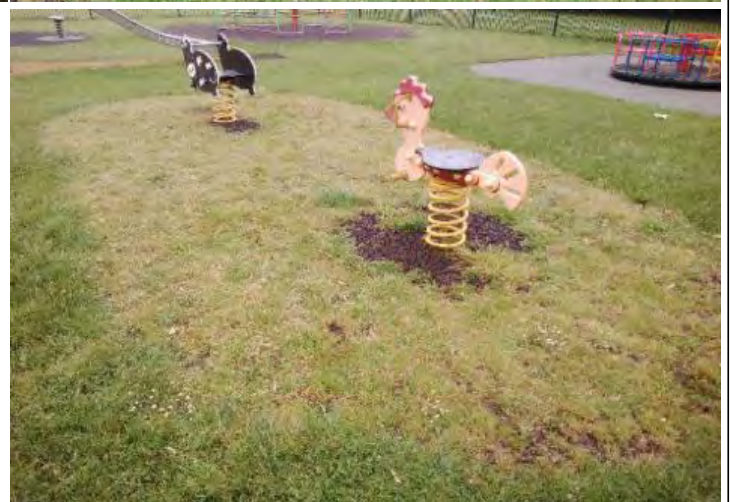
Finding: There is weed / vegetation growth on, between, or around the edges of the surfacing
Action: Remove weed / vegetation growth

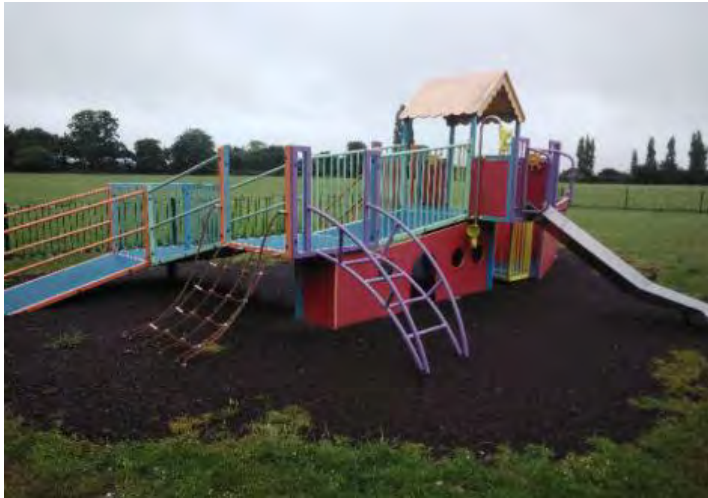
Finding: There is an opening in the barriers exceeding the width allowed (500mm) in BS EN 1176, this is a low risk failure and no remedial action is required

Action: Monitor - No remedial work recommended

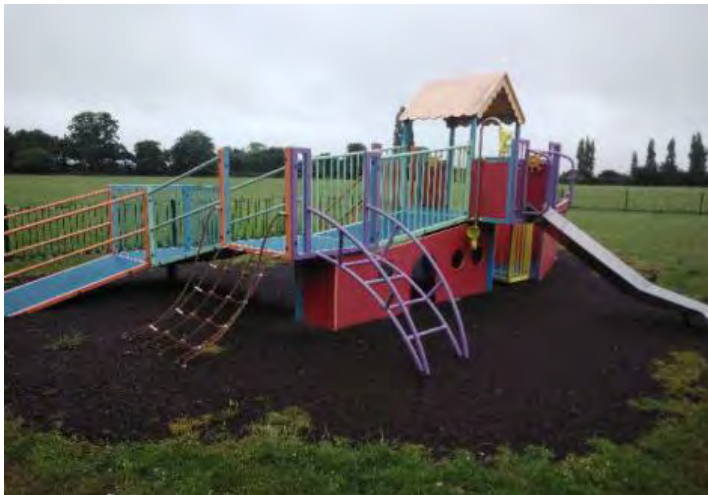
Finding: The unit is easily accessible and should have the appropriate barriers installed to meet the requirements of BS EN 1176 Part 1 as the height of the unit exceeds 600mm

Action: Monitor - No remedial work recommended

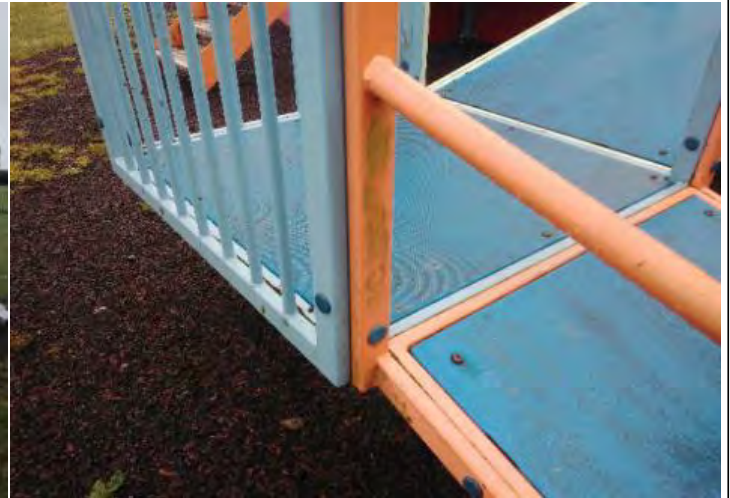
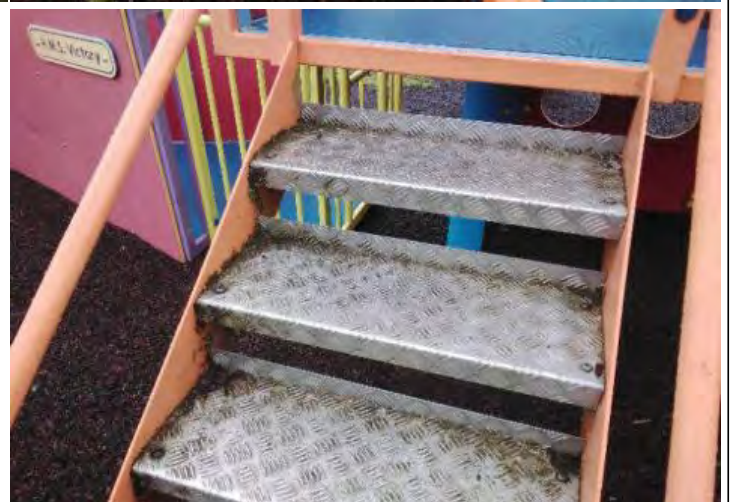
Finding: There is algae or moss on the surface of the equipment

Action: Clean and treat appropriately

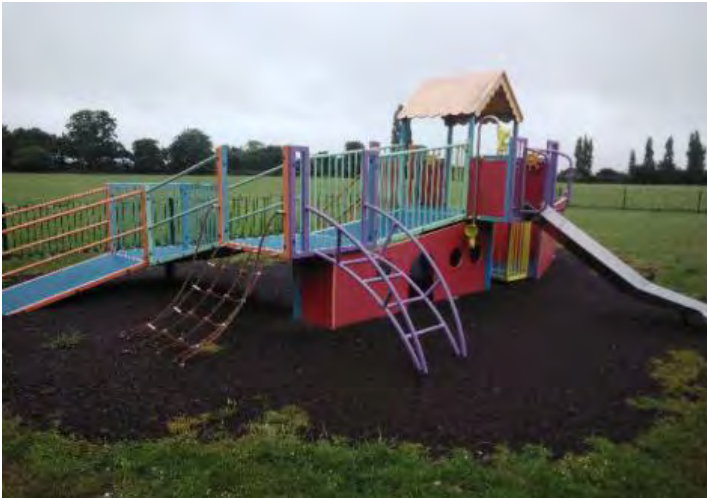
Finding: There is/are several inserts missing

Action: Replace missing inserts

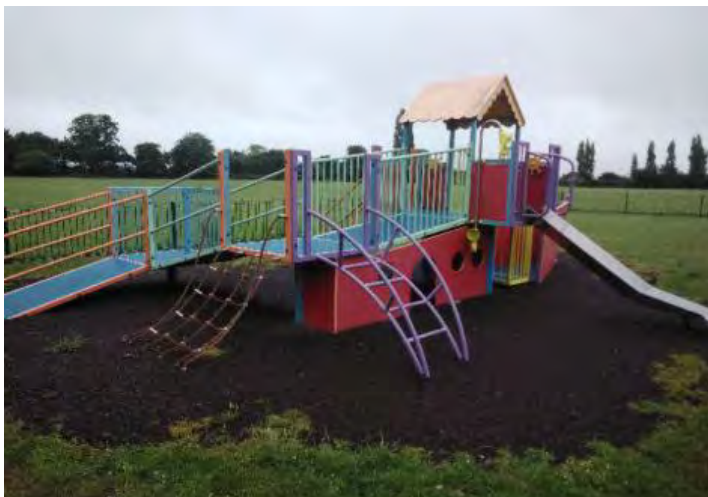
Finding: The item fails to meet the requirements of BS EN 1176 Part 1 4.2.7.2 head and neck entrapment in the barriers and/or steps

Action: Monitor - No remedial work recommended

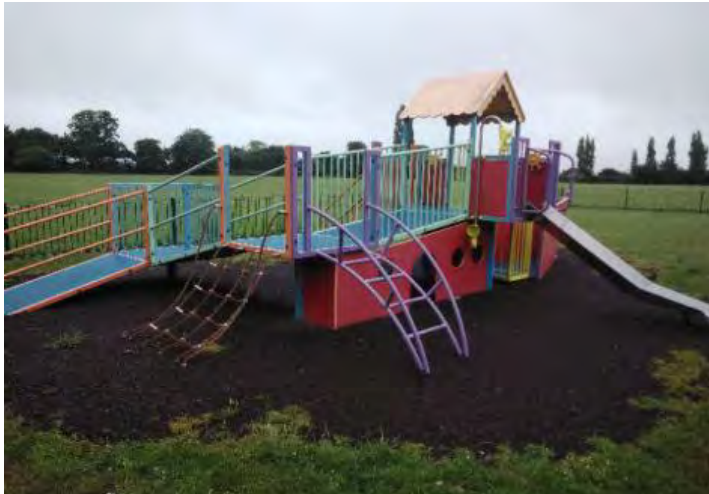
Finding: The tube(s) on this item have corroded from the inside and split the steel

Action: Replace all affected parts

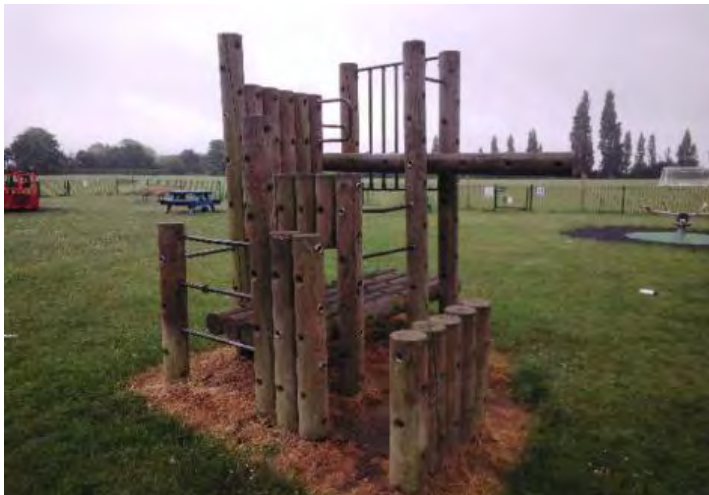
Finding: The item fails to meet the requirements of BS EN 1176 Part 1 4.2.7.2 head and neck entrapment in the barriers and/or steps

Action: Monitor - No remedial work recommended

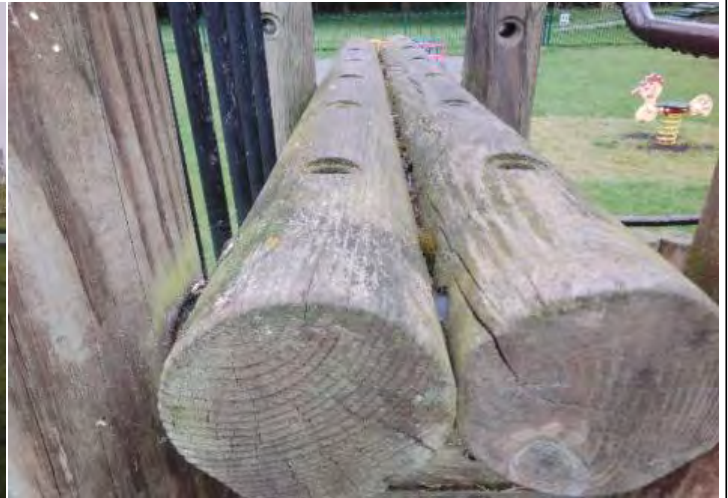
Finding: There is algae or moss on the surface of the equipment

Action: Clean and treat appropriately

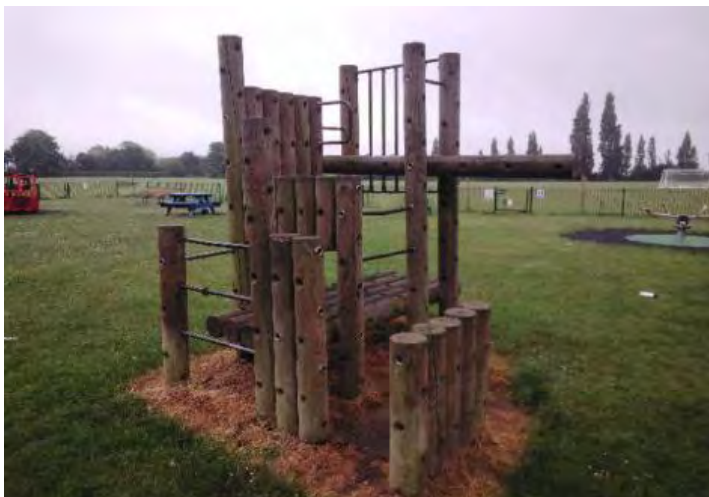
Finding: There is some damage to the item

Action: Monitor for any further deterioration and repair as required

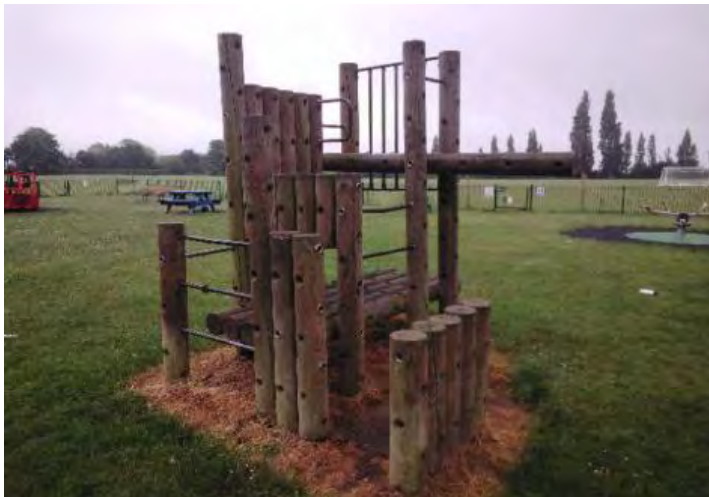
Finding: There is some strimmer / machinery damage apparent on the posts, this can penetrate the preservative applied to the timber and accelerate the rotting process

Action: Monitor for any deterioration (rot) and replace as required

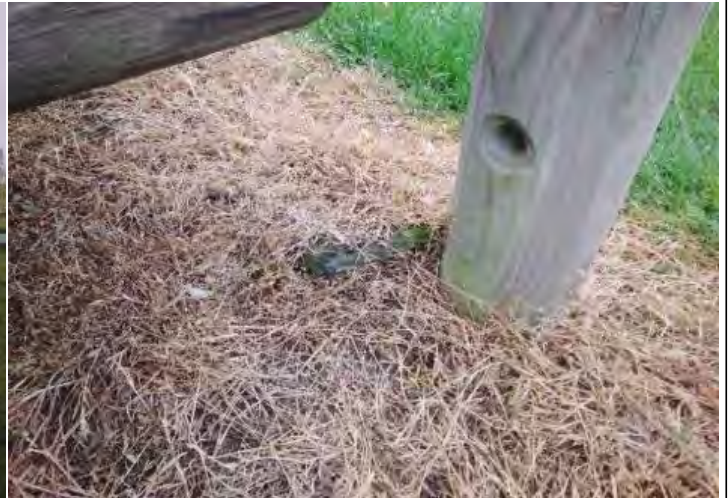
Finding: There are gaps opening between the grass mat tiles

Action: Provide additional ties or secure / reinstate surface

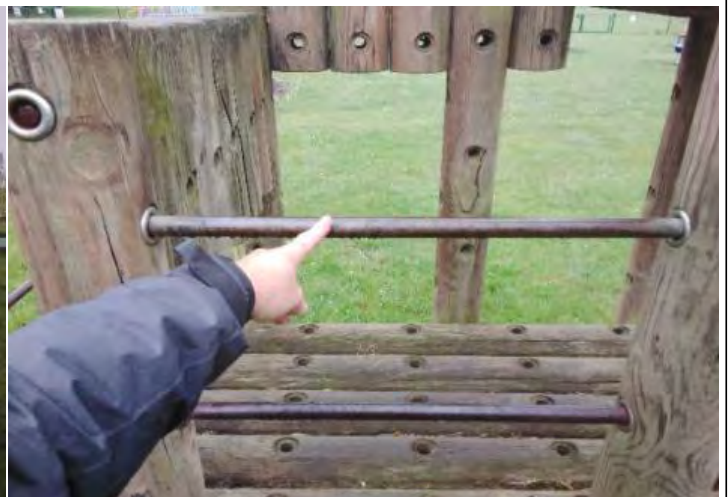
Finding: The rungs rotate

Action: Secure

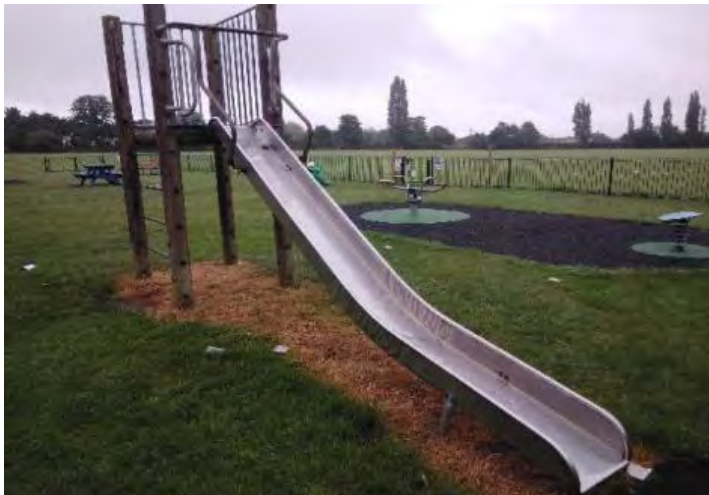
Finding: There are a number of dents in the slide surface

Action: Monitor for any further deterioration and repair as required

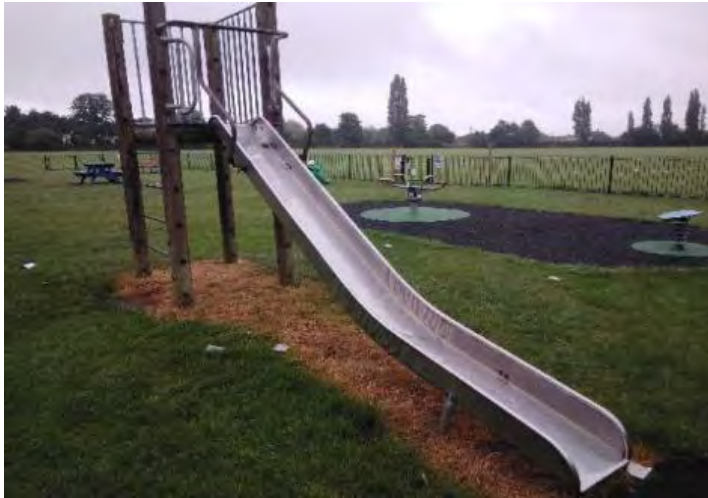
Finding: There is/are finger entrapment/s in the slide starting section and the item fails to meet the requirements of BS EN 1176 Part 1 4.2.7.6 Entrapment of fingers

Action: Monitor - No remedial work recommended

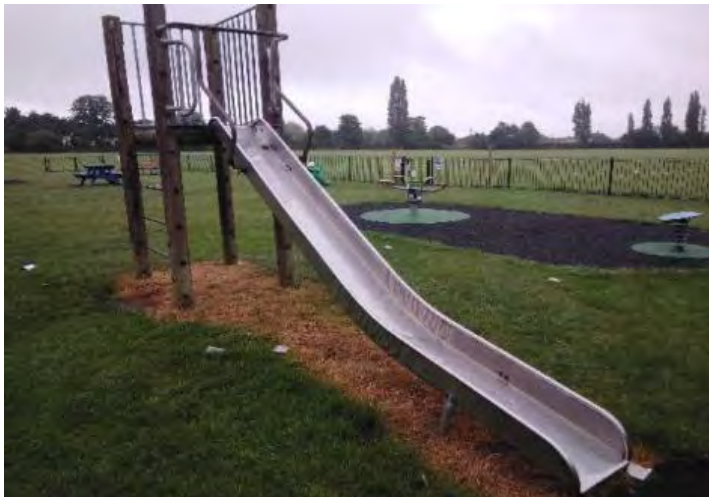
Finding: The paintwork on this item has been damaged or worn exposing the metal underneath which is rusting

Action: Treat any rusting components and repaint

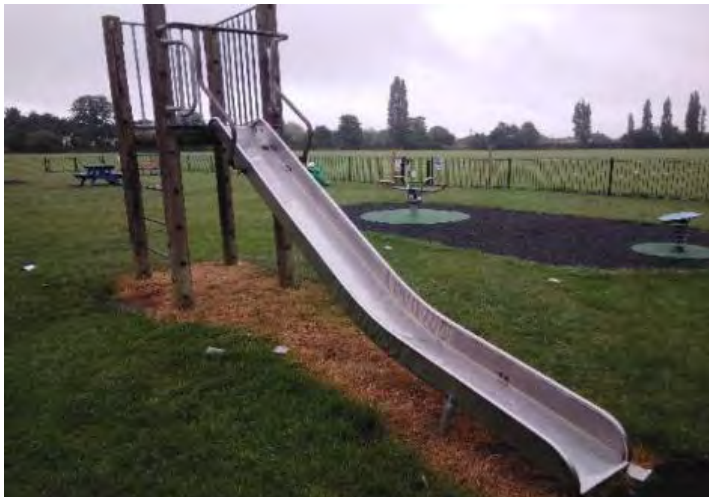
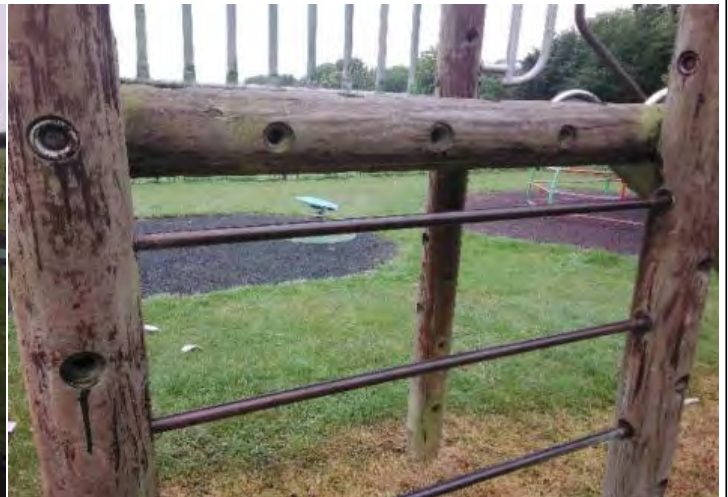
Finding: The bars rotate

Action: Secure

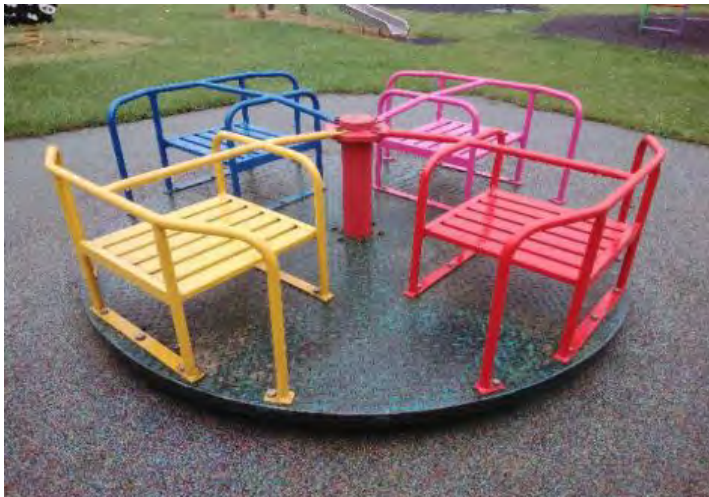
Finding: The underside of the rotating platform shall be smooth for the first 500mm towards the axis to comply with the requirements of BS EN 1176 Part 5

Action: Monitor - No remedial work recommended

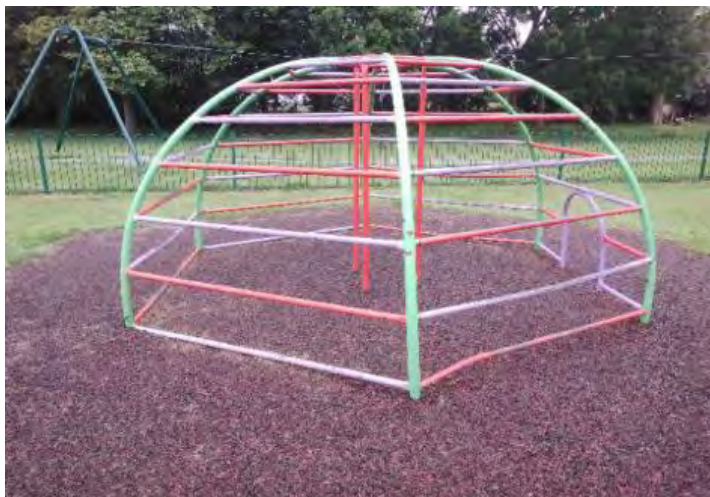
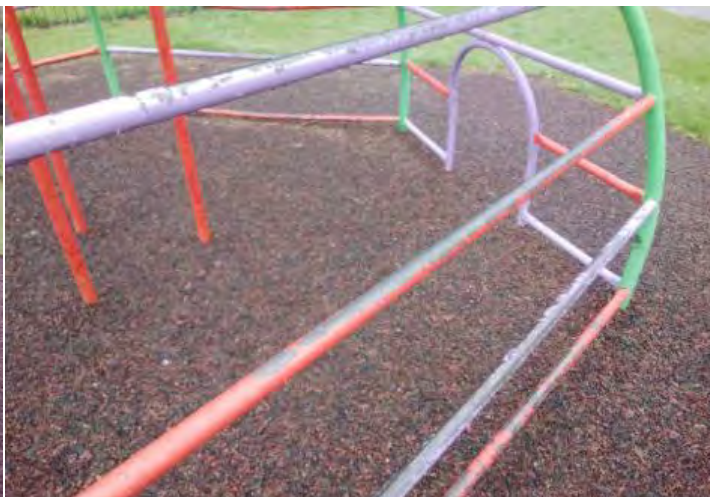
Finding: The paint is flaking off the metalwork

Action: Rub down and re-paint

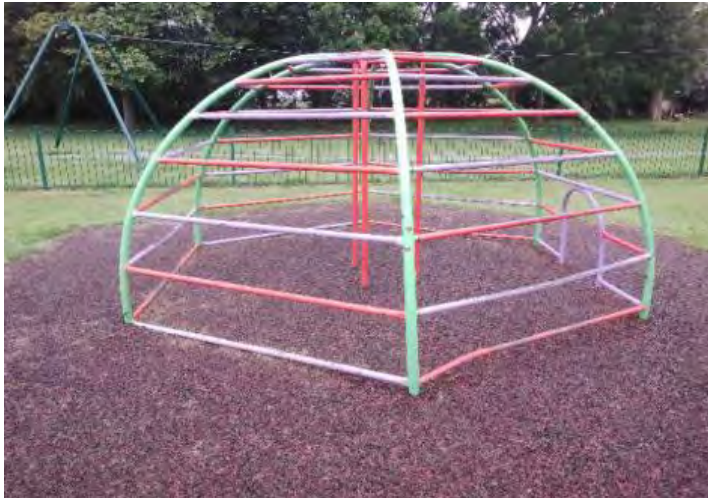
Finding: There is some damage to the item

Action: Monitor for any further deterioration and repair as required

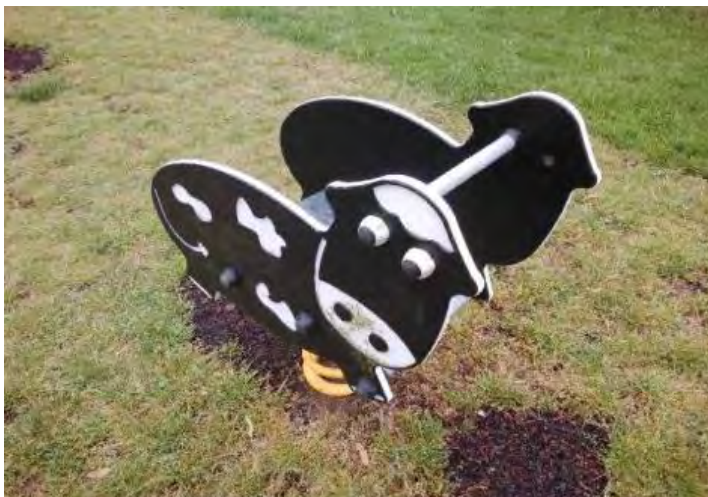
Finding: The paintwork on this item has been damaged or worn exposing the metal underneath which is rusting

Action: Treat any rusting components and repaint

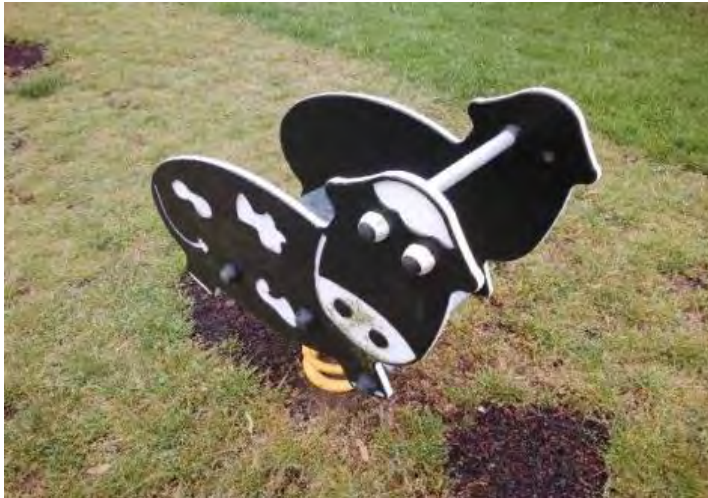
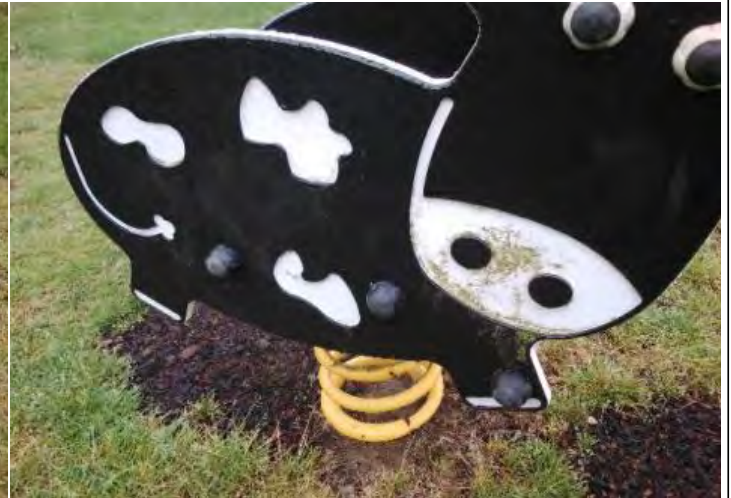
Finding: There is algae or moss on the surface of the equipment

Action: Clean and treat appropriately

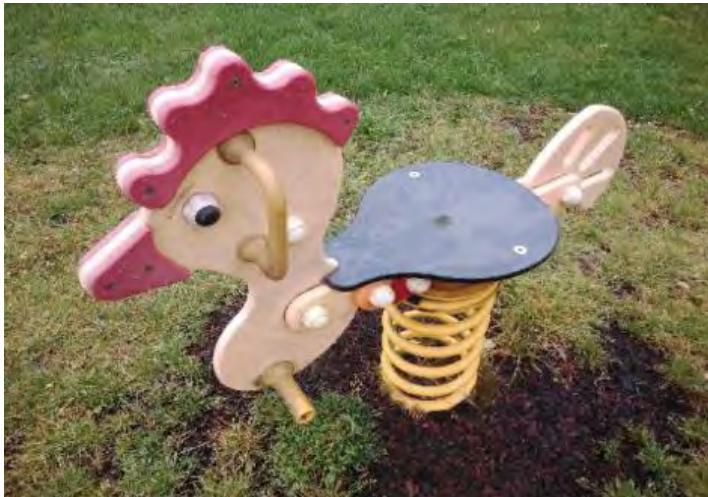
Finding: The end caps are missing on the Handgrips/Footrests

Action: Replace missing end caps

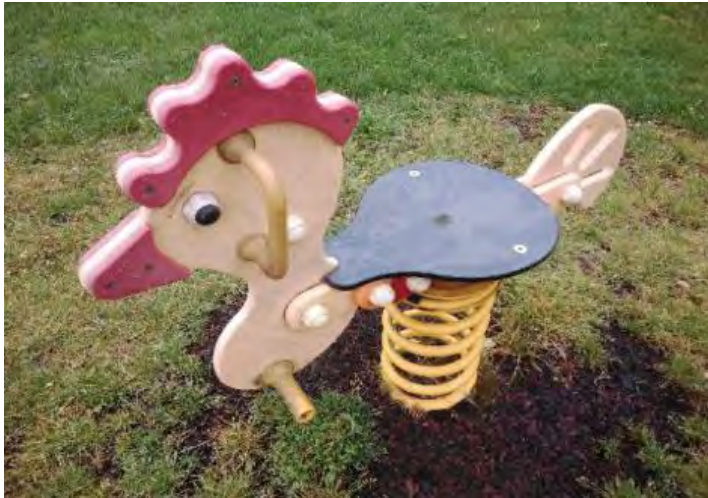
Finding: The end of handgrips and/or footrests have a cross section of less than 15cm² and fail to meet the requirements of BS EN 1176 Part 6
Action: Monitor - No remedial work recommended

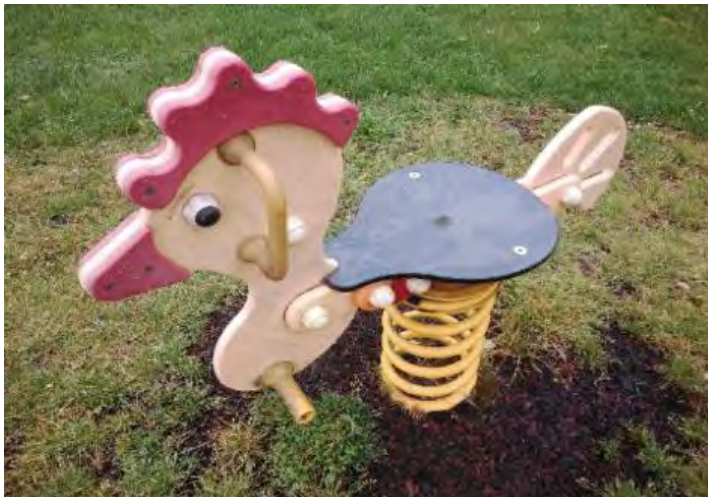
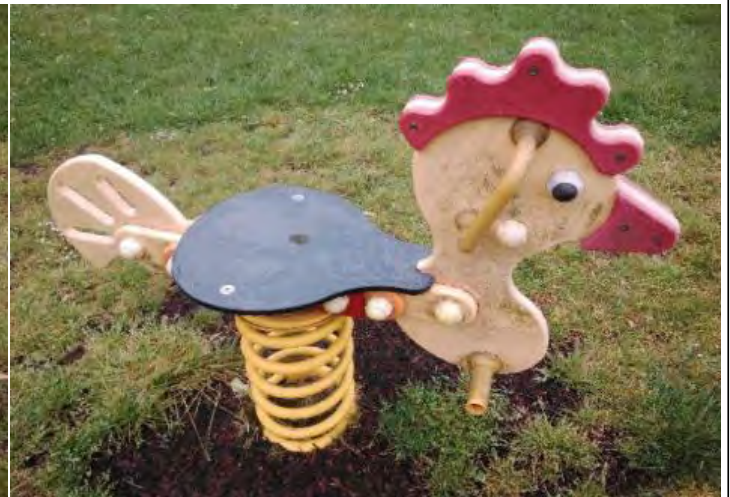
Finding: There is algae or moss on the surface of the equipment

Action: Clean and treat appropriately

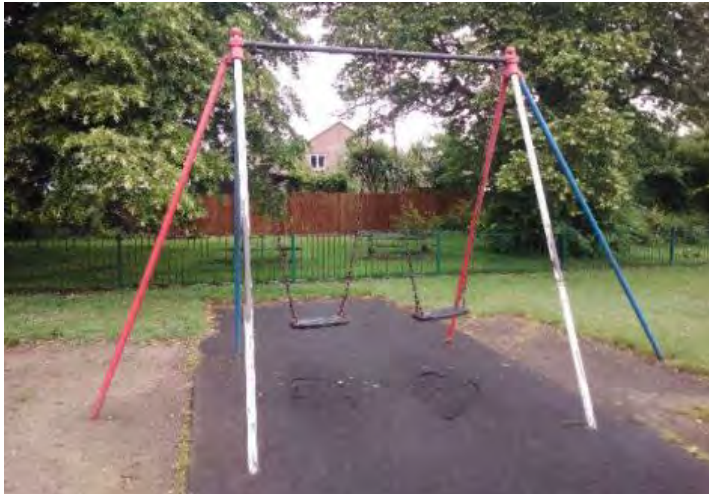
Finding: The chain openings are in excess of the 8.6mm as recommended by BS EN 1176

Action: Monitor - No remedial work recommended

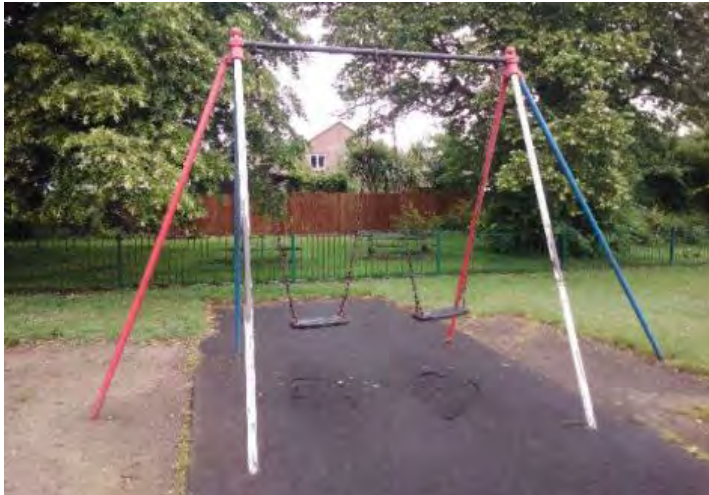
Finding: There is some notable evidence of chain wear

Action: Monitor for any further deterioration and replace when 40% worn
