TOLLESBURY
PARISH
COUNCIL

AGENDA – RECREATION GROUND COMMITTEE
11TH OCTOBER 2022

7. Play Inspection Report

To receive the report from the Annual Independent Play Area inspection.

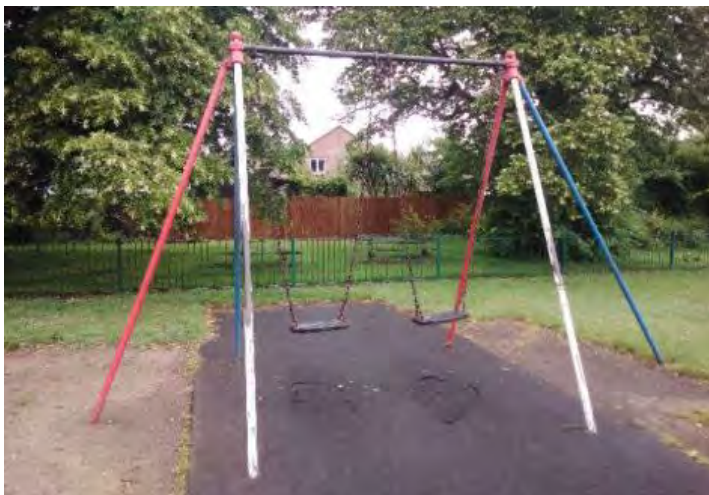
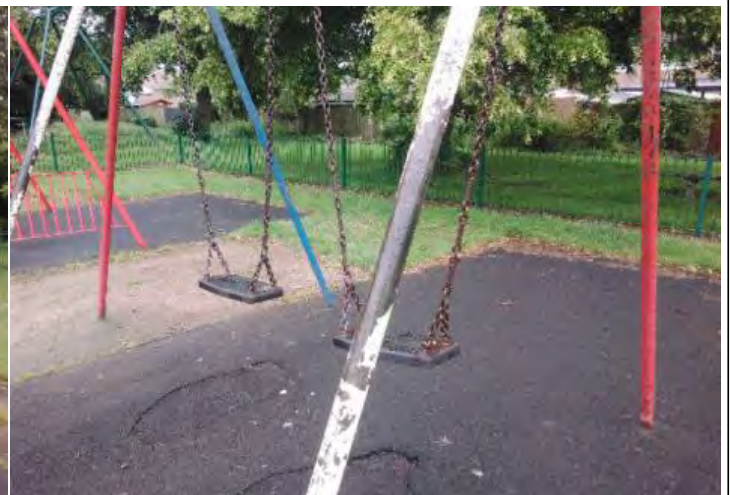
Finding: The paint is flaking off the metalwork

Action: Rub down and re-paint

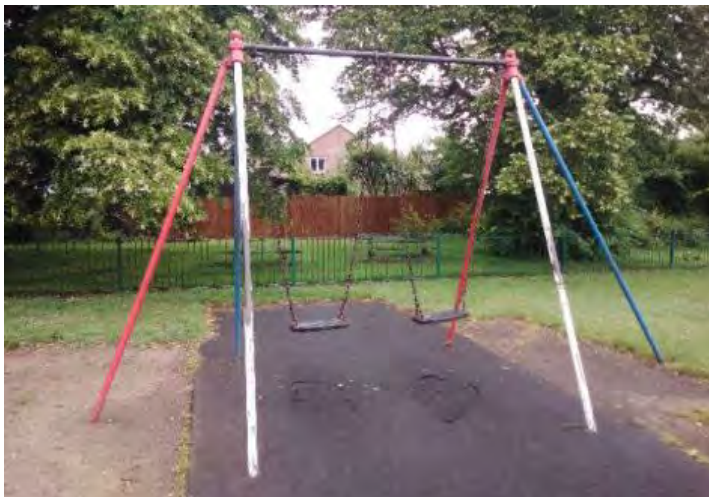
Finding: The seats are too close to the frame as defined in BS EN 1176 Part 2; this is a low risk failure and no remedial action is required

Action: Monitor - No remedial work recommended

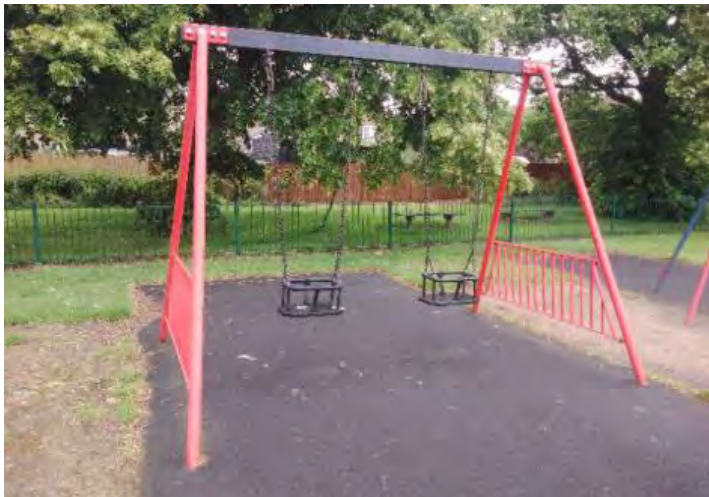
Finding: The chain openings are in excess of the 8.6mm as recommended by BS EN 1176
Action: Monitor - No remedial work recommended

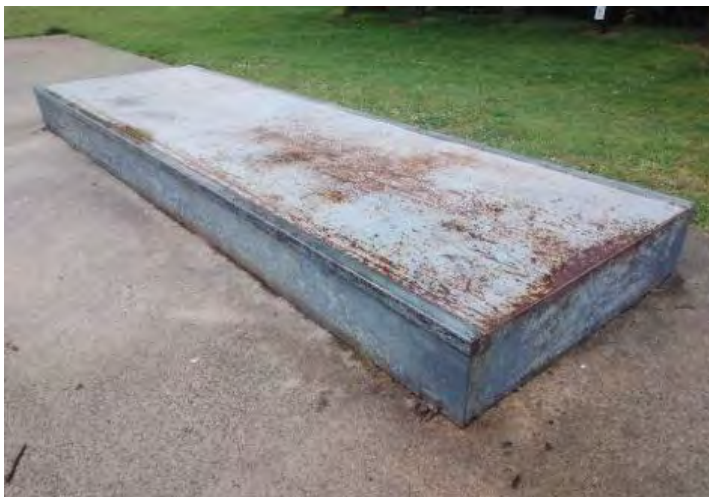
Finding: The paintwork on this item has been damaged or worn exposing the metal underneath which is rusting

Action: Treat any rusting components and repaint

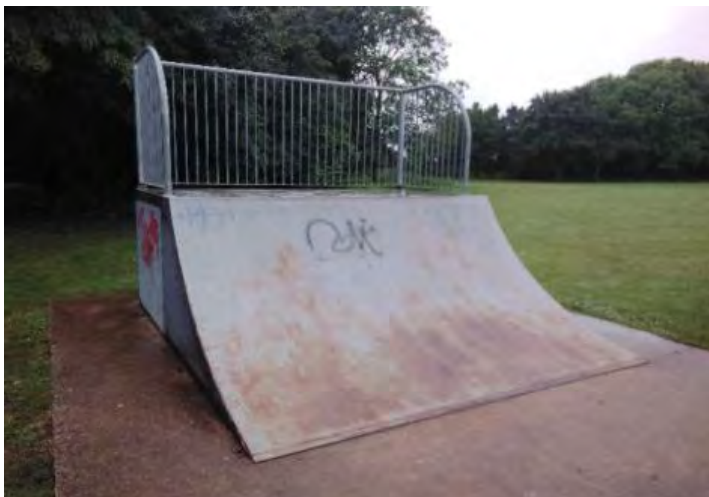
Finding: The height of the barrier is less than 1200mm and fails the requirements of BS EN 14974

Action: Monitor - No remedial work recommended

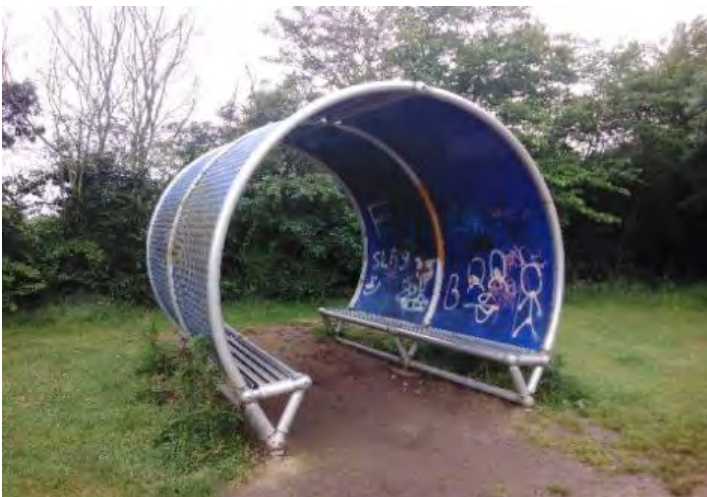
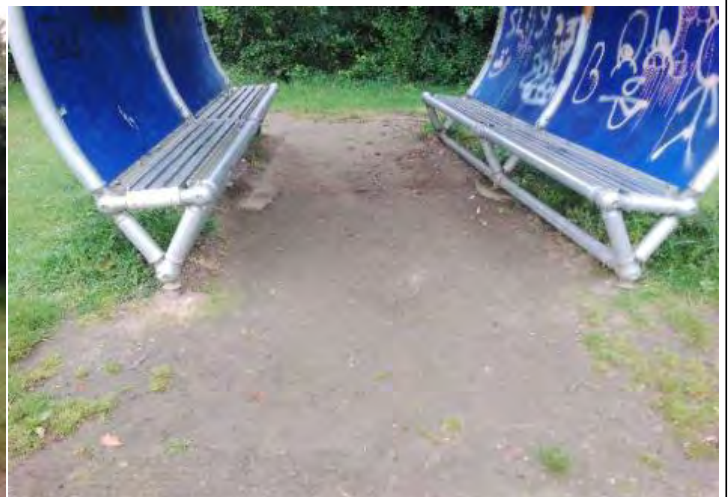
Item: Ancillary Items - Shelter
Manufacturer: Not Identified

Risk Level: L - Low Risk
Surface: Grass

Finding: The surface has eroded in some areas

Action: Reinstate the surface

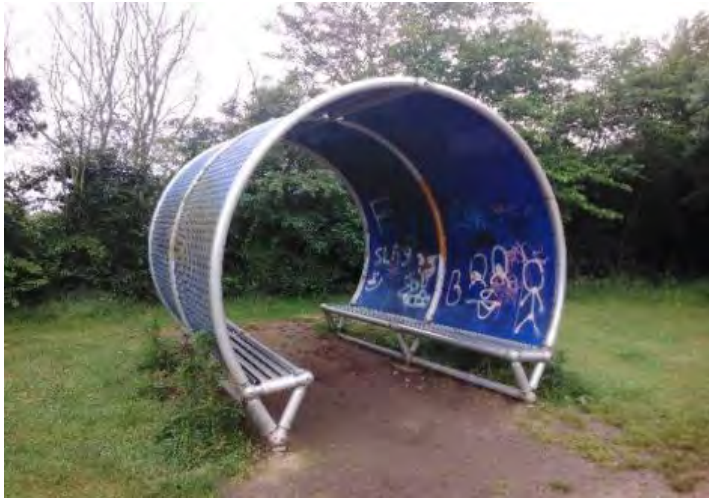
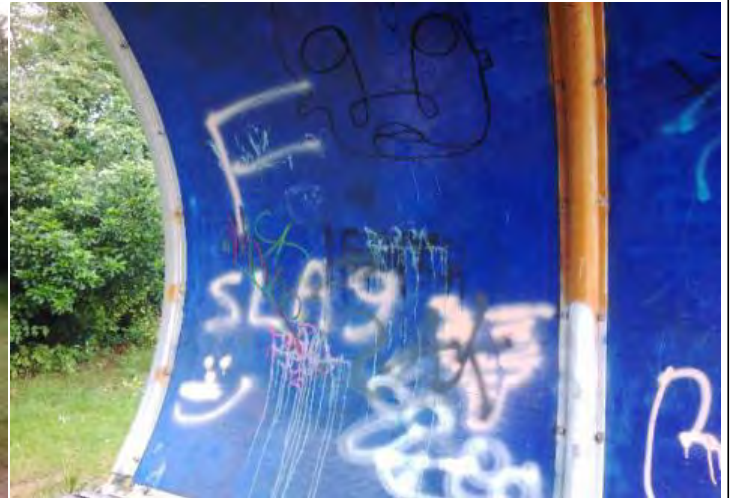
Item: Ancillary Items - Shelter
Manufacturer: Not Identified

Risk Level: N - Risk Assessment not Undertaken
Surface: Grass

Finding: There is offensive graffiti present

Action: Remove as soon as practicable

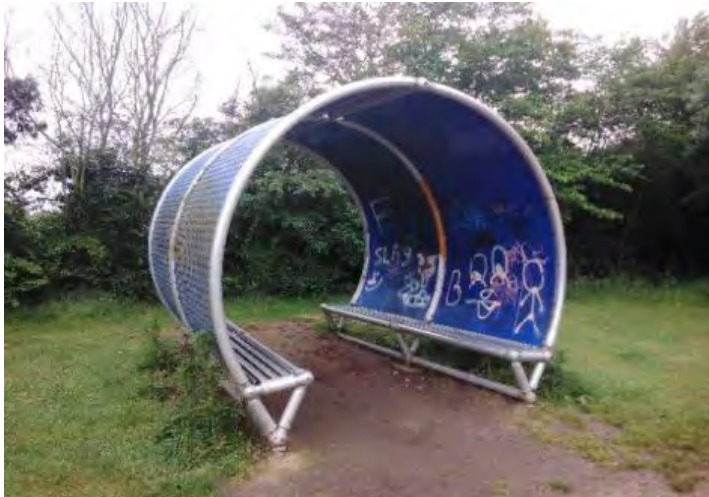
Item: Ancillary Items - Shelter
Manufacturer: Not Identified

Risk Level: L - Low Risk
Surface: Grass

Finding: There is excessive movement within the structure

Action: Monitor for any further deterioration and repair as required

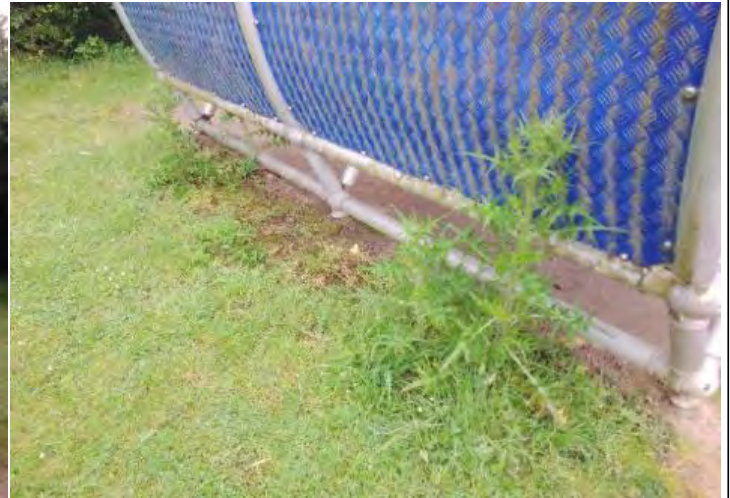
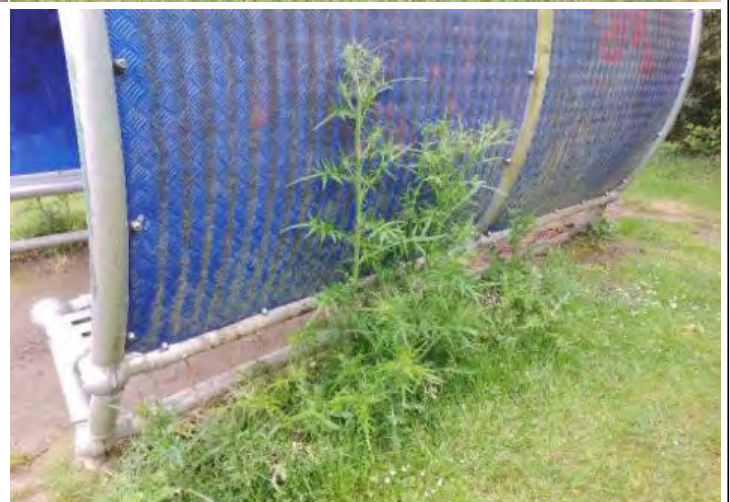
Item: Ancillary Items - Shelter
Manufacturer: Not Identified

Risk Level: L - Low Risk
Surface: Grass

Finding: There is weed / vegetation growth on, between, or around the edges of the surfacing
Action: Remove weed / vegetation growth

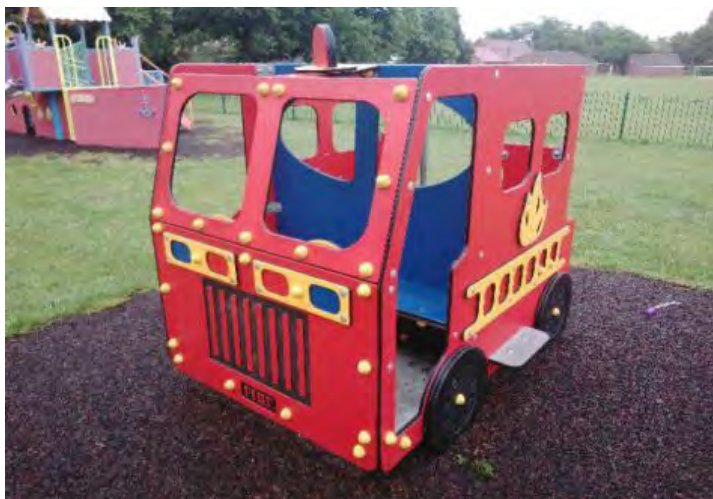
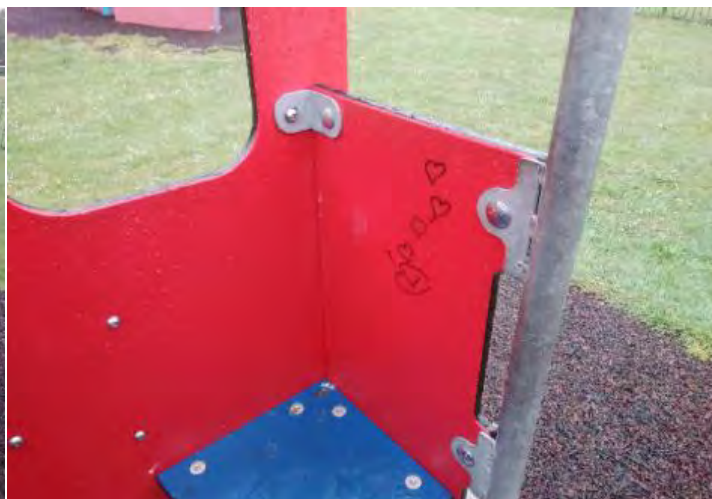
Item: Activity Equipment - Multi Play (Toddler)
Manufacturer: Not Identified

Risk Level: N - Risk Assessment not Undertaken
Surface: Bonded Rubber Mulch

Finding: There is some graffiti present

Action: Remove the graffiti

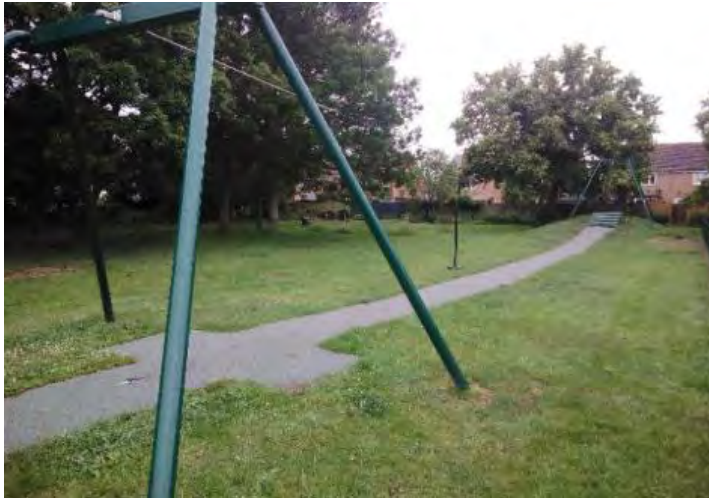
Item: Other - Cable Runway
Manufacturer: Not Identified

Risk Level: L - Low Risk
Surface: Wet Pour

Finding: There is some notable evidence of chain wear

Action: Monitor for any further deterioration and replace when 40% worn

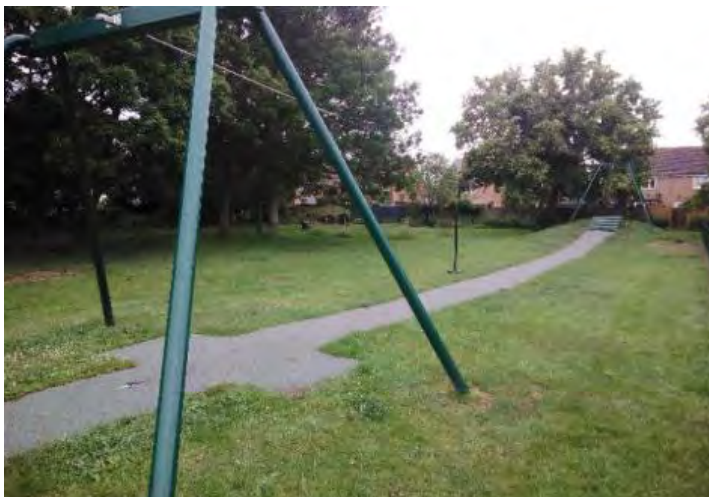
Item: Other - Cable Runway
Manufacturer: Not Identified

Risk Level: L - Low Risk
Surface: Wet Pour

Finding: The seat suspension cover has been damaged

Action: Monitor for any further deterioration and replace as required

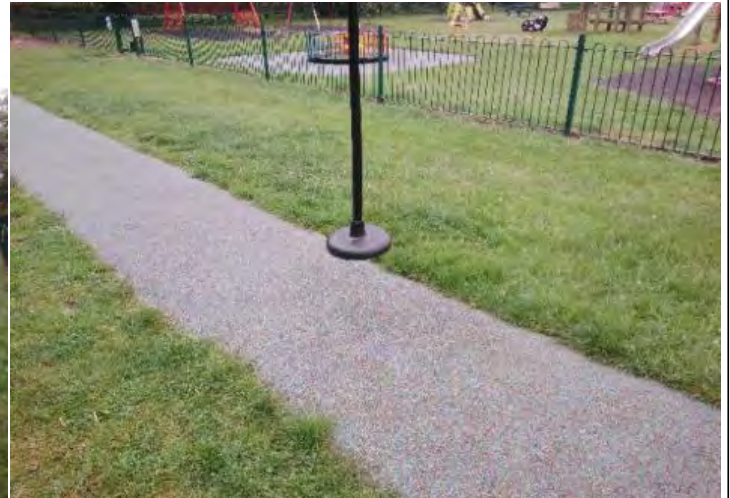
Item: Other - Cable Runway
Manufacturer: Not Identified

Risk Level: L - Low Risk
Surface: Wet Pour

Finding: The height of the seat is less than 350mm when loaded and does not meet the requirements of BS EN 1176 Part 4

Action: Ensure the seat is a minimum of 350mm above ground level when loaded with 69.5kg

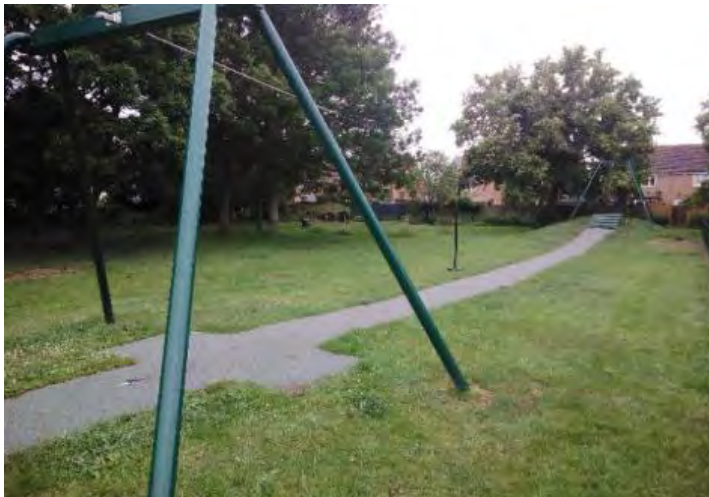
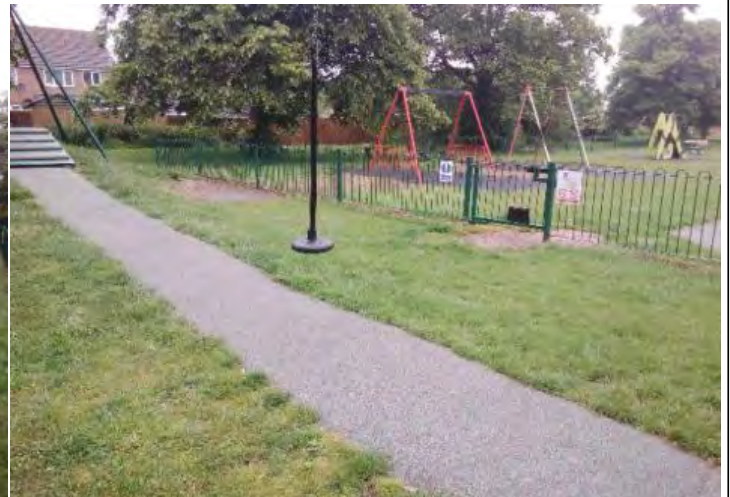
Item: Other - Cable Runway
Manufacturer: Not Identified

Risk Level: L - Low Risk
Surface: Wet Pour

Finding: There is the potential for users to pass through the freespace of the cableway when entering or exiting the play area

Action: Monitor use

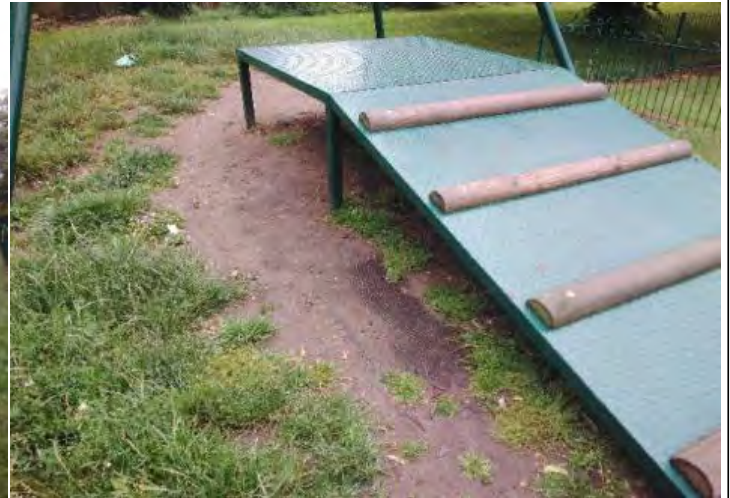
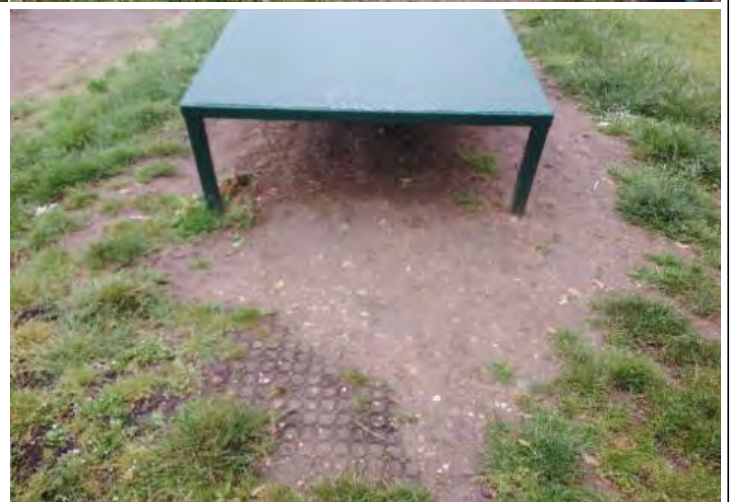
Item: Other - Cable Runway
Manufacturer: Not Identified

Risk Level: L - Low Risk
Surface: Wet Pour

Finding: The surface has eroded in some areas

Action: Reinststate the surface
